**CLIENT NAME:**  
Borough of Emerson

**PROJECT NAME:**  
Stormwater Outfall Survey

**PROJECT No.:**  
EM-325

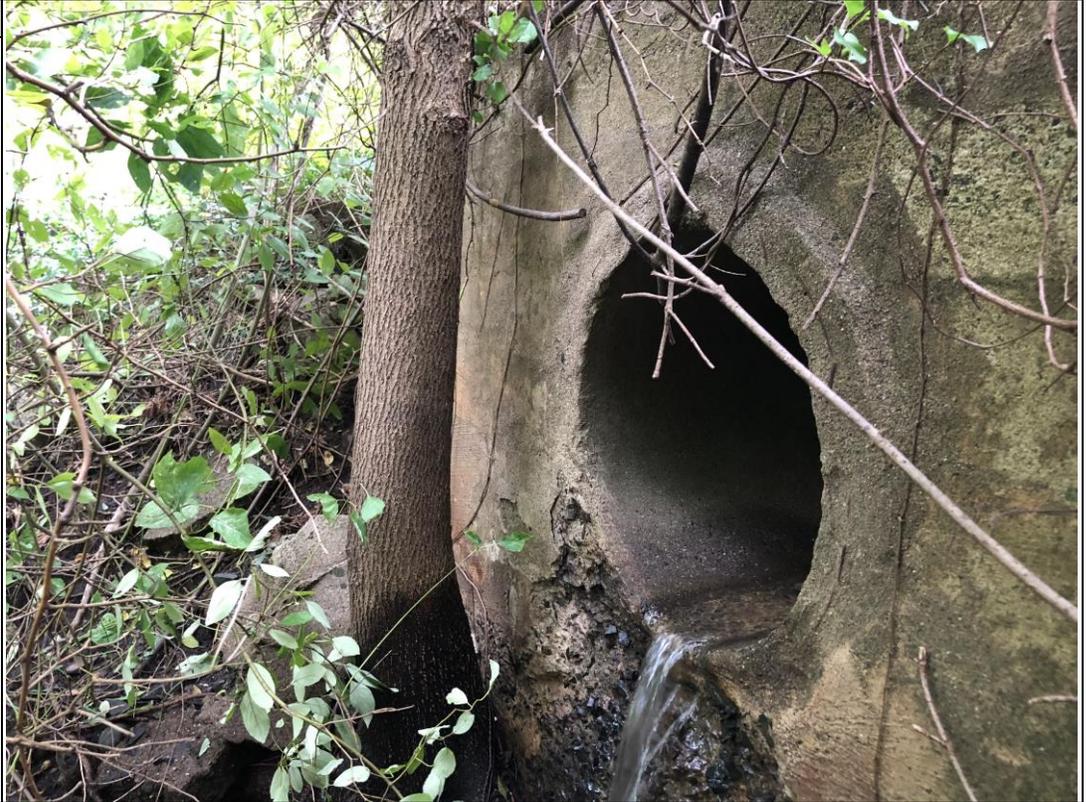
**Photo No. 1.**

Discharge ID:  
D-1

Location:  
98 Dorchester Rd

Watercourse:  
Musquapsink Brook

Size:  
24" RCP

Condition:  
Good

Scour:  
No

Illicit Connection:  
No

Repair:  
No

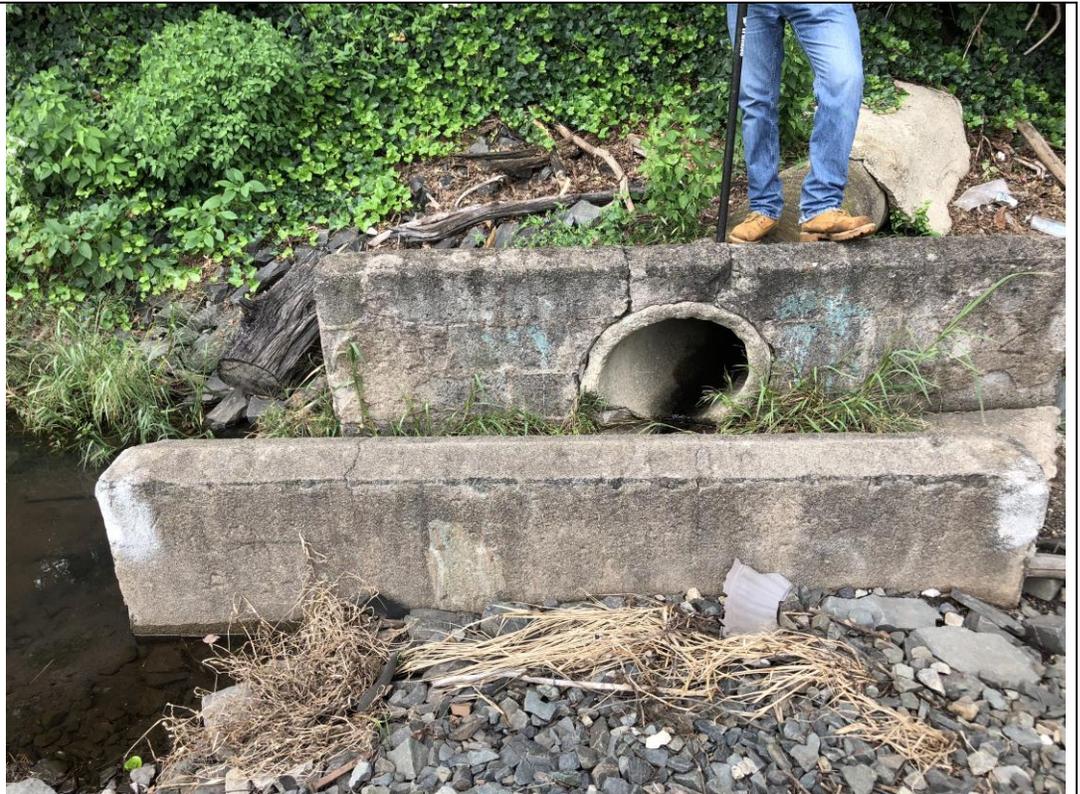
**Photo No. 2.**

Discharge ID:  
D-2

Location:  
Chestnut Street

Watercourse:  
Unknown Ditch

Size:  
18" RCP

Condition:  
Good

Scour:  
No

Illicit Connection:  
No

Repair:  
No

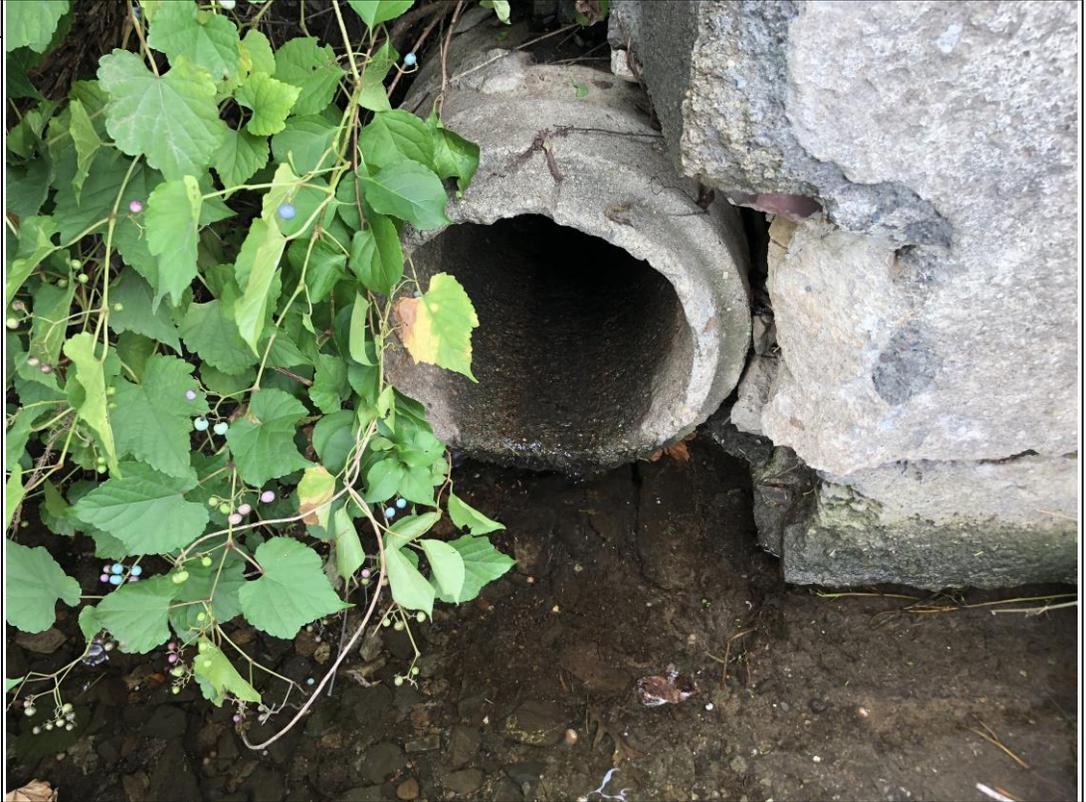
**Photo No. 3.**

Discharge ID:  
D-3

Location:  
Lozier Ave.

Watercourse:  
Unknown Ditch

Size:  
15" RCP

Condition:  
Fair

Scour:  
Yes

Illicit Connection:  
No

Repair:  
Repair Headwall  
**NJDEP Permit Required**

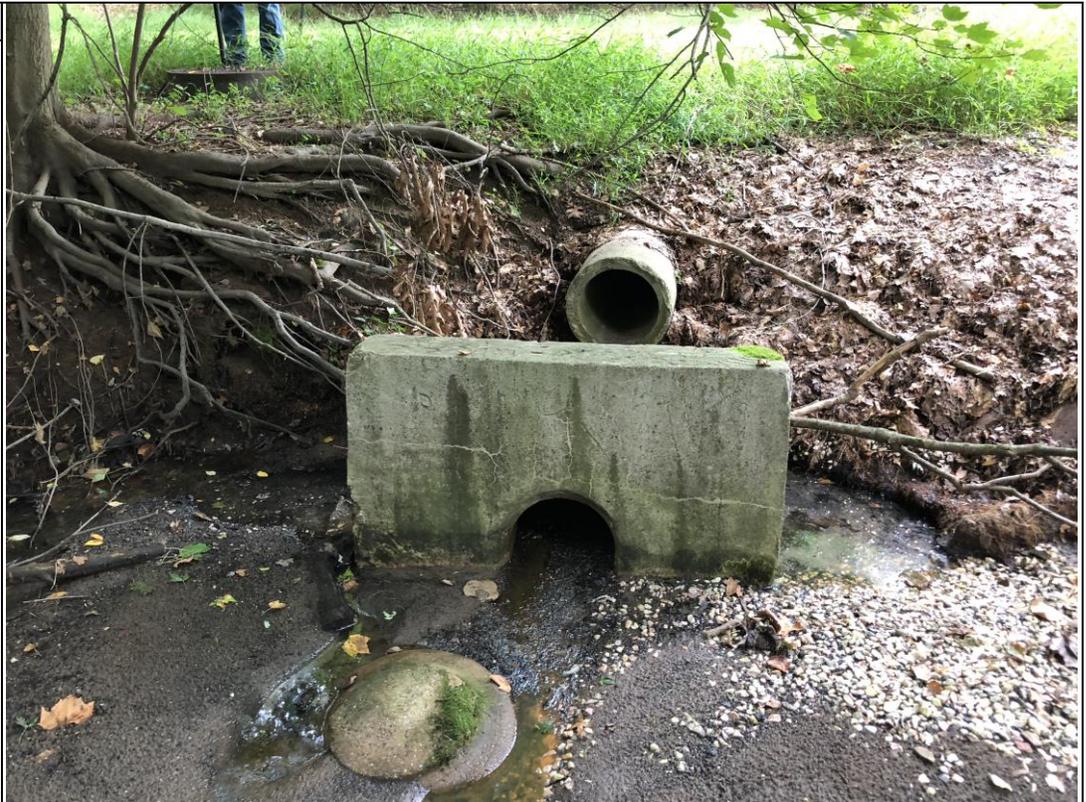
**Photo No. 4.**

Discharge ID:  
D-4

Location:  
160 Highland Ave.

Watercourse:  
Emerson Brook

Size:  
18" RCP

Condition:  
Poor

Scour:  
Yes

Illicit Connection:  
No

Repair:  
Reset Headwall  
**NJDEP Permit Required**

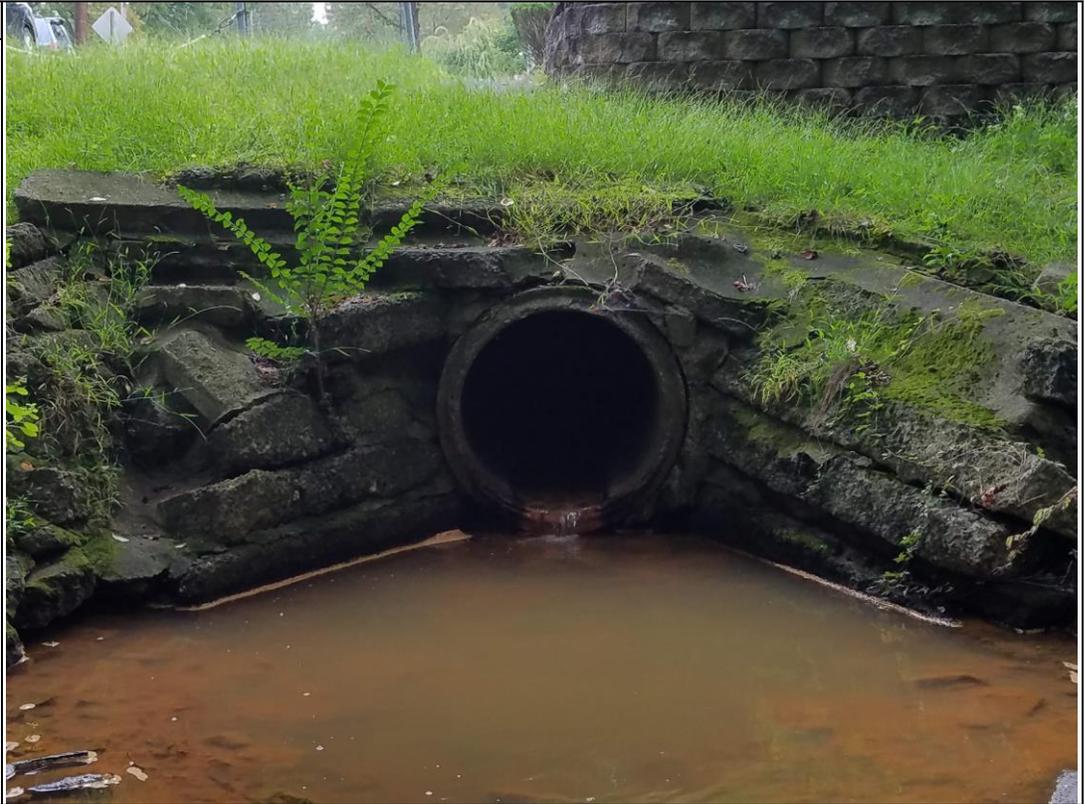
**Photo No. 5.**

Discharge ID:  
D-5

Location:  
1 Daned Rd

Watercourse:  
Emerson Brook

Size:  
36" RCP

Condition:  
Excellent

Scour:  
No

Illicit Connection:  
No

Repair:  
No

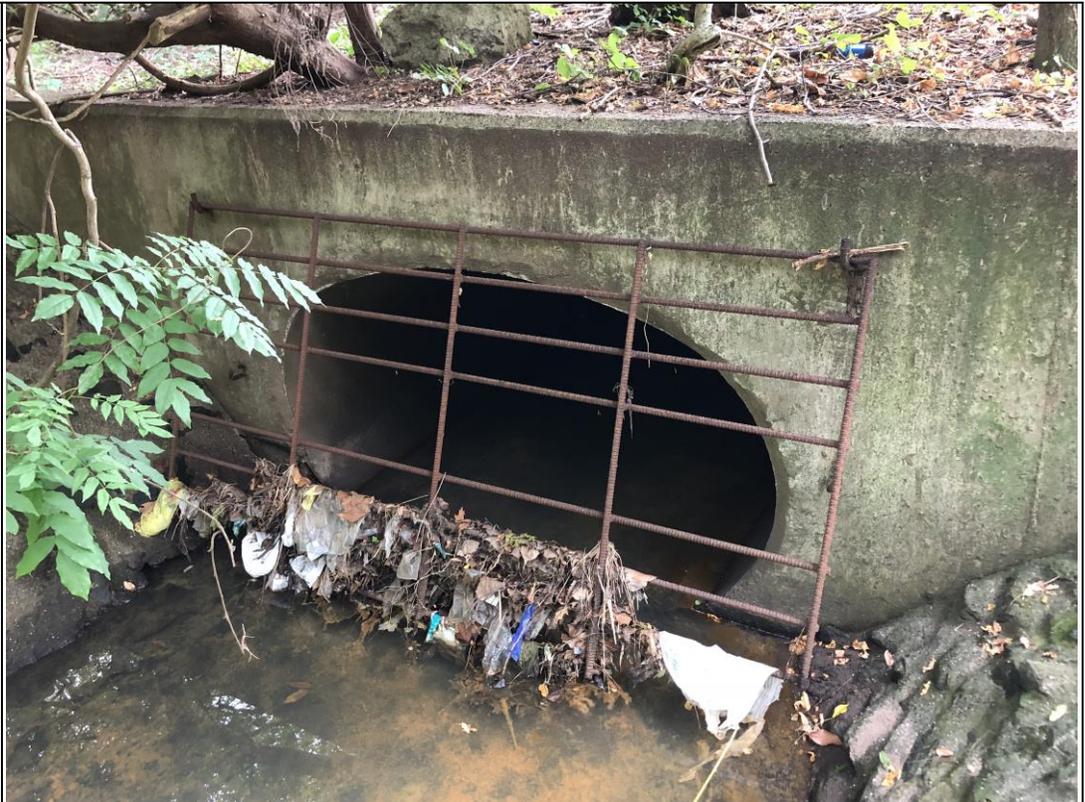
**Photo No. 6.**

Discharge ID:  
D-6

Location:  
133 Eagle Drive

Watercourse:  
Emerson Brook

Size:  
48"x72" RECP

Condition:  
Excellent

Scour:  
No

Illicit Connection:  
No

Repair:  
Clear Trash

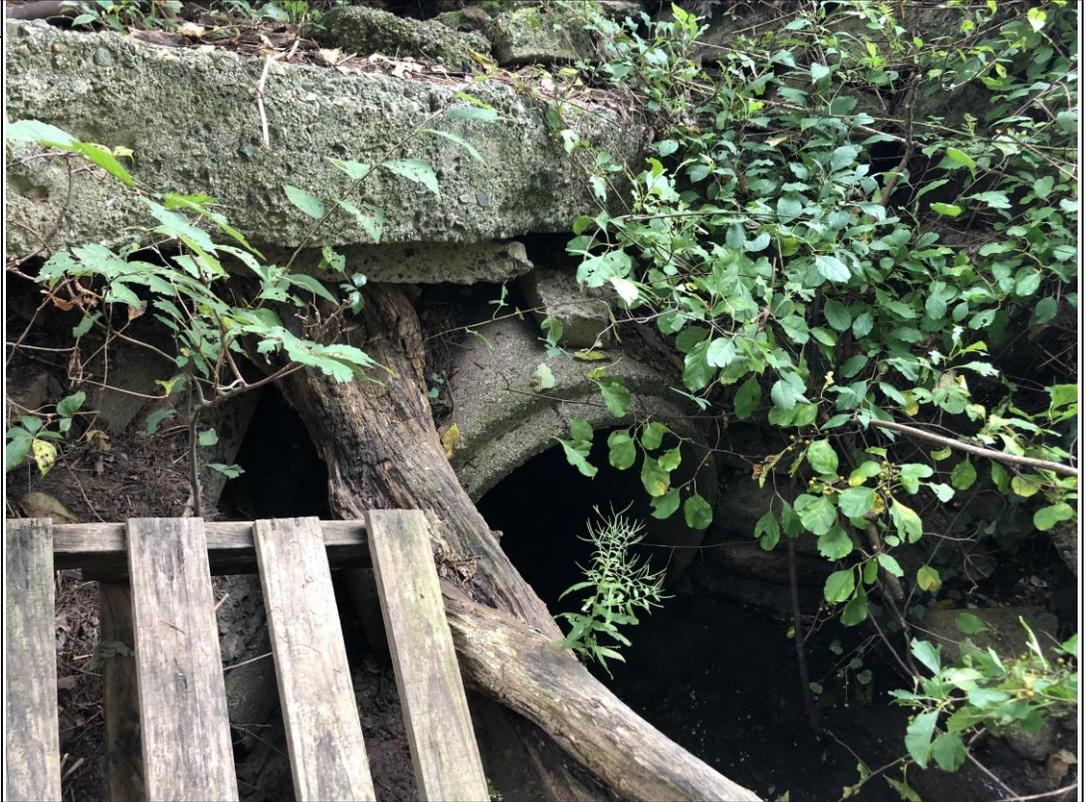
**Photo No. 7.**

Discharge ID:  
D-7

Location:  
169 Eagle Drive

Watercourse:  
Emerson Brook

Size:  
21" RCP

Condition:  
Good

Scour:  
No

Illicit Connection:  
No

Repair:  
Clear Trash

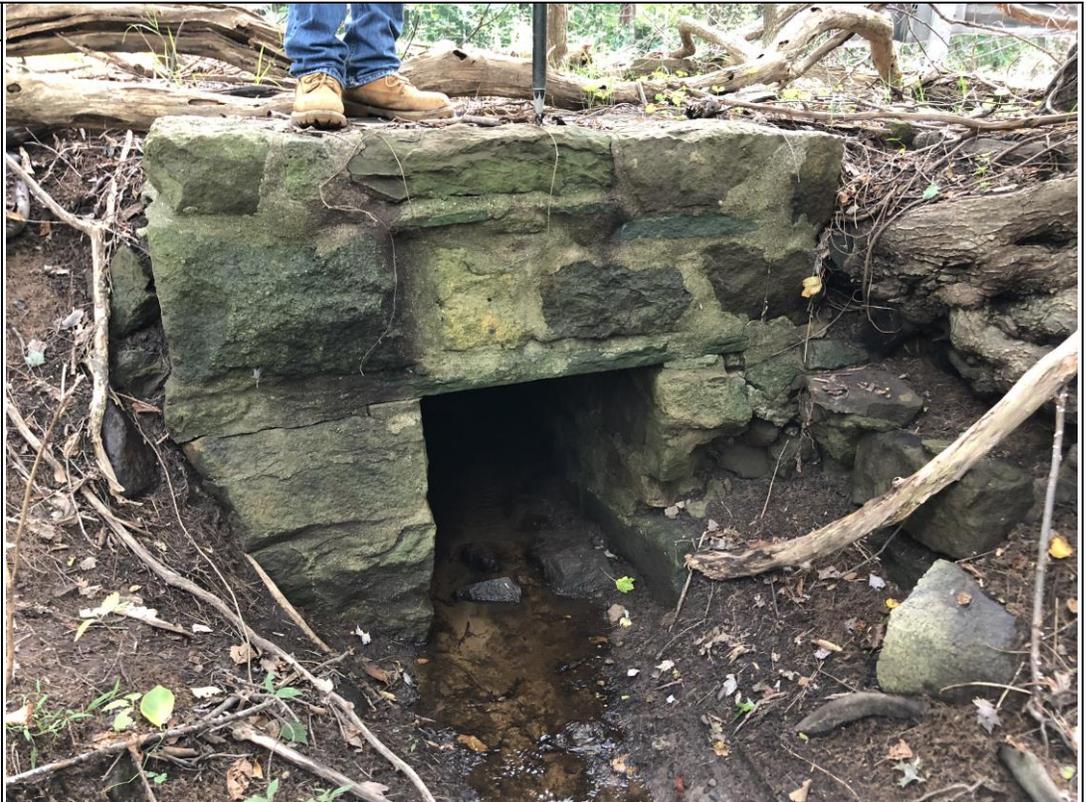
**Photo No. 8.**

Discharge ID:  
D-8

Location:  
Old Hook Rd

Watercourse:  
Pascack Brook

Size:  
2'x3' 3-sided Box Culvert

Condition:  
Good

Scour:  
No

Illicit Connection:  
No

Repair:  
No

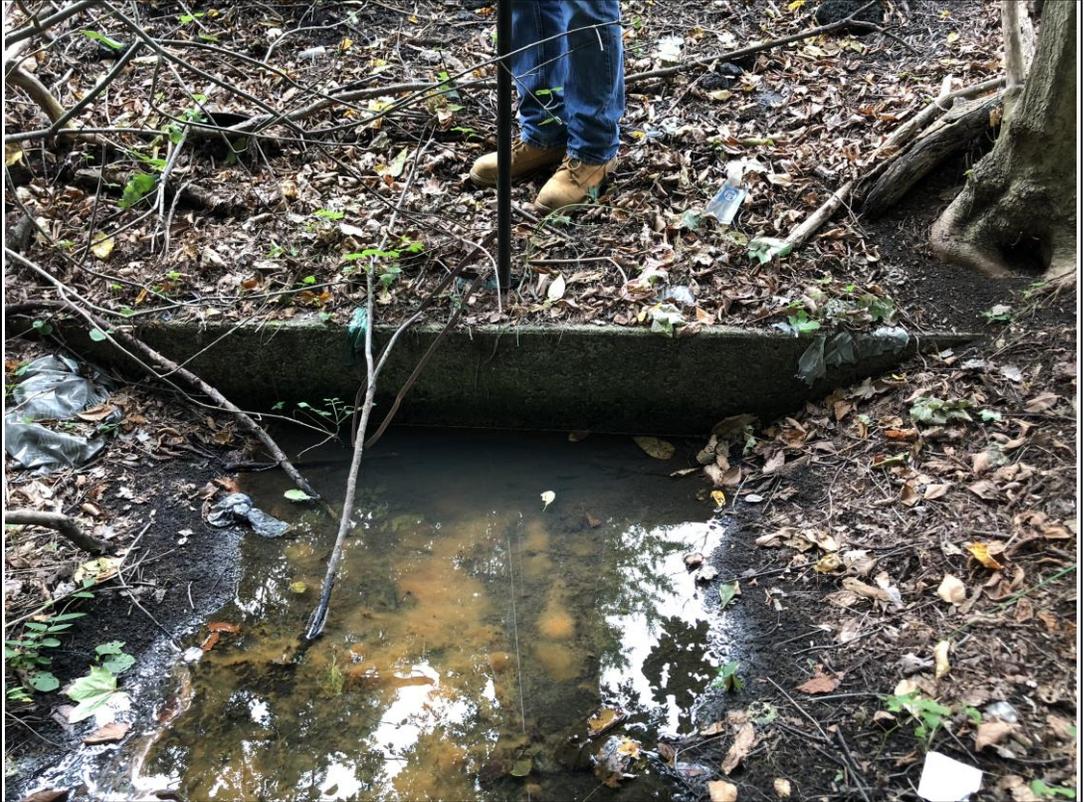
**Photo No. 9.**

Discharge ID:  
D-9

Location:  
Old Hook Rd

Watercourse:  
Pascack Brook

Size:  
Unknown

Condition:  
Poor

Scour:  
No

Illicit Connection:  
Unknown

Repair:  
Remove Sediment  
**NJDEP Permit Required**

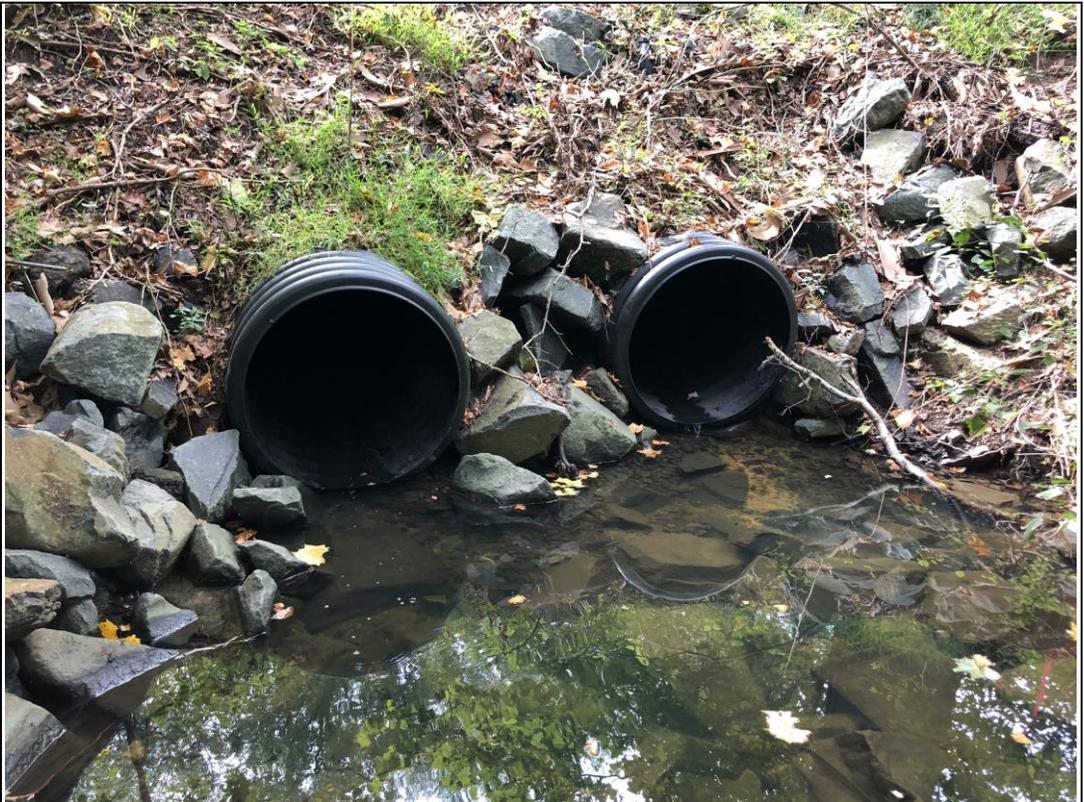
**Photo No. 10.**

Discharge ID:  
D-10

Location:  
Old Hook Rd

Watercourse:  
Pascack Brook

Size:  
36" HDPE

Condition:  
Excellent

Scour:  
No

Illicit Connection:  
No

Repair:  
No

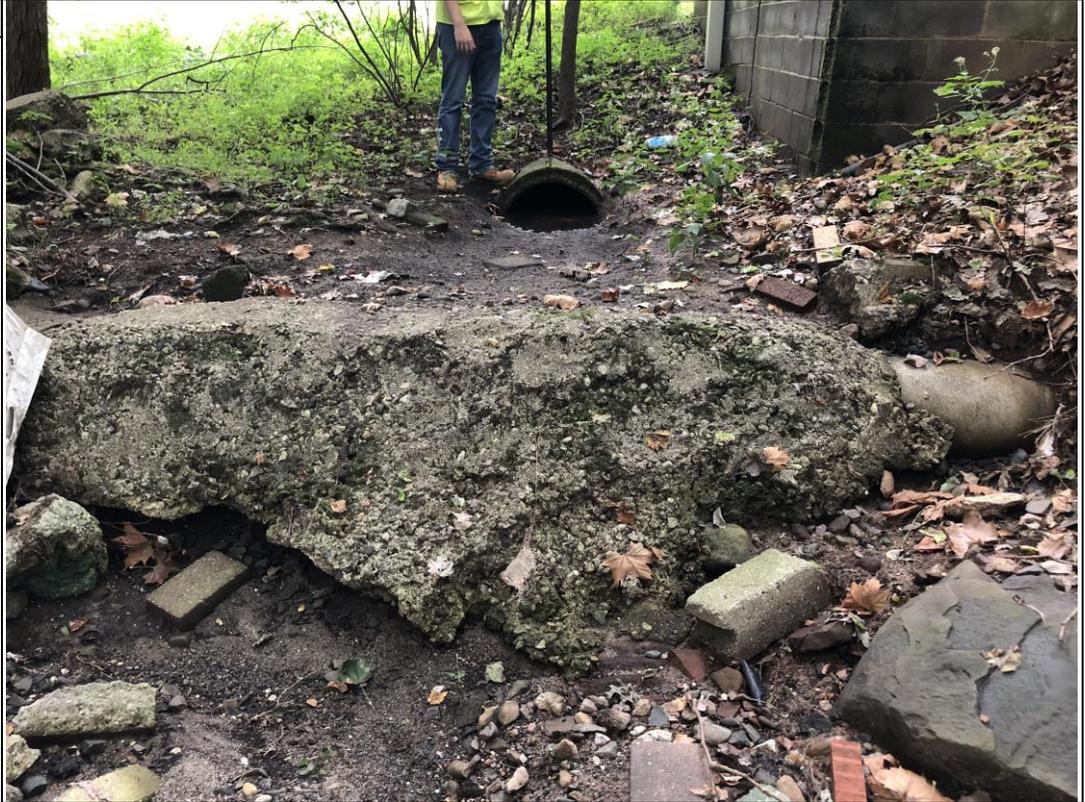
**Photo No. 11.**

Discharge ID:  
D-11

Location:  
Lakeview Drive

Watercourse:  
Hackensack River UNT

Size:  
24" RCP

Condition:  
Poor

Scour:  
No

Illicit Connection:  
No

Repair:  
Construct Pre-Form Scour  
Conduit Outlet Protection

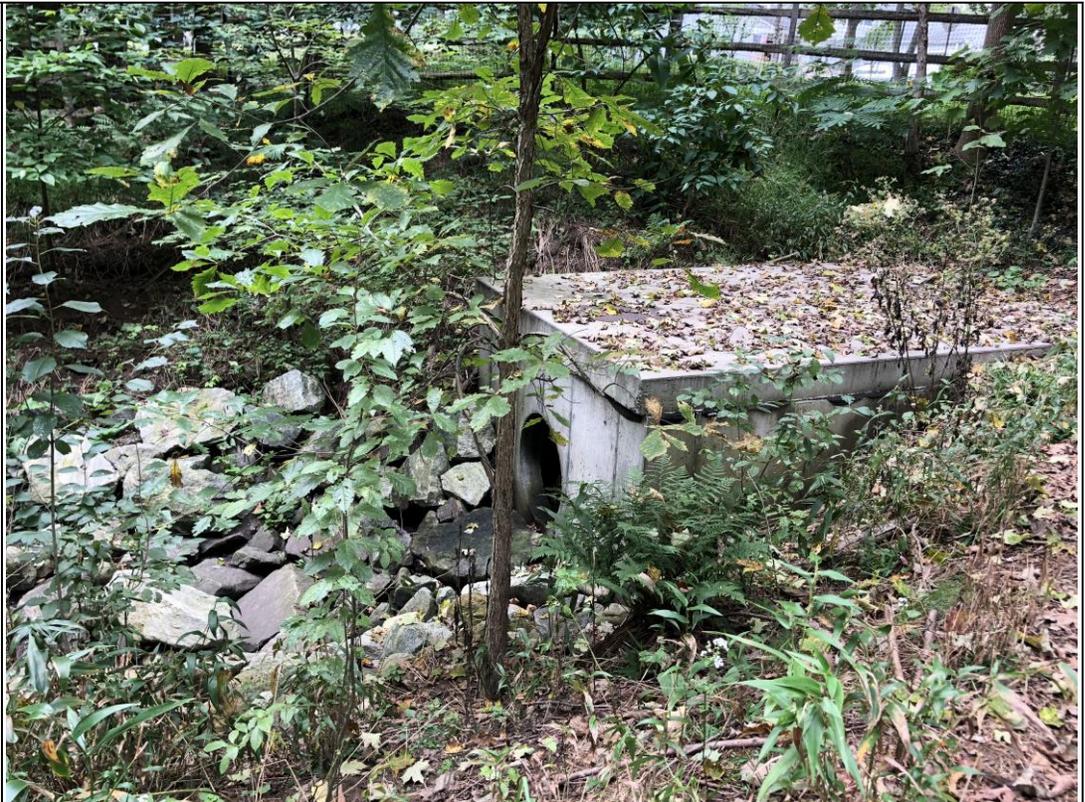
**Photo No. 12.**

Discharge ID:  
D-12

Location:  
Main St. & Ridge Rd.

Watercourse:  
Hackensack River UNT

Size:  
30" RCCP

Condition:  
Good

Scour:  
No

Illicit Connection:  
No

Repair:  
Manufactured Treatment  
Device may require service

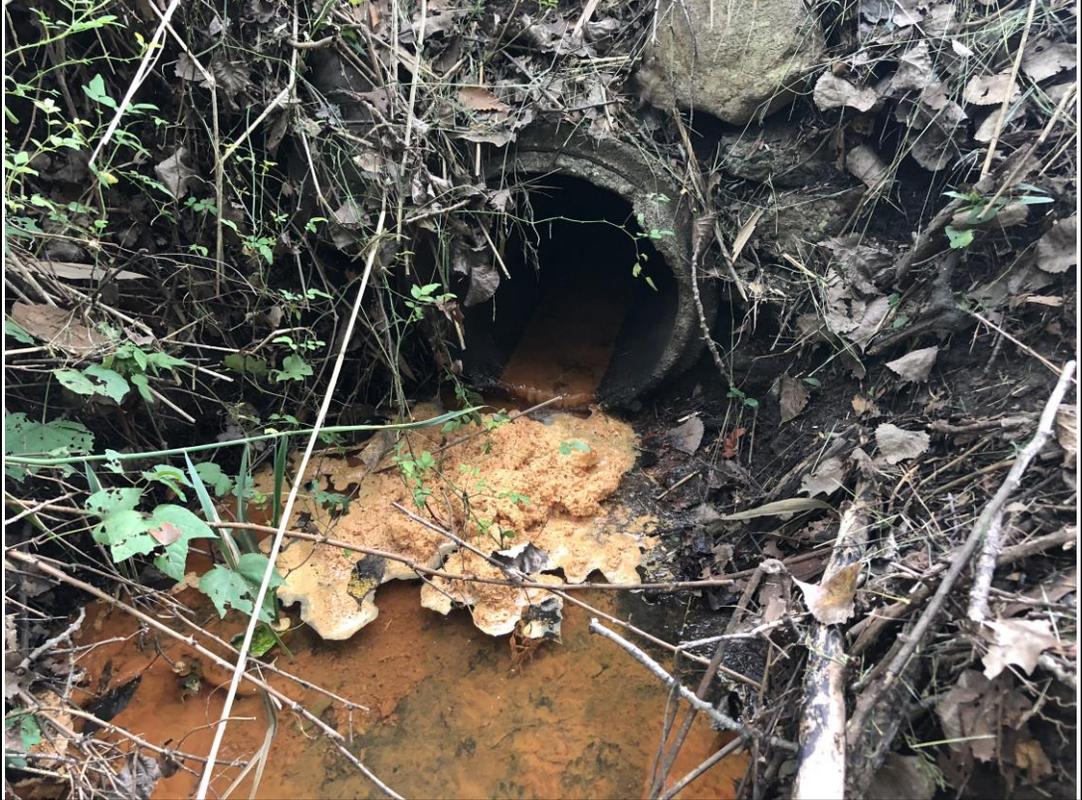
**Photo No. 13.**

**Description:**  
Discharge ID:  
D-13  
Location:  
Pine Dr. & Emwood Dr.  
Watercourse:  
Emerson Brook  
Size:  
18" RCP  
Condition:  
Good  
Scour:  
No  
Illicit Connection:  
No  
Repair:  
No

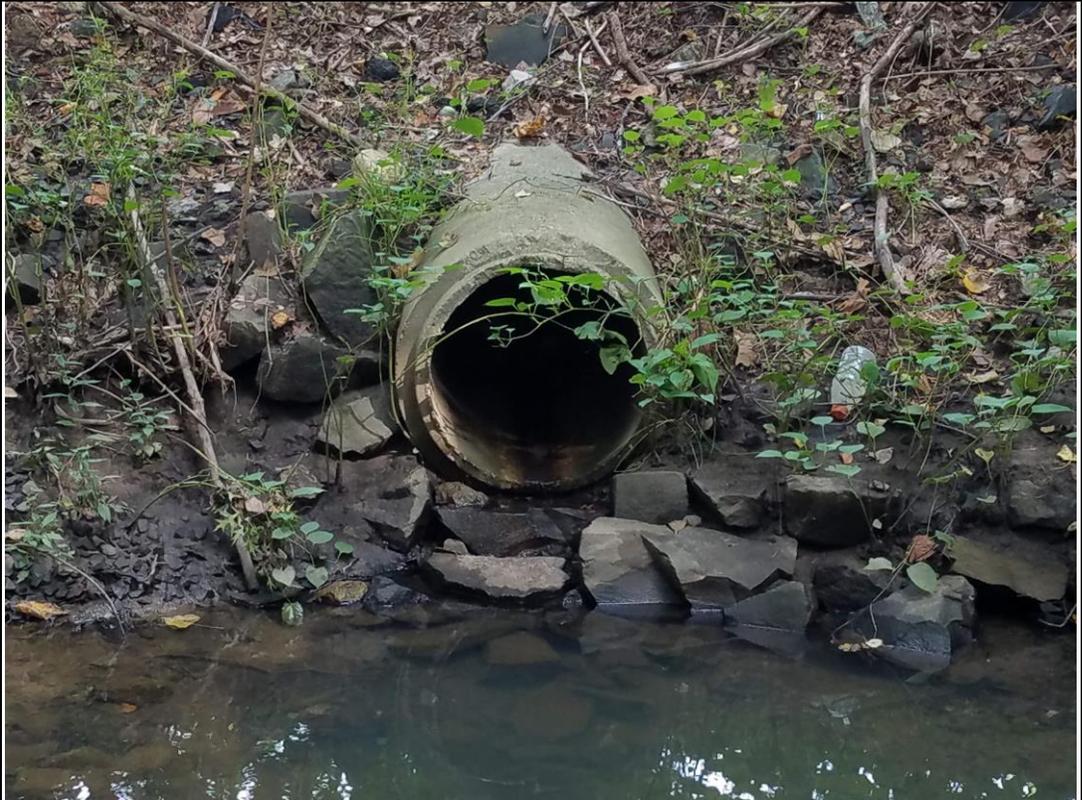
**Photo No. 14.**

**Description:**  
Discharge ID:  
D-14  
Location:  
Main St. & Pine Dr.  
Watercourse:  
Emerson Brook  
Size:  
24" RCP  
Condition:  
Good  
Scour:  
No  
Illicit Connection:  
No  
Repair:  
No

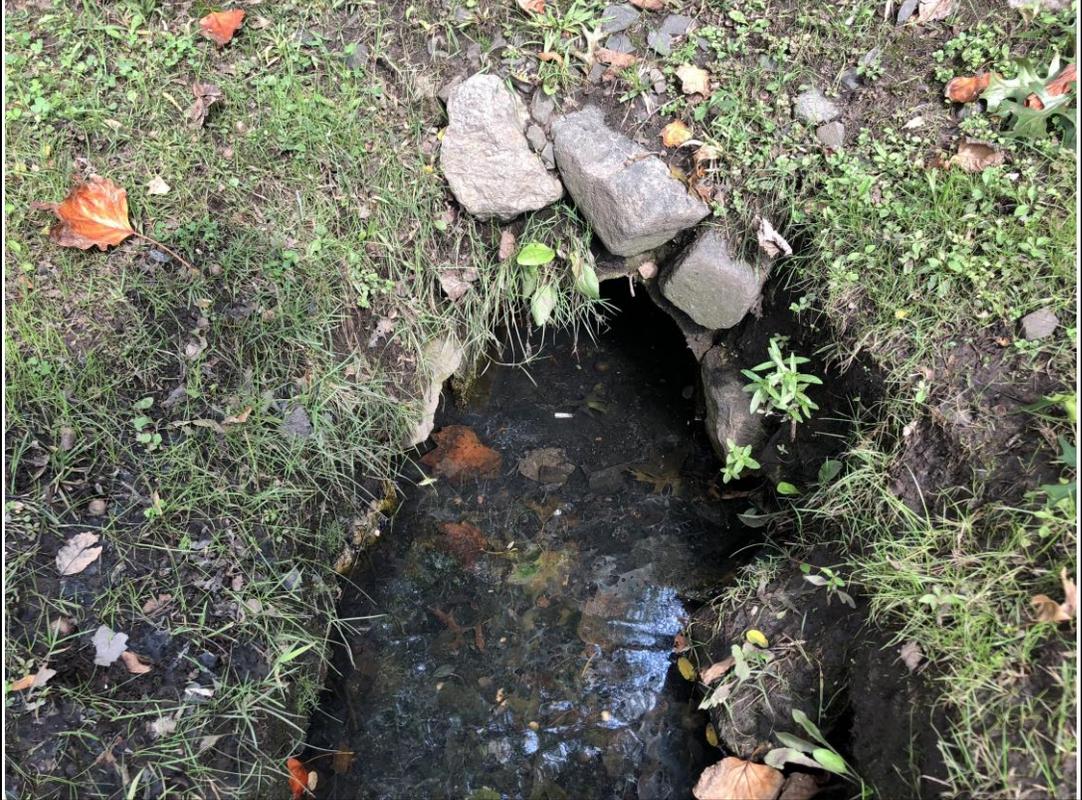
**Photo No. 15.**

Discharge ID:  
D-15

Location:  
Highschool Entrance

Watercourse:  
Emerson Brook

Size:  
15" Flared End Section

Condition:  
Good

Scour:  
No

Illicit Connection:  
No

Repair:  
No

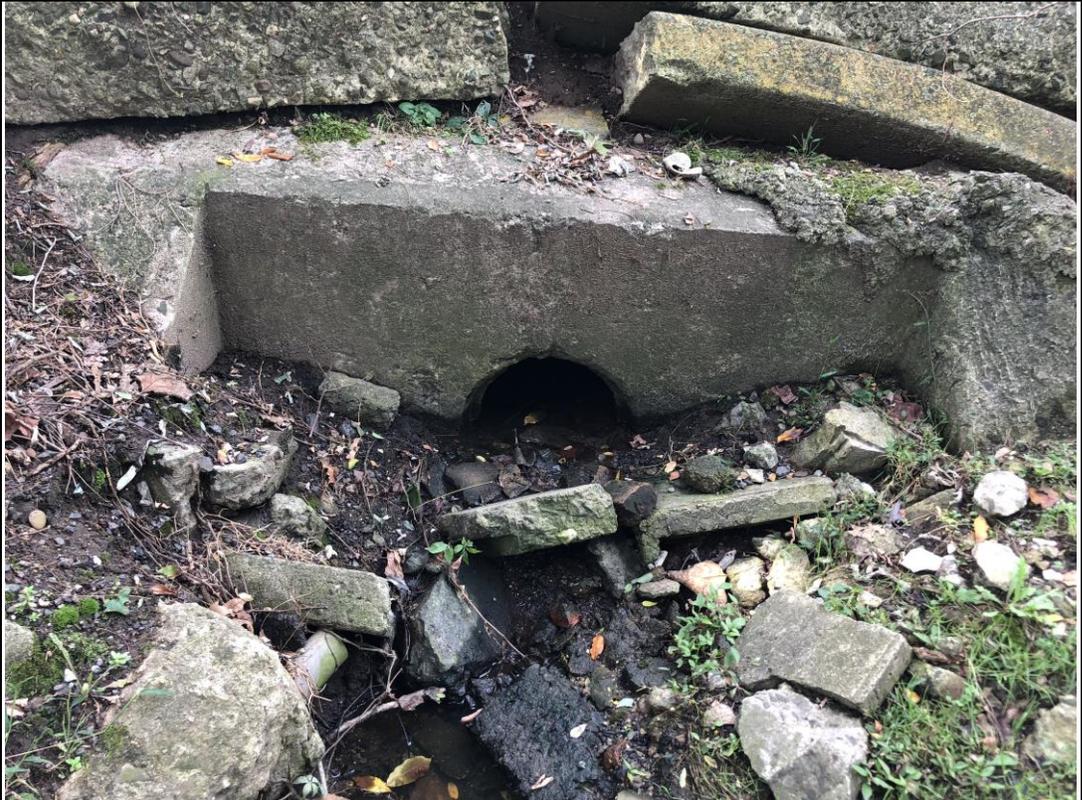
**Photo No. 16.**

Discharge ID:  
D-16

Location:  
Highschool Entrance

Watercourse:  
Emerson Brook

Size:  
15" RCP

Condition:  
Fair

Scour:  
No

Illicit Connection:  
No

Repair:  
Clean Apron  
No NJDEP Permit  
Required

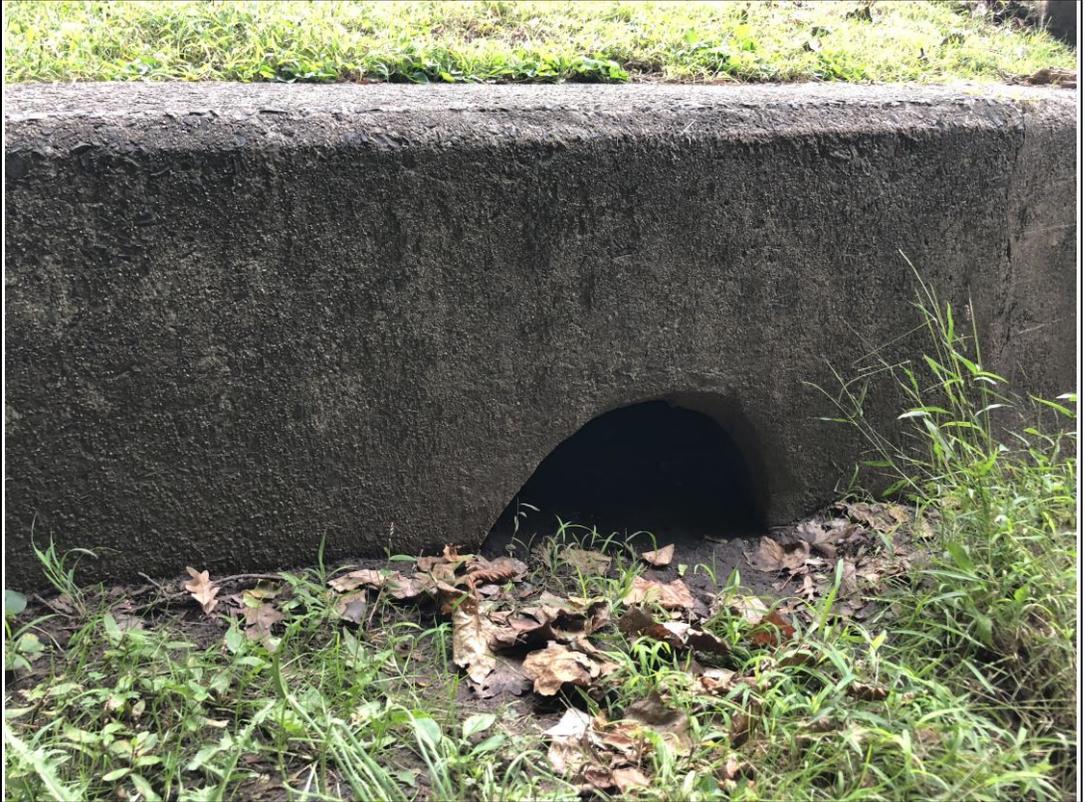
**Photo No. 17.**

Discharge ID:  
D-17

Location:  
Main Street

Watercourse:  
Emerson Brook

Size:  
24" RCP

Condition:  
Good

Scour:  
No

Illicit Connection:  
No

Repair:  
Remove Sediment

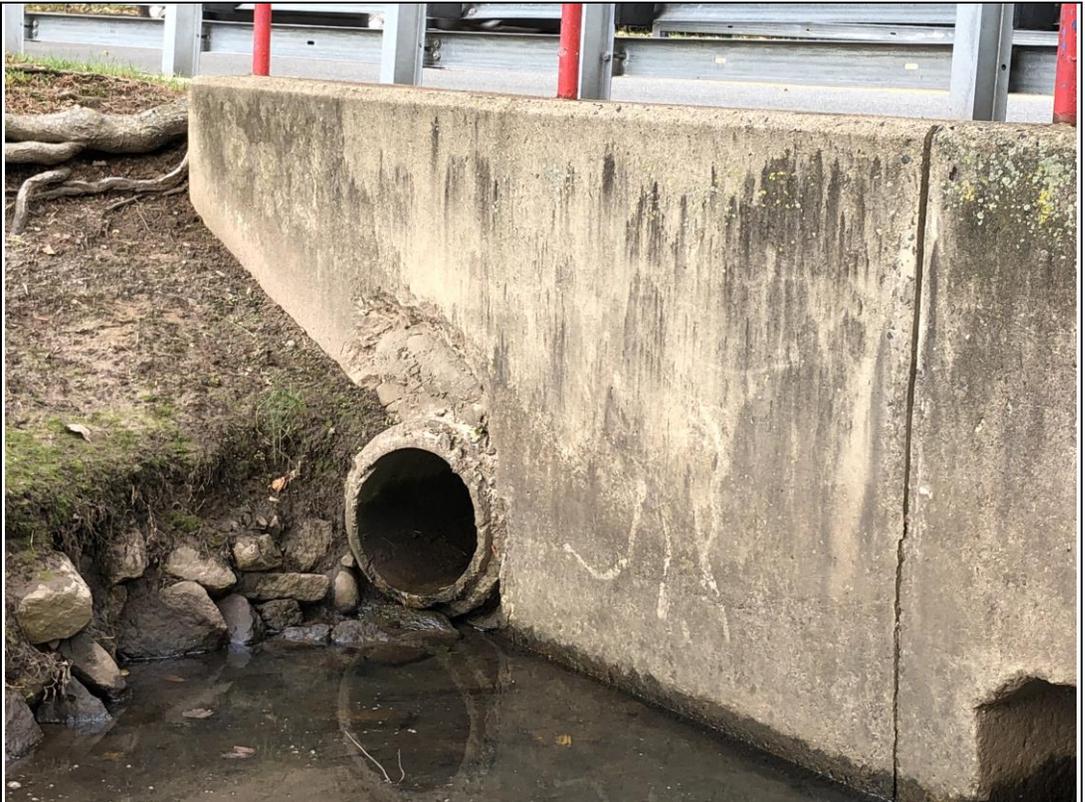
**Photo No. 18.**

Discharge ID:  
D-18

Location:  
South West Main Street

Watercourse:  
Emerson Brook

Size:  
18" RCP

Condition:  
Good

Scour:  
Yes

Illicit Connection:  
No

Repair:  
Replace Rip-Rap Conduit  
Outlet Protection

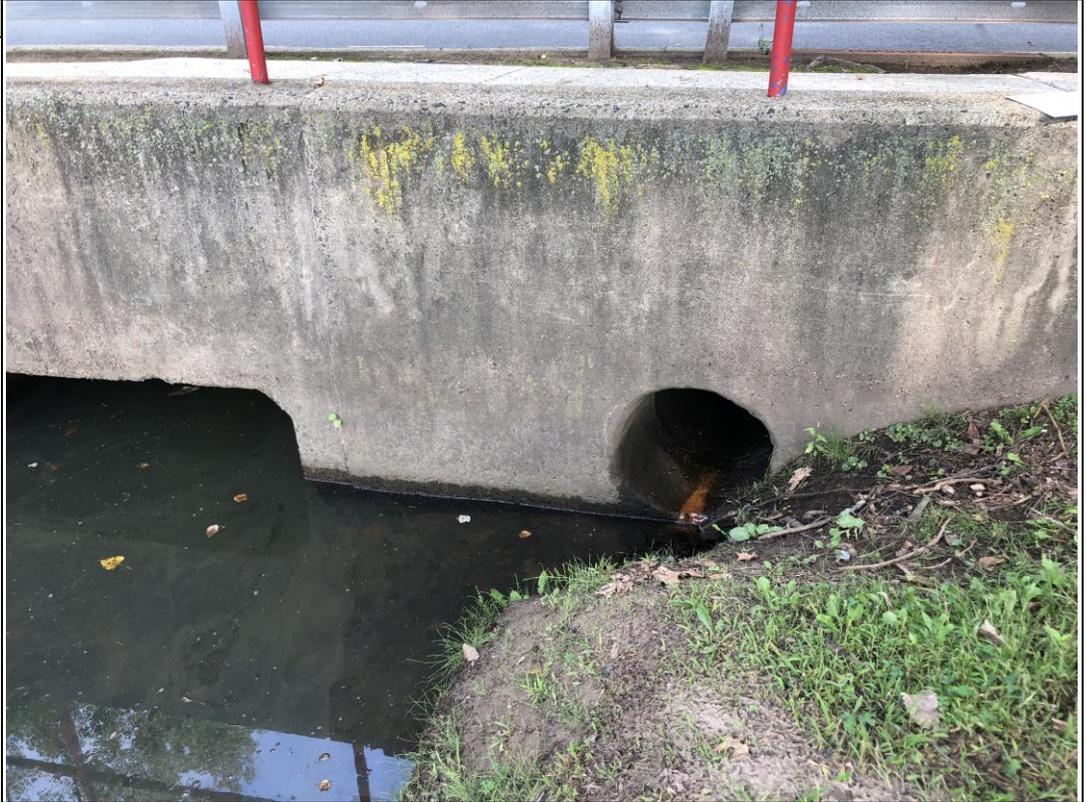
**Photo No. 19.**

Discharge ID:  
D-19

Location:  
Southeast Main Street

Watercourse:  
Emerson Brook

Size:  
18" RCP

Condition:  
Good

Scour:  
Yes

Illicit Connection:  
No

Repair:  
Replace Rip-Rap Conduit  
Outlet Protection

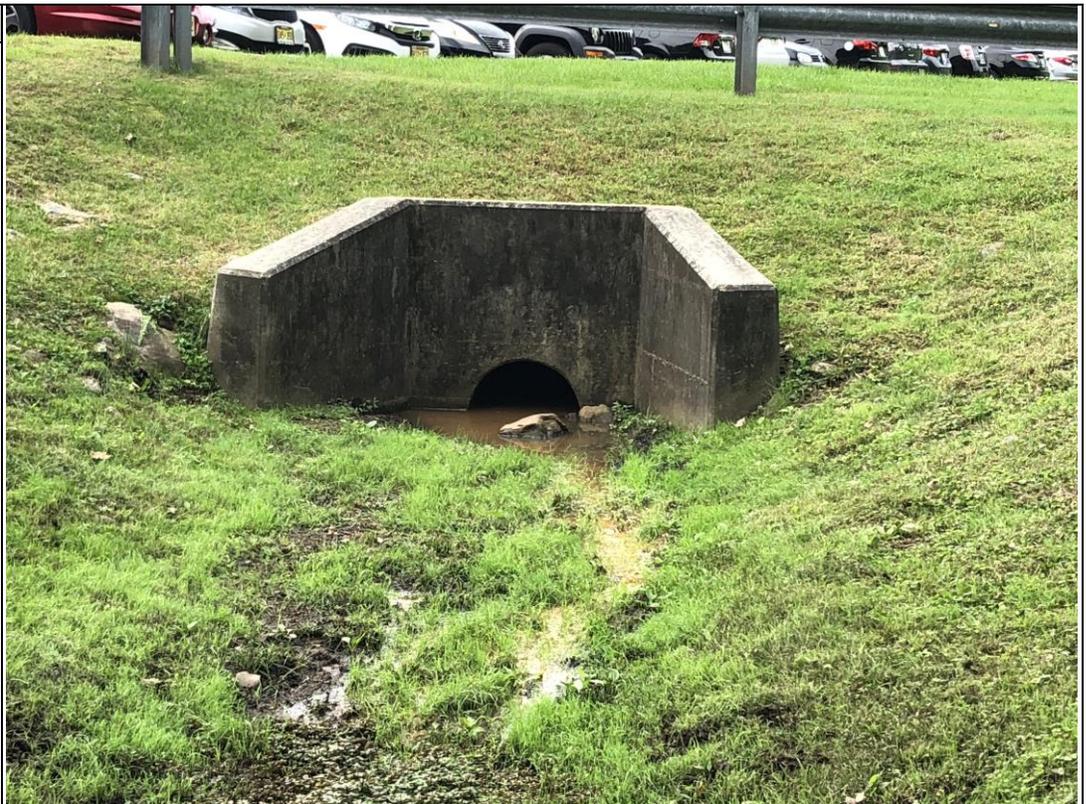
**Photo No. 20.**

Discharge ID:  
D-20

Location:  
Highschool Parking Lot

Watercourse:  
Emerson Brook

Size:  
18" RCP

Condition:  
Fair

Scour:  
No

Illicit Connection:  
No

Repair:  
Clean Apron / Remove  
Sediment / Replace  
Conduit Outlet Protection

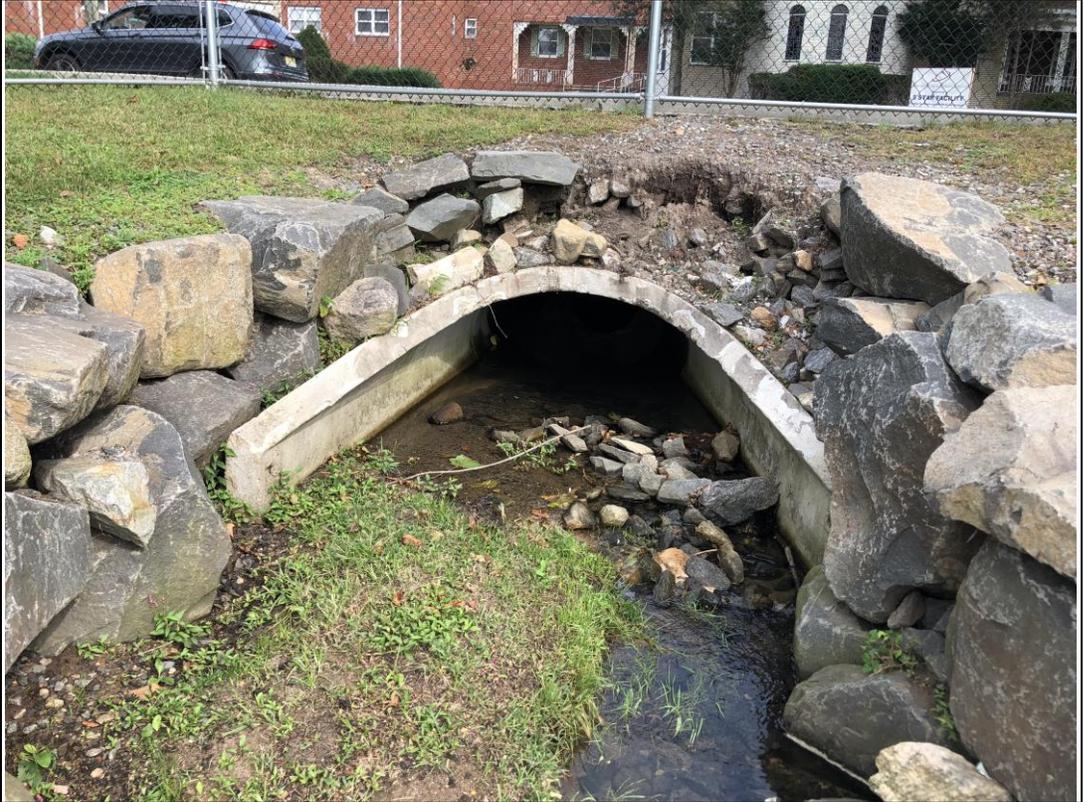
**Photo No. 21.**

Discharge ID:  
D-21

Location:  
Main Street

Watercourse:  
Emerson Brook UNT

Size:  
36" Elliptical Concrete Pipe

Condition:  
Excellent

Scour:  
Yes

Illicit Connection:  
No

Repair:  
Remove Sediment from Apron

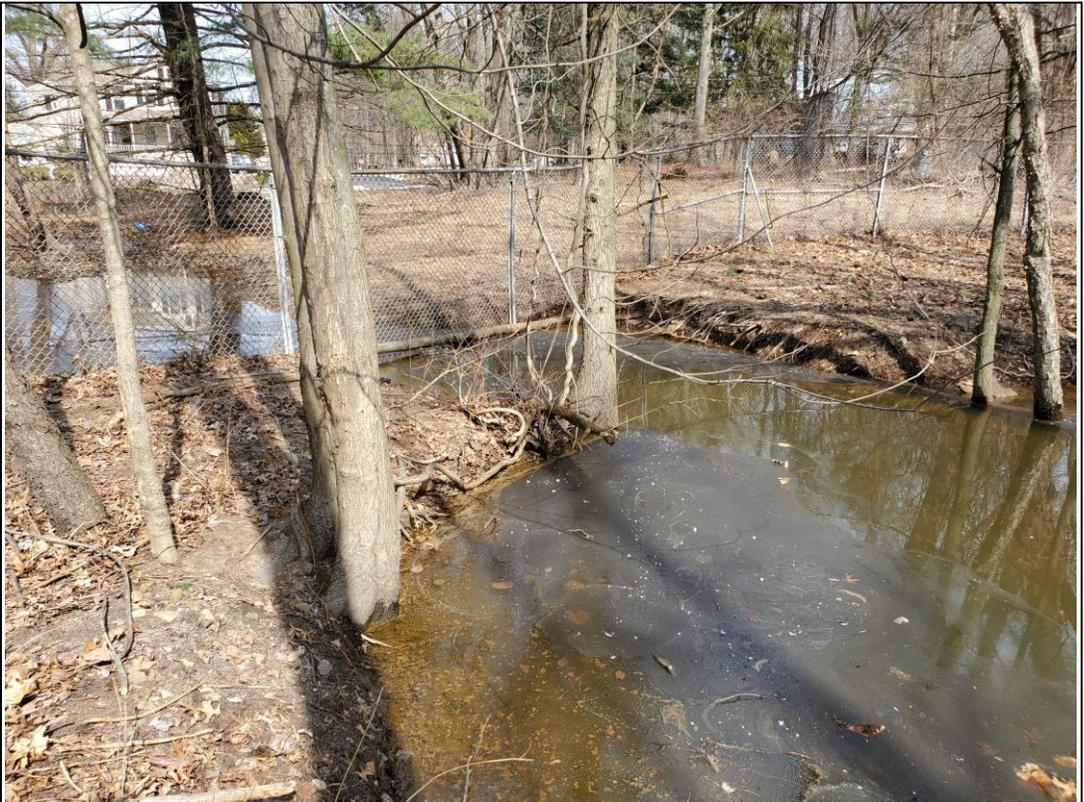
**Photo No. 22.**

Discharge ID:  
D-22

Location:  
Randolph Ave.

Watercourse:  
Oradell Reservoir

Size:  
Unknown

Condition:  
Unknown

Scour:  
Unknown

Illicit Connection:  
Unknown

Repair:  
Unknown

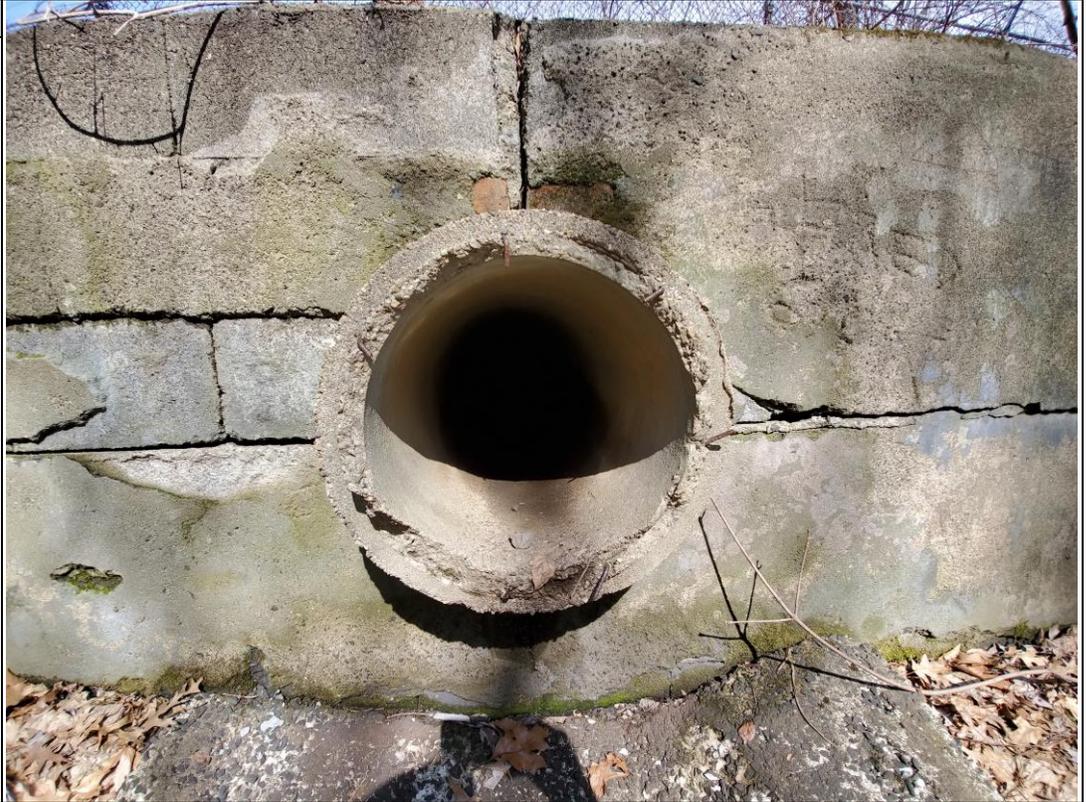
**Photo No. 23.**

Discharge ID:  
D-23

Location:  
Third Street

Watercourse:  
Hackensack River UNT

Size:  
18" RCP

Illicit Connection:  
No

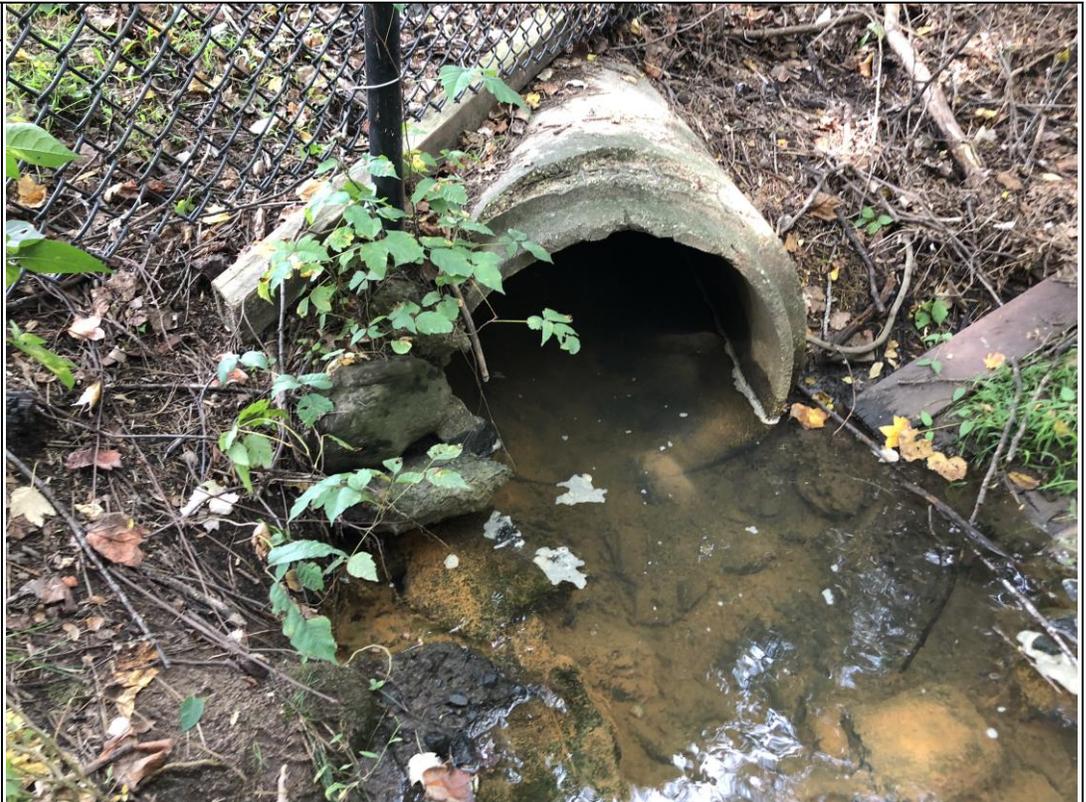
**Photo No. 24.**

Discharge ID:  
D-24

Location:  
Palisade Ave.

Watercourse:  
Hackensack River UNT

Size:  
18" RCP

Condition:  
Good

Scour:  
No

Illicit Connection:  
No

Repair:  
No

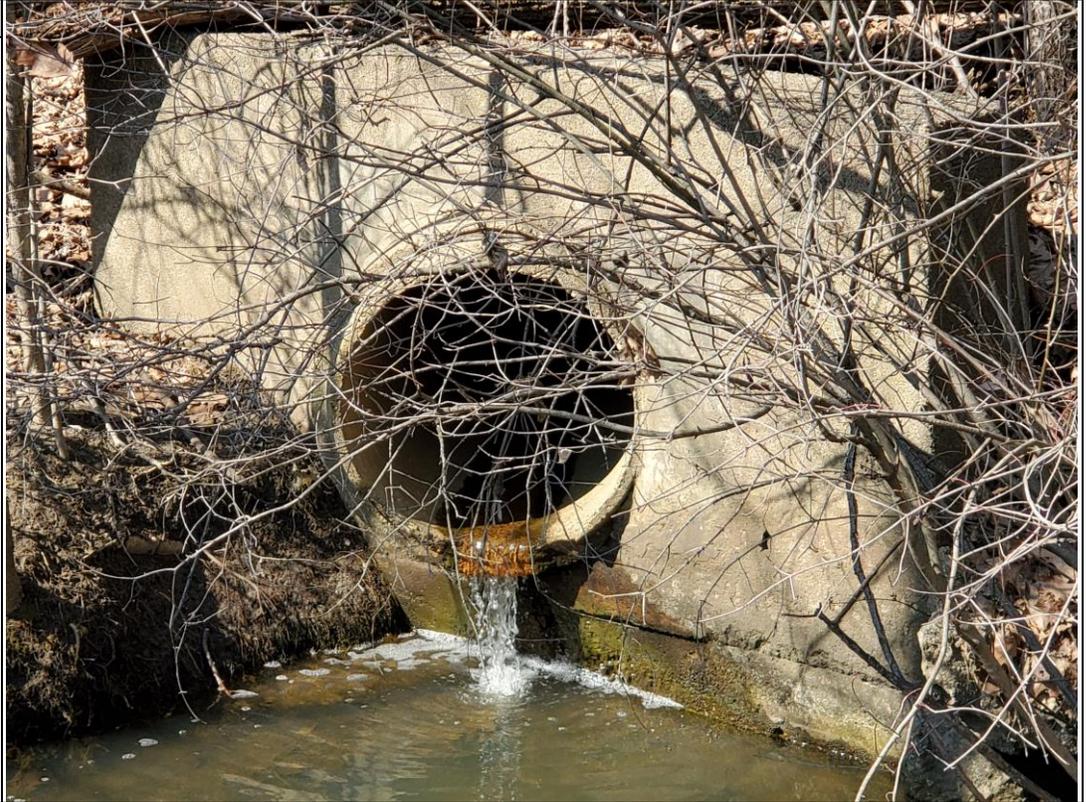
**Photo No. 25.**

Discharge ID:  
D-25

Location:  
55 Palisade Avenue

Watercourse:  
Hackensack River UNT

Size:  
24" RCP

Condition:  
Excellent

Scour:  
No

Illicit Connection:  
No

Repair:  
No
