**CLIENT NAME:**  
Borough of Emerson

**PROJECT NAME:**  
Stormwater Outfall Survey

**PROJECT No.:**  
EM-325

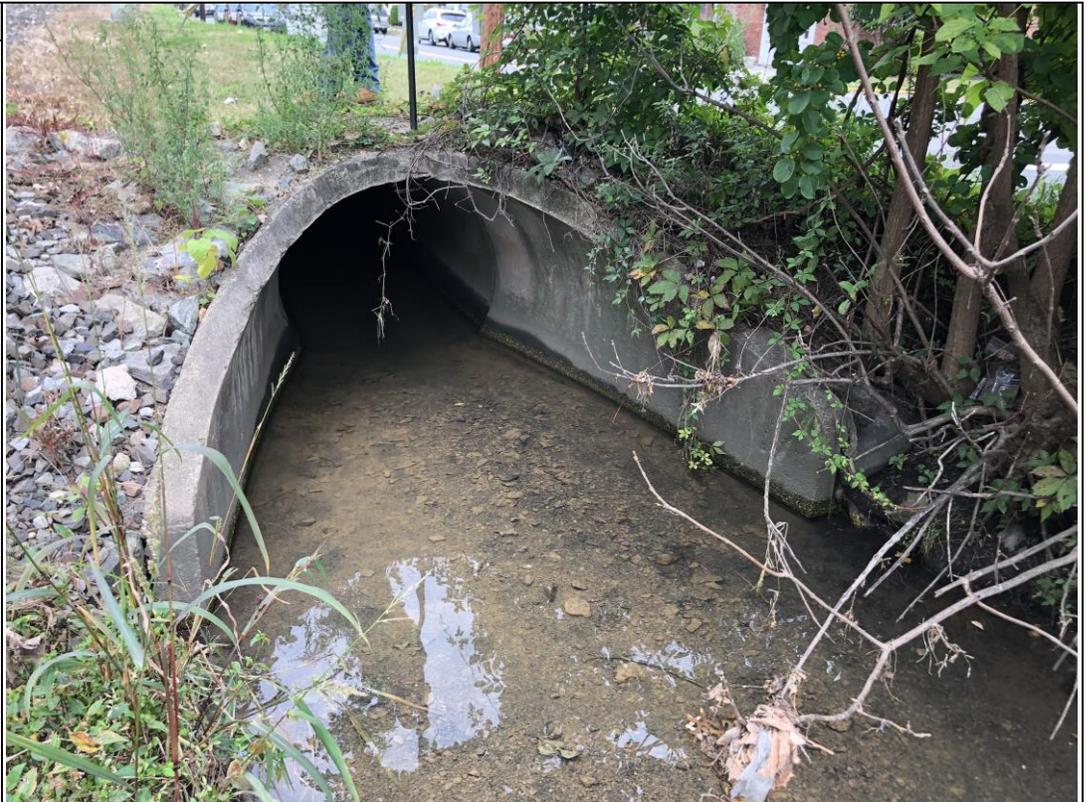
**Photo No. 26.**

Discharge ID:  
D-26

Location:  
Emerson Plaza East

Watercourse:  
Unknown Tributary

Size:  
42" RCP

Condition:  
Excellent

Scour:  
No

Illicit Connection:  
No

Repair:  
No

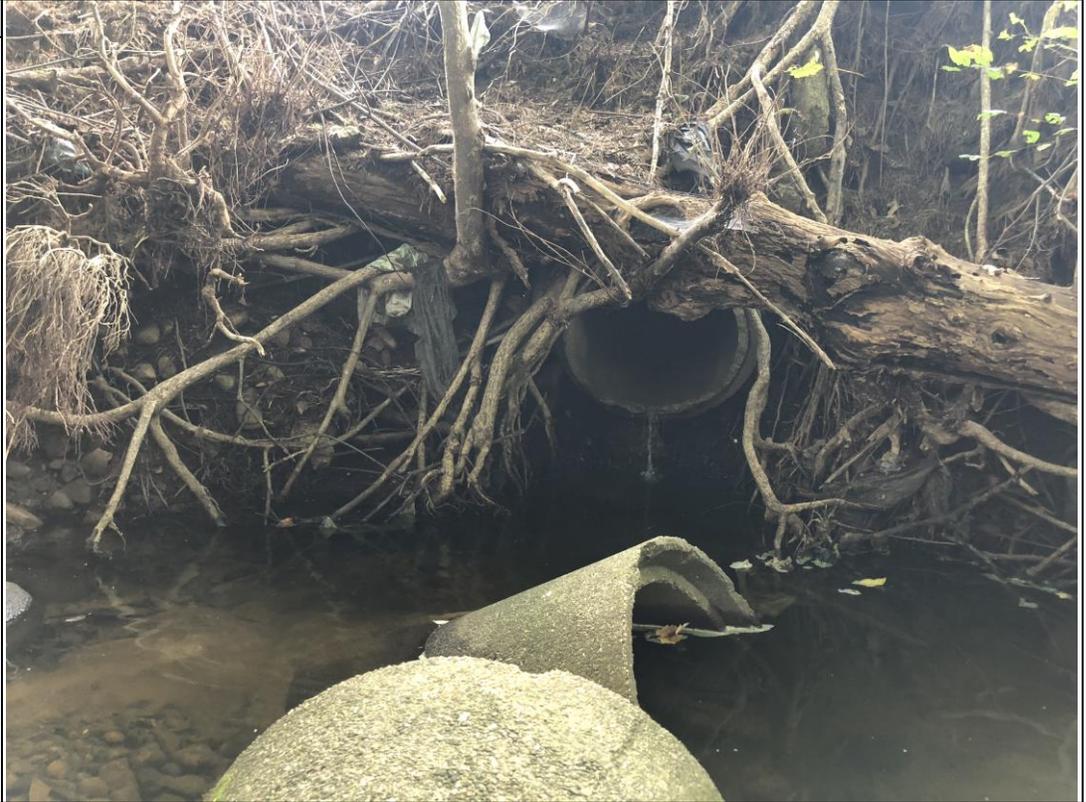
**Photo No. 27.**

Discharge ID:  
D-27

Location:  
Huyler Street

Watercourse:  
Van Saun Mill Brook

Size:  
24" RCP

Condition:  
Poor

Scour:  
Yes

Illicit Connection:  
No

Repair:  
Replace Pipe and  
Headwall / Stabilize Bank  
**NJDEP Permit Required**

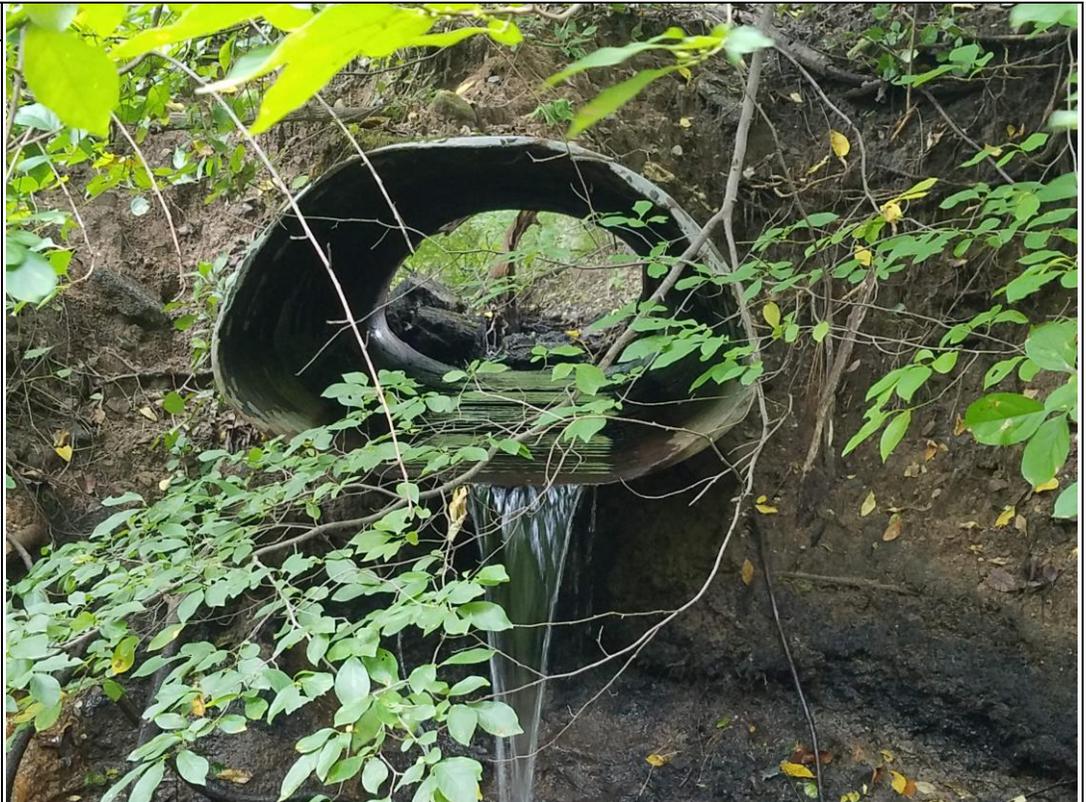
**Photo No. 28.**

Discharge ID:  
D-28

Location:  
Washington Ave

Watercourse:  
Unknown Tributary

Size:  
36"x48" EMCP

Condition:  
Fair

Scour:  
Yes

Illicit Connection:  
No

Repair:  
Install Rip-Rap Conduit  
Outlet Protection  
**NJDEP Permit Required**

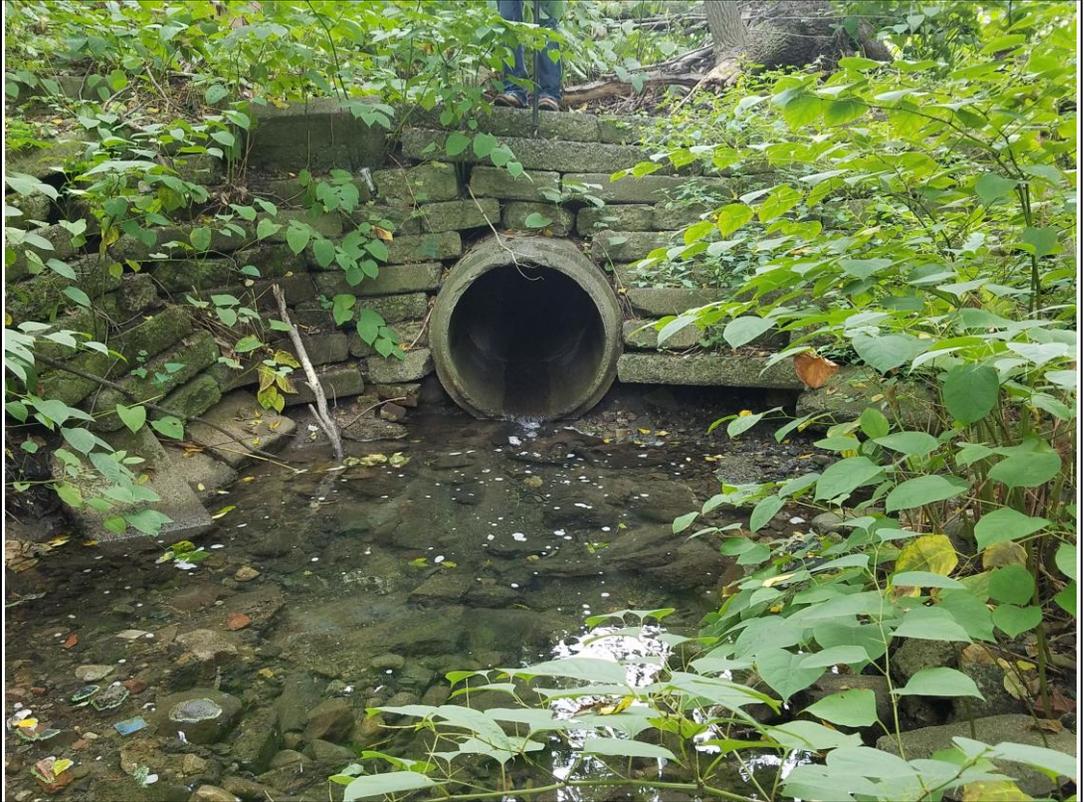
**Photo No. 29.**

**Description:**  
Discharge ID:  
D-29  
Location:  
Washington Ave  
Watercourse:  
Unknown Tributary  
Size:  
36" RCP  
Condition:  
Excellent  
Scour:  
No  
Illicit Connection:  
No  
Repair:  
No

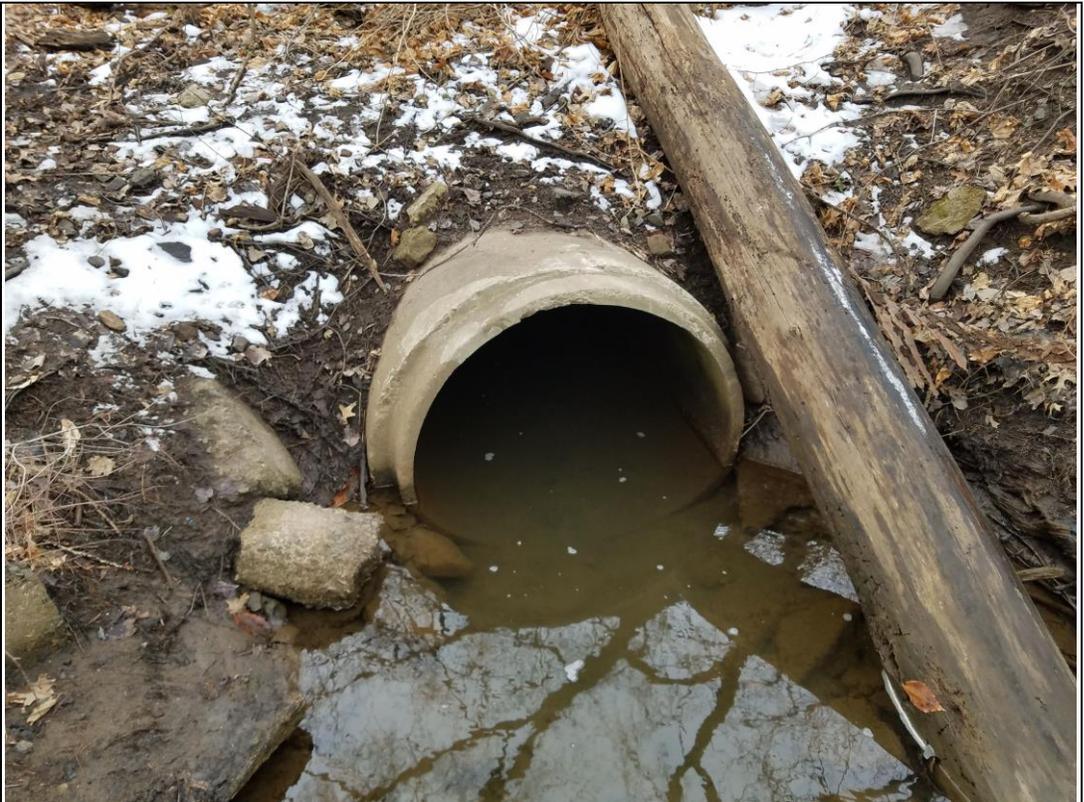
**Photo No. 30.**

**Description:**  
Discharge ID:  
D-30  
Location:  
Cedar Park Cemeteries  
Watercourse:  
Musquapsink Brook  
Size:  
36" RCP  
Condition:  
Good  
Scour:  
No  
Illicit Connection:  
No  
Repair:  
Remove Fallen Tree

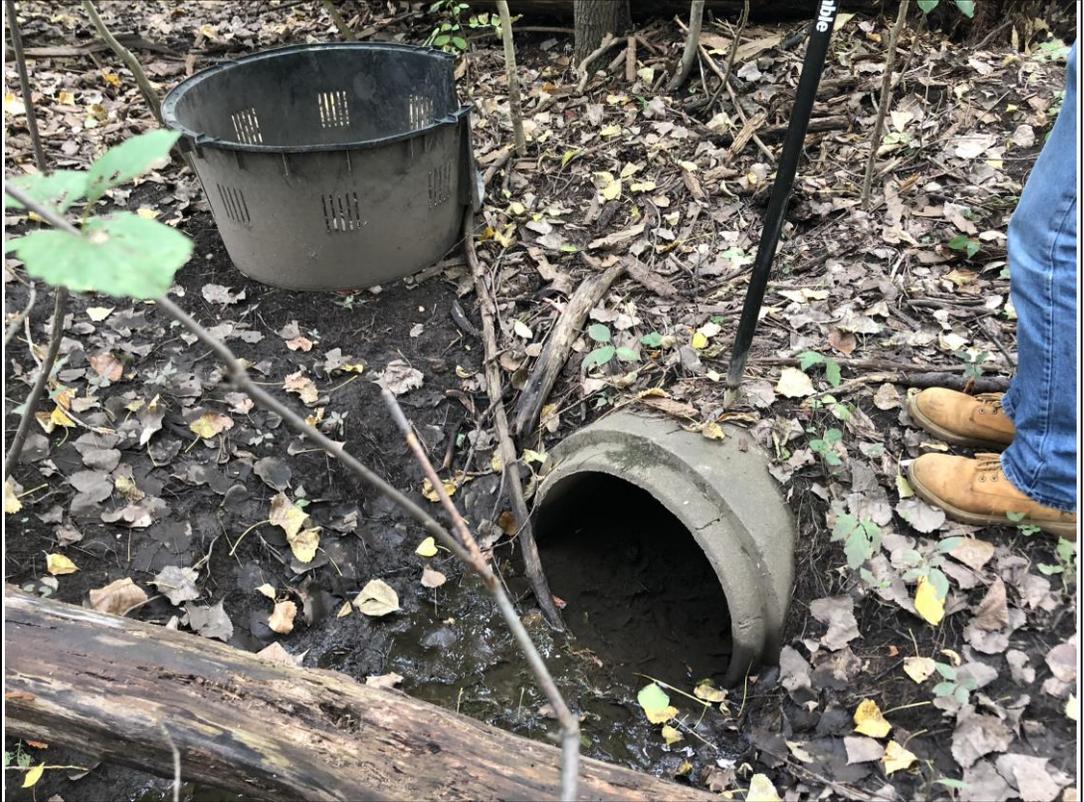
**Photo No. 31.**

Discharge ID:  
D-31

Location:  
Cedar Park Cemeteries

Watercourse:  
Musquapsink Brook

Size:  
24" RCP

Condition:  
Good

Scour:  
No

Illicit Connection:  
No

Repair:  
Remove Fallen Tree

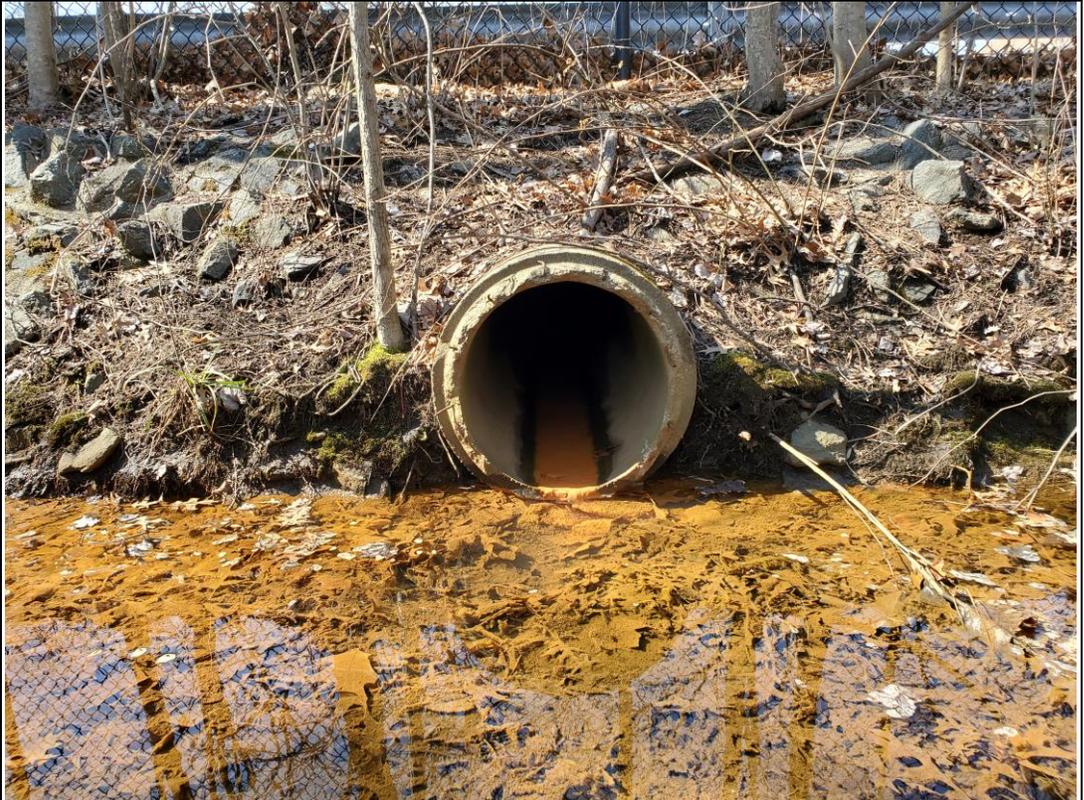
**Photo No. 32.**

Discharge ID:  
Private-1

Location:  
55 Palisade Ave

Watercourse:  
Hackensack River UST

Size:  
15" RCP

Condition:  
Good

Scour:  
No

Illicit Connection:  
No

Repair:  
No

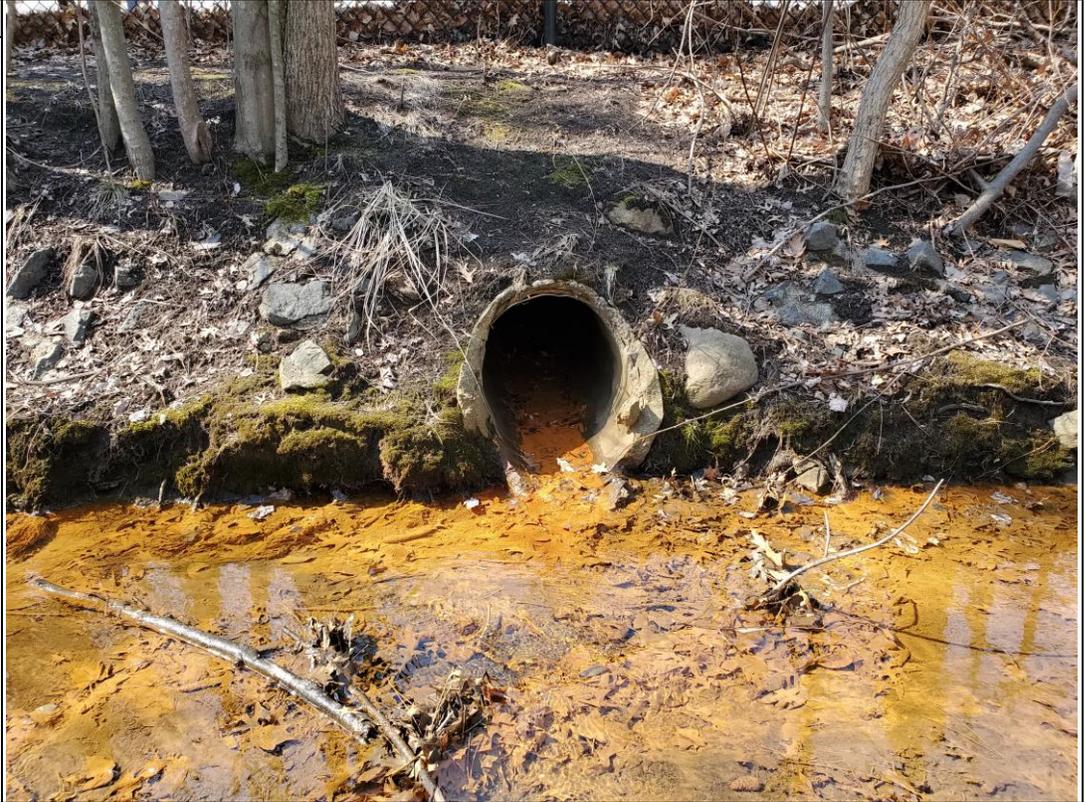
**Photo No. 33.**

Discharge ID:  
Private-2

Location:  
55 Palisade Ave

Watercourse:  
Hackensack River UST

Size:  
12" RCP

Condition:  
Good

Scour:  
No

Illicit Connection:  
No

Repair:  
No
