BOROUGH OF EMERSON

Supplemental Planning Report to Determine if the Downtown Emerson Redevelopment Area Continues to Meet the Criteria for Designation as An Area in Need of Redevelopment

August 18, 2008

BA # 1951.03

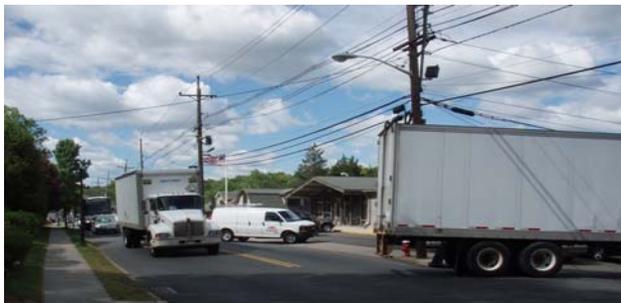
Block 412 along Kinderkamack Road contains wide curb cuts, decreasing safety for pedestrians & providing

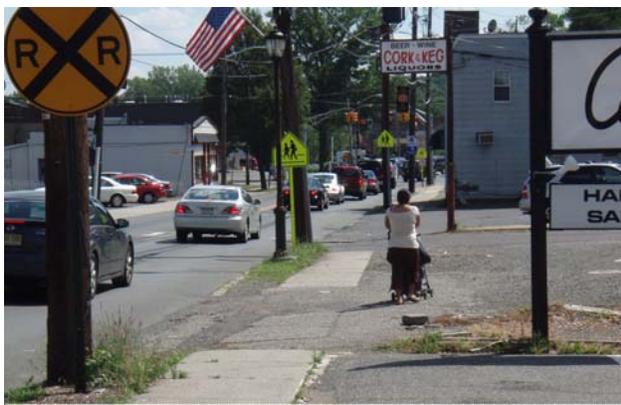
Block 419 significantly lacks curbing, and delineation for both pedestrian and vehicular circulation.

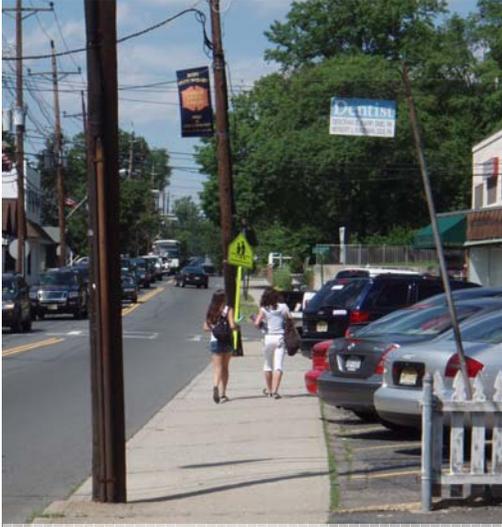
Block 422 along Kinderkamack Road contains wide curb cuts, decreasing safety for pedestrians & providing poor vehicular circulation.

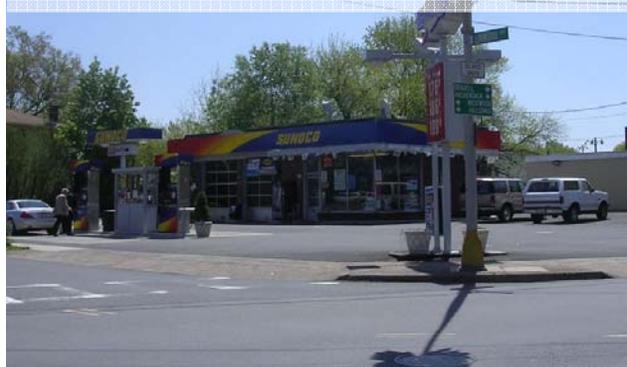
Block 616 contains wide curb cuts, decreasing safety for pedestrians & providing poor vehicular circulation.

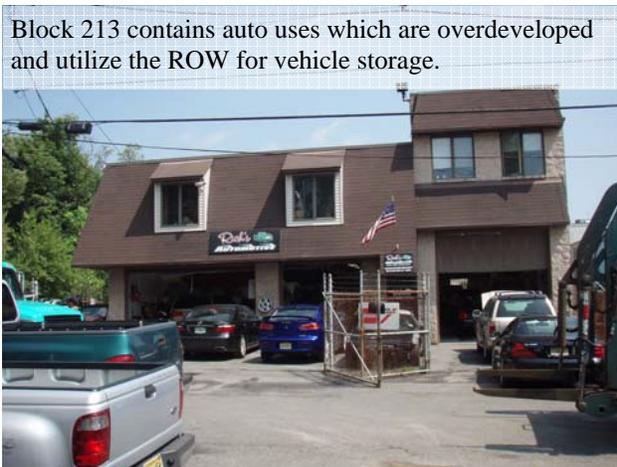
Block 213 contains auto uses which are overdeveloped and utilize the ROW for vehicle storage.

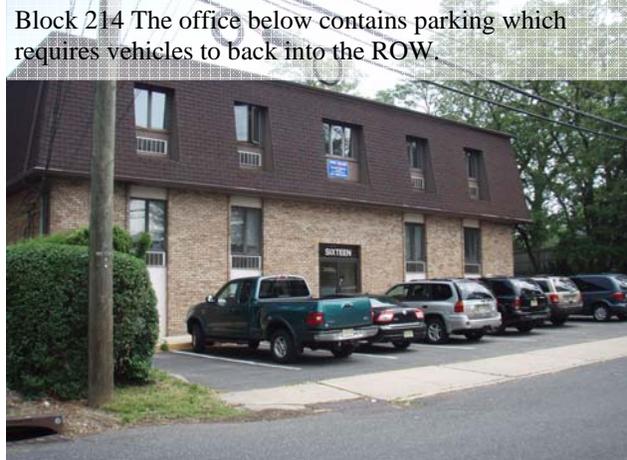
Block 214 The office below contains parking which requires vehicles to back into the ROW.

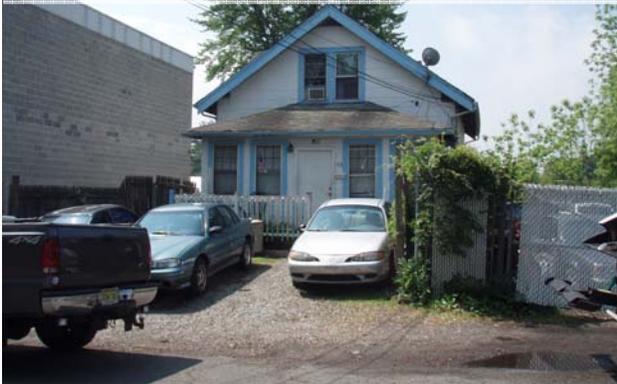
Block 405 A run down dwelling with vehicle storage on the property.

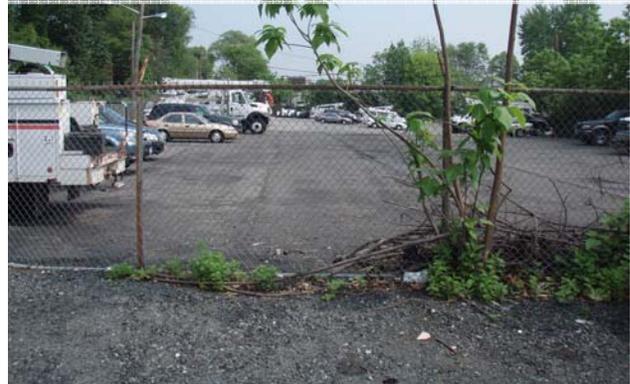
Block 405 The Verizon property shown below is highly impervious and lacking appropriate circulation elements.

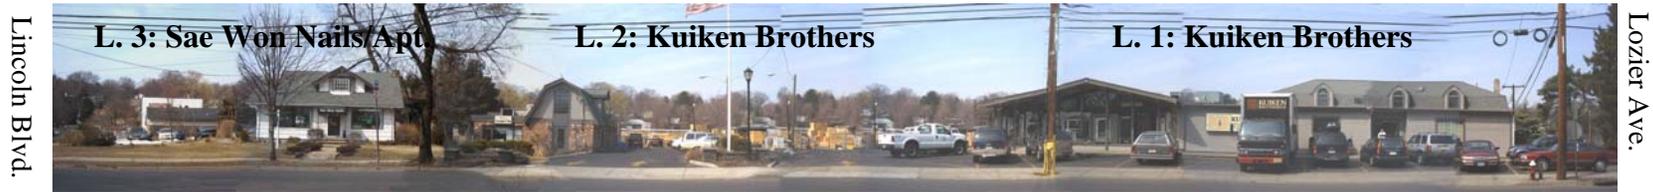
1.a. Block 412

Panoramic View of Block 412 along Kinderkamack Rd.

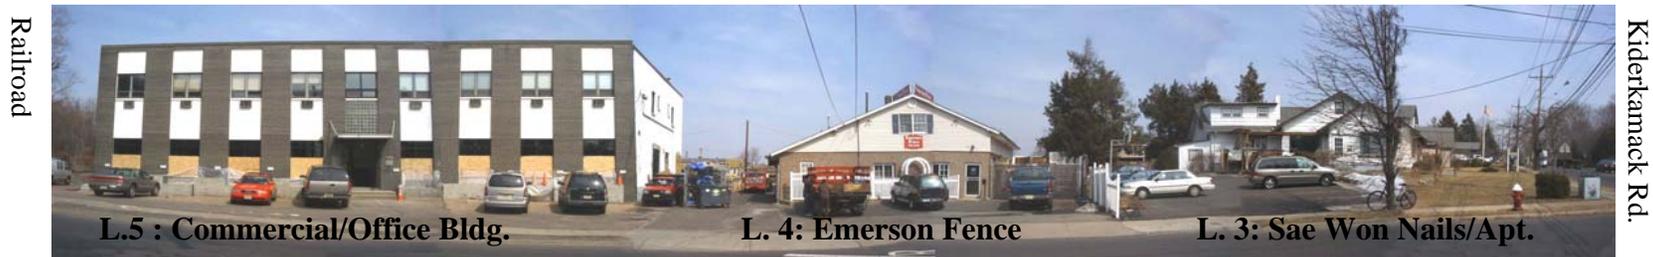
Panoramic View of Block 412 along Lincoln Blvd.

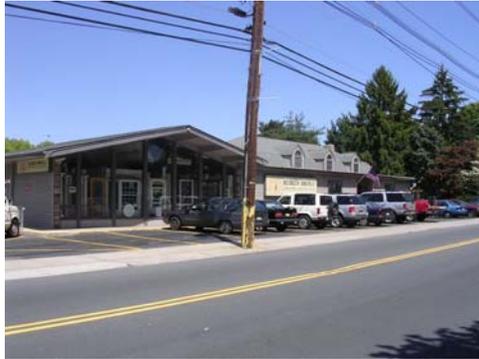
Block: 412 Lot: 1
Use Description: Commercial
Establishment: Kuiken Brothers
Land Value: \$1,106,800.00
Improvements Value: \$542,800.00
Land Area: 1.7 acres / **Zone:** IM & RC
GFA: 21,655 sf. / **No. of Stories:** 1
Parking: 23 ps.

Comments: Site design includes parking arrangement requiring vehicles to back directly out into Kinderkamack Road, which is inconsistent with planning design standards. Site’s curb cut extends along width of lot, precluding ability to channelize and direct vehicular movements. Outdoor storage. No buffer between site and adjoining residential zone. Excessive land coverage.

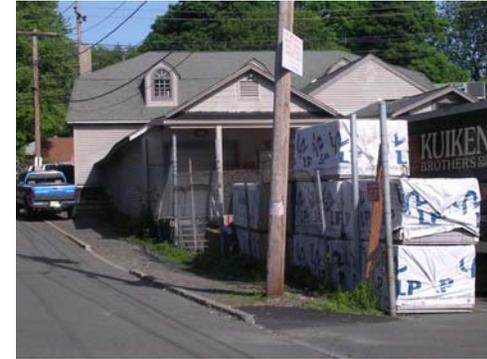
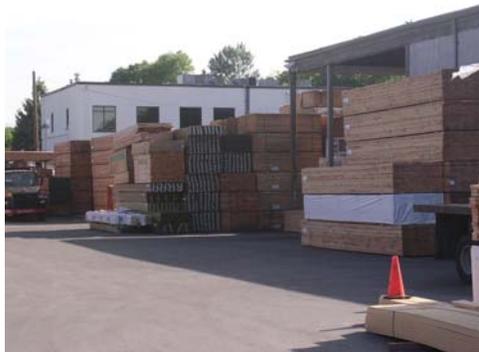
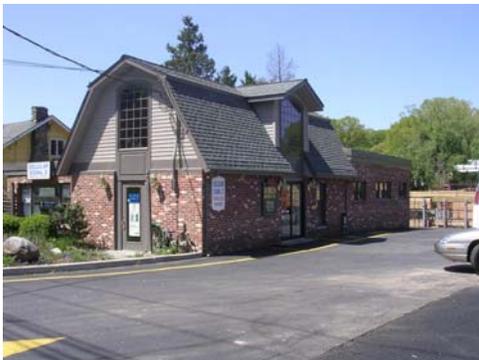
Block: 412 Lot: 2
Use Description: Commercial
Establishments: Kuiken Brothers
Land Value: \$324,100.00
Improvements Value: \$397,800.00
Land Area: 0.22 acres / **Zone:** RC
GFA: 2,940 sf. / **No. of Stories:** 2
Parking: 8 ps.

Comments: Attractive well maintained building. Two way curb cut immediately next to

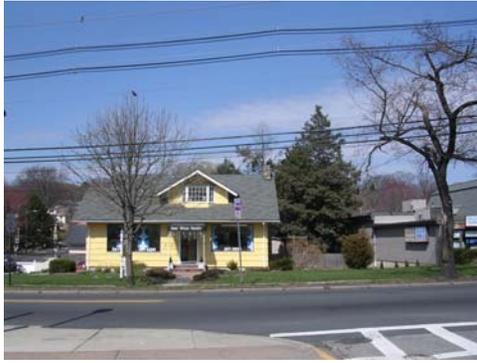
Block: 412 Lot: 3

Comments: Existing residential use not permit-

ted in zone. Site improvements represents only 49% of land value. Building façade appears to have been recently repainted.

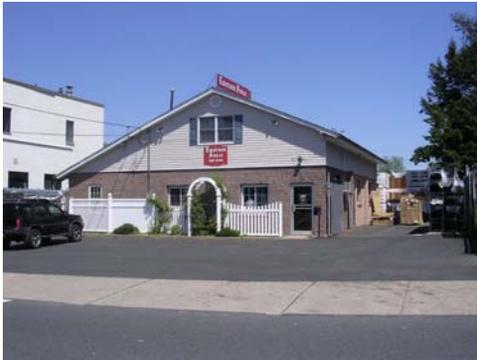
Block: 412 Lot: 4

Comments: Building façade good. Outdoor storage in side and rear. Excessive land coverage.

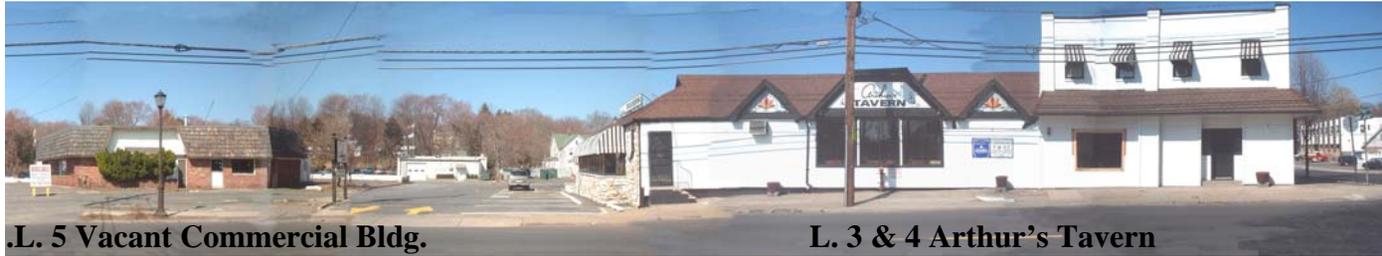
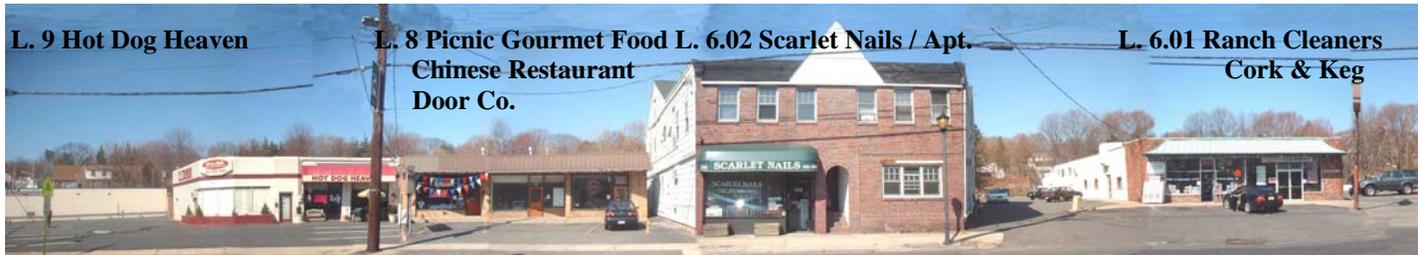
1.b. Block 419

Panoramic View of Block 419 along Kinderkamack Rd.

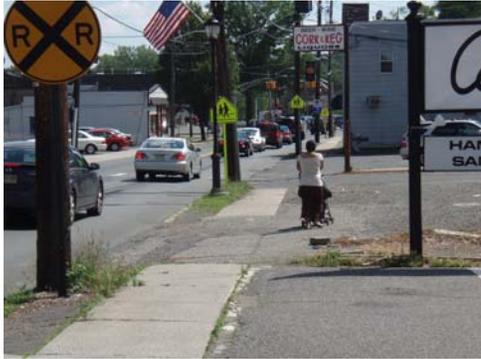
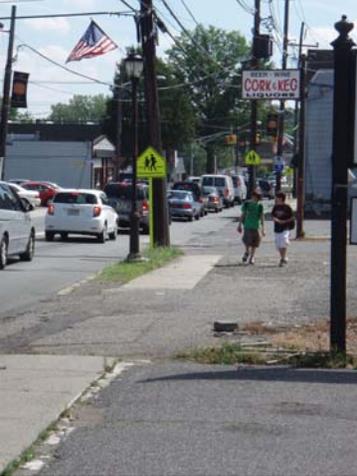
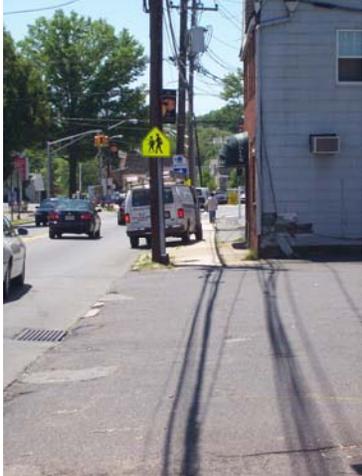
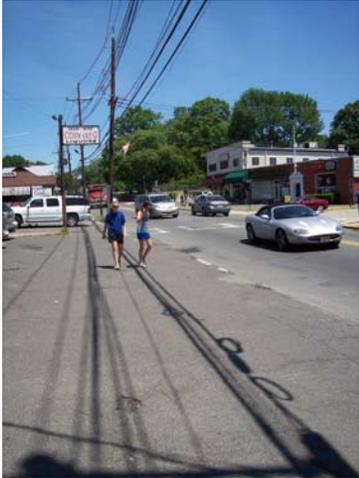
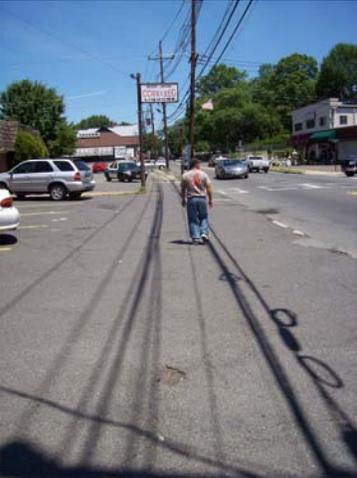
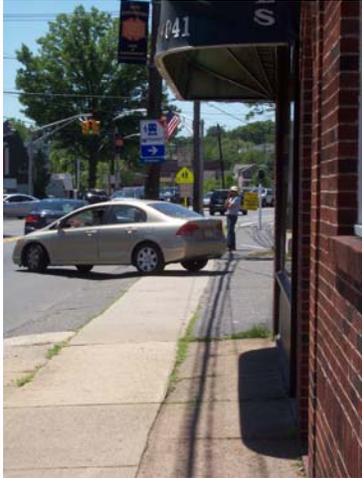
As depicted in the accompanying photos, the existing circulation elements along much of the properties in Block 419 along Kinderkamack Road pose significant hazards for pedestrians and for vehicles. In addition, they are aesthetic eyesores. The following pages analyze Block 419 on a lot-by-lot basis.

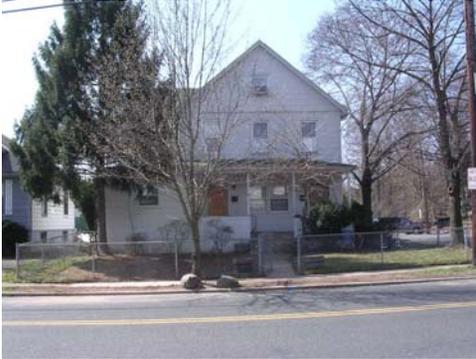
Block: 419 Lot: 1

Comments: Residence not permitted in zone. No parking. Percentage of improvement-to-land value is 81%. Lot very small.

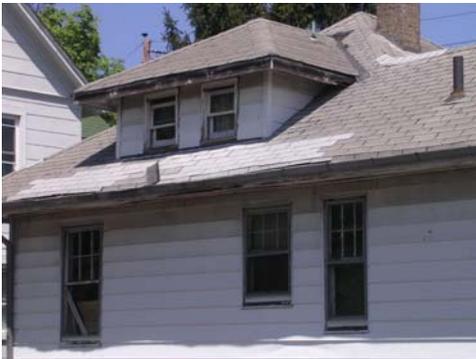
Comments: Residence not permitted in zone. No parking. Roof and windows appear to be in need of repair. Percentage of improvement-to-land value is 19%.

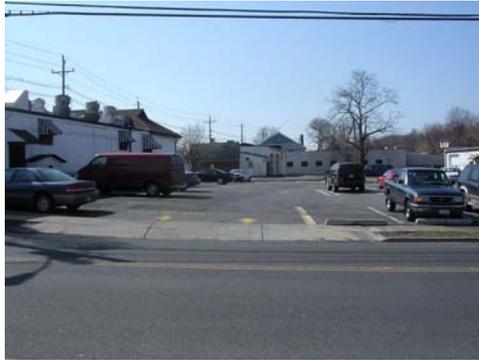
Block: 419 **Lots:** 3
Use Description: Parking
Establishments: Parking for Arthur’s Tavern
Land Value: \$238,200.00
Improvements Value: \$10,600.00
Land Area: 0.18 acres / **Zone:** RC
GFA: See Lot 4
Parking: See Lot 4
Comments: Lot used for parking for adjoining Arthur’s Tavern. Excessive land coverage.

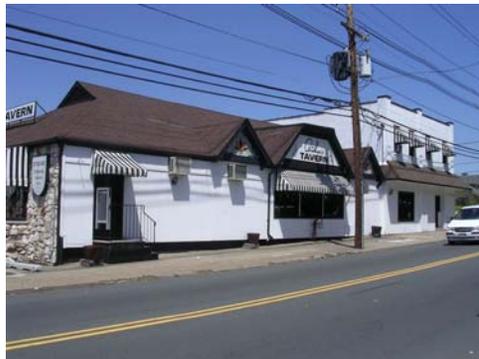
Block: 419 **Lot:** 4
Use Description: Eating and Drinking Establishments
Establishment: Arthur’s Tavern
Land Value: \$506,400.00
Improvements Value: \$1,040,200.00
Land Area: 0.45 acres / **Zone:** RC
GFA: 7,628 sf. / **No. of Stories:** 1½ / **No. of Seats:** 180 / **Parking:** 48 ps.
Comments: Insufficient parking per planning

design standards. Façade of building appears in a good condition. Excessive land coverage. There have been several traffic accidents over the last few years involving ingress/egress from this site.

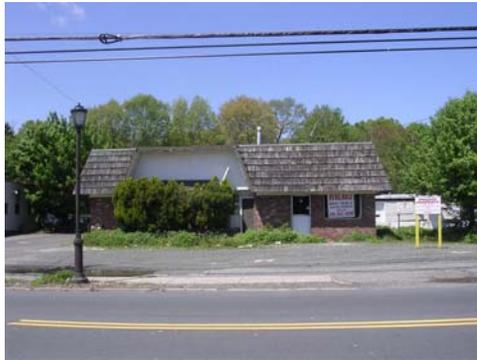
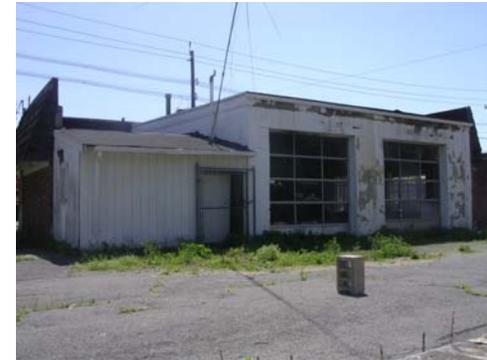
Block: 419 Lot: 6.01

Comments: Existing structure appears in need of repair, with peeled wooden façade and peeling paint, and displaced cinder blocks. Overgrown weeds evident in rear. Site is identified on 2008 list of known contaminated sites of New Jersey.

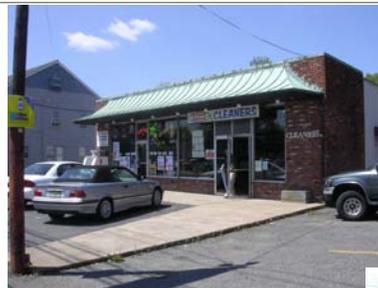
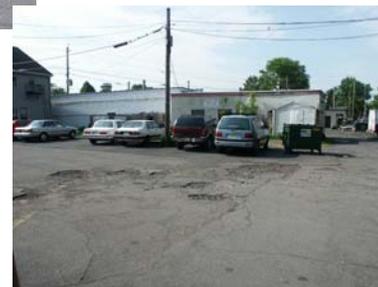
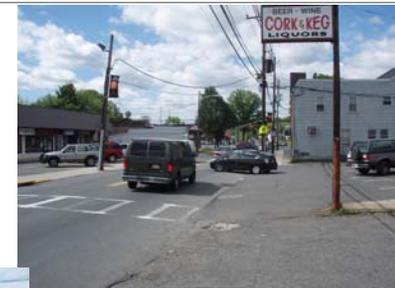
Comments: Curb cut extends width of site; precludes controlled access/egress & results in potential for conflicting turning movements. Observed vehicles backing directly out into Kinderkamack Road. Too many window signs. Potholes in paved parking lot provided in the rear yard of the property.

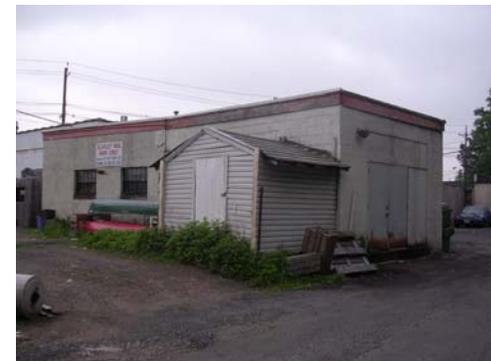
Comments: Site lacks sufficient parking per planning design standards. Lacks delineated parking spaces. Building façade missing some shingles, and contains a variety of building materials. Telephone pole in parking lot. Lot very small to stand on its own for conventional development.

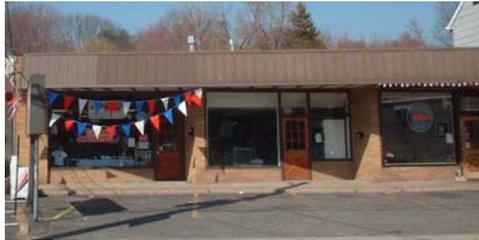
Block: 419 Lot: 8

Comments: Curb cut extends width of lot, precluding controlled access/egress. Peeling paint on façade. Excessive land coverage.

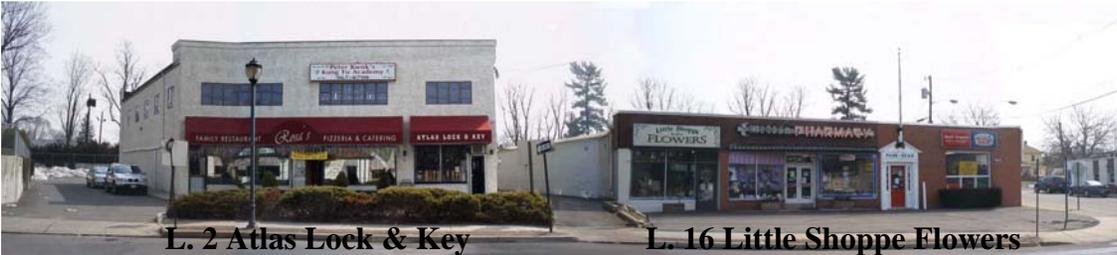
Panoramic View of Block 420 along Kinderkamack Rd.

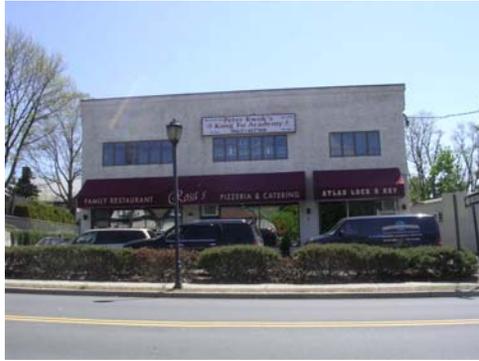
Block: 420 Lot: 2

Comments: Insufficient parking based on planning design standards. Building appears to have been upgraded, canopies add to character. Landscape amenity in front serves to enhance site.

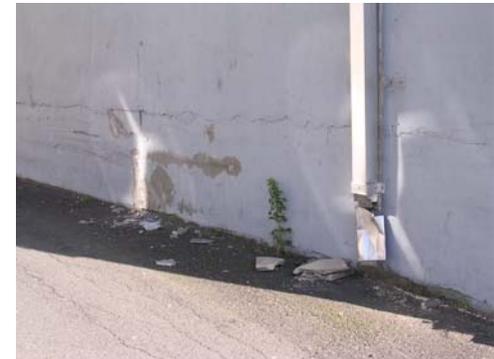
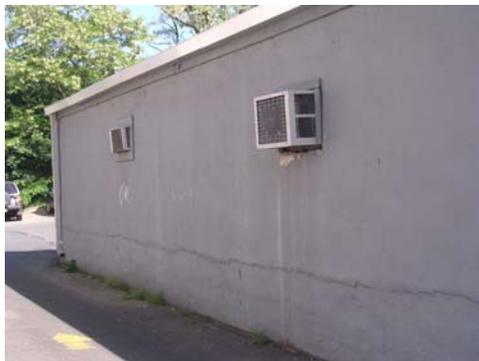
Comments: Insufficient parking per design standards. No landscape amenity, no integrated signage; presents discordant image. Building façade has some peeling/cracked paint and staining.

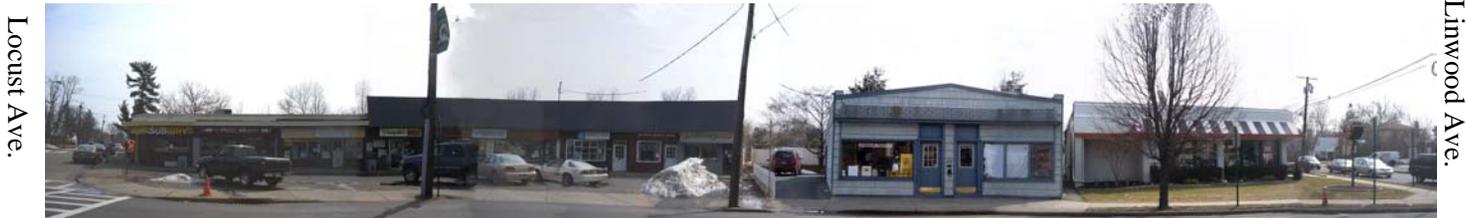
Panoramic View of Block 422 along Kinderkamack Rd.

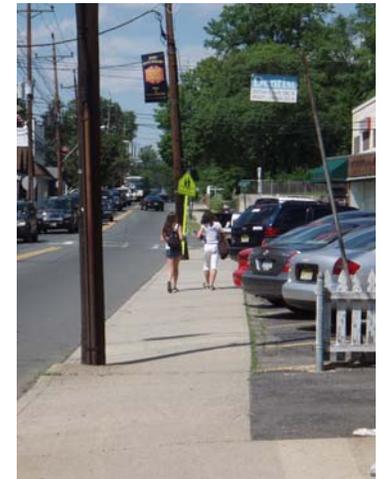
Comments: No landscape amenity, lack of integrated signage, and disconnected parapet presents discordant image. Signs on front façade inconsistent in design and material. Rear of building has all rooftop appurtenances visible. Potholes in rear parking area; characterized by poor design including some parking spaces with 'blind' movements around buildings. All of the individual tax lots are too small to stand on their own as developable parcels. There have been several traffic accidents over the last few years involving ingress/egress from these parcels along Kinderkamack Road where curb cut extend the width of lot, precluding controlled access/egress.

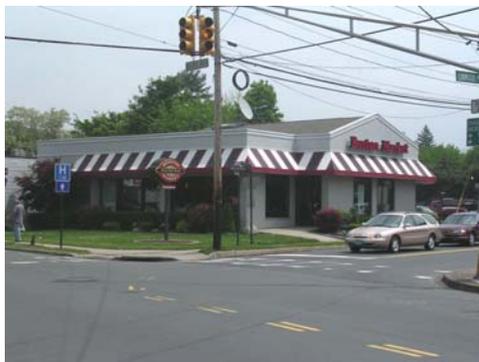
Block: 422 Lots: 10&11 parking lot design.
Use Description: Eating and Drinking Establishments
Establishment: Boston Market
Land Value: \$424,500.00
Improvements Value: \$650,100.00
Land Area: 0.36 acres / **Zone:** RC
GFA: 2,355 sf. / **No. of Stories:** 1 / **No of Seats:** 31 / **Parking:** 31 ps.
Comments: Site well maintained with suitable

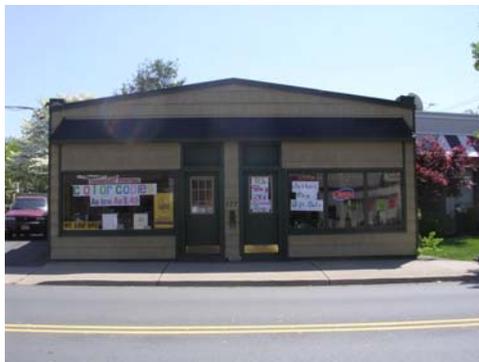
Block: 422 Lot: 12 tectural merit. Inconsistent façade materials and signage. Site too small to accommodate any meaningful level of development on its own.
Use Description: Commercial
Establishment: Coin dealer / Astrology/Tarot Card reader
Land Value: \$258,900.00
Improvements Value: \$75,100.00
Land Area: 0.09 acres / **Zone:** RC
GFA: 960 sf. / **No. of Stories:** 1
Parking: 1 ps.
Comments: Small building without any archi-

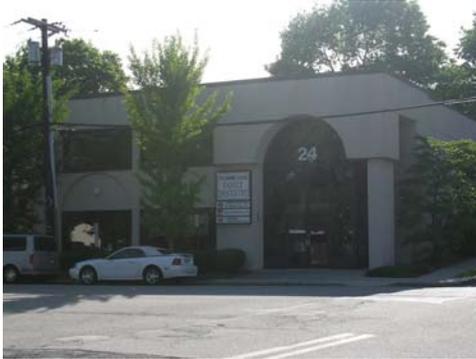
Block: 603 Lot: 2

Comments: Office use not permitted in zone. Building maintained in acceptable manner.

Insufficient parking based on design standards.

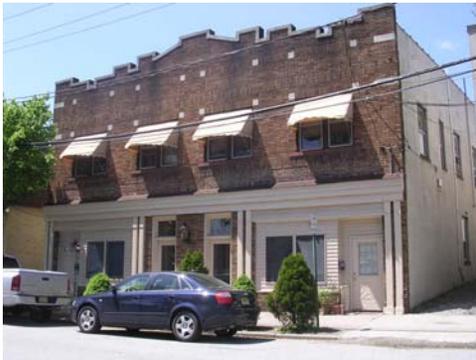
Block: 603 Lot: 3

Comments: Residential use not permitted in zone. The gravel/grass parking area does not

delineate parking spaces. Parking less than required by standard design criteria. Site's driveway has no vision clearance from parking lot onto sidewalk; conflicting movement with pedestrians.

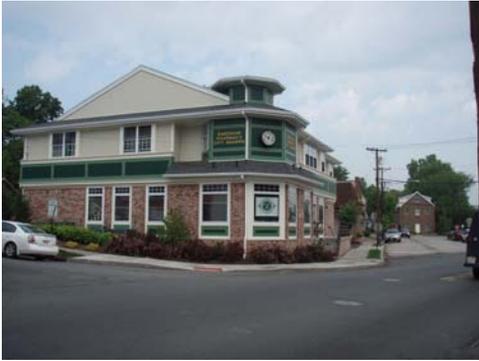
Block: 603 **Lot:** 5, 6
Use Description: Commercial
Establishment: Emerson Pharmacy/Gift Shop
Land Value: \$570,200.00
Improvements Value: \$ 1,076,100.00
Land Area: 0.24 acres / **Zone:** RC
Parking: 15 ps.
Comments: Recently developed property furthering the improvement of the CBD.

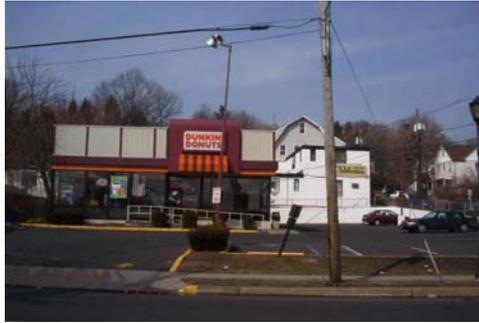
Block: 606 Lot: 3

Comments: Site well maintained with suitable parking lot design.

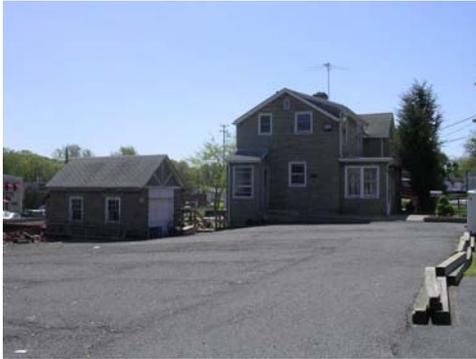
Block: 610 Lot: 1
Use Description: Residential
Establishment: 2 Family Residential
Land Value: \$290,400.00
Improvements Value: \$205,900.00
Land Area: 0.24 acres / **Zone:** LBE
GFA: 1,280 sf. / **No. of Stories:** 2½
Parking: 4 ps.**
Comments: This underutilized site lacks appropriate design features & contains a nonconforming use.

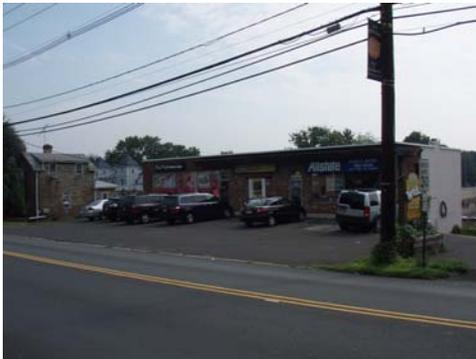
Block: 610 Lot: 2
Use Description: Commercial
Establishment: A-La-Mode Nail & Spa / Wicker Wonderland / All State
Land Value: \$328,700.00
Improvements Value: \$531,700.00
Land Area: 0.28 acres / **Zone:** LBE
GFA: 2,605 sf. / **No. of Stories:** 1
Parking: 11 ps.**
Comments: Building is nondescript and lacks

architectural merit. Existing signage inconsistent throughout. Lacks suitable landscape amenity. Curb cut extends along width of lot, thereby precluding controlled access/egress movement.

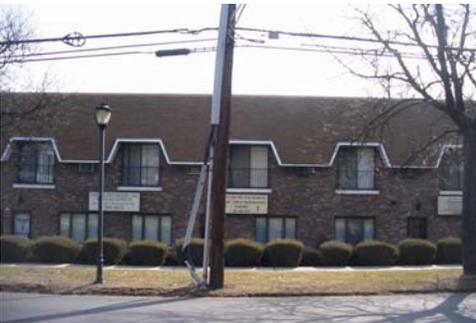
Block: 610 Lot: 4
Use Description: Multi Family Development / Medical Office
Establishment: 10 unit Apartment / Medical Office
Land Value: \$428,100.00
Improvements Value: \$889,700.00
Land Area: 0.44 acres / **Zone:** LBE
GFA: 4,150 sf. / **No. of Stories:** 2 /
Parking: 29 ps.**

Comments: Multi-family residential use not permitted in zone. Building and site maintained.

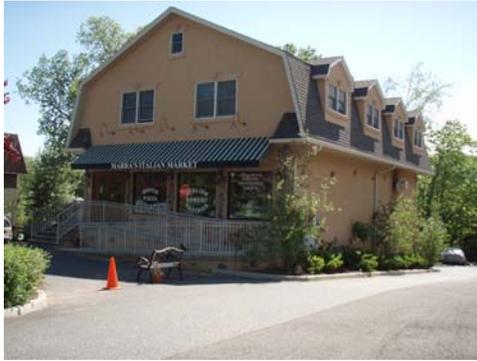
Block: 610 **Lot:** 5.01
Use Description: Commercial / Residential
Establishment: Marra's Italian Market
Land Value: \$367,800.00
Improvements Value: \$764,600.00
Land Area: 0.38 acres / **Zone:** LBE
GFA: 1,935 sf. / **No. of Stories:** 1½
Parking: 18 ps.
Comments: Updated building.

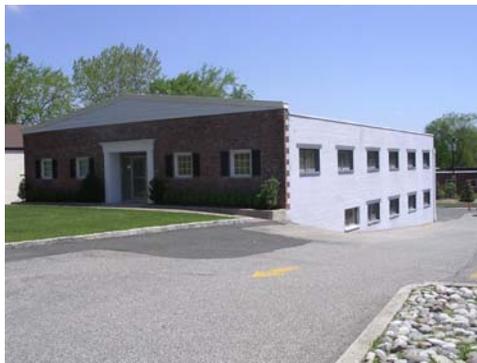
Block: 610 **Lot:** 5.02
Use Description: Office
Establishment: Law Office / Public Accountant / Kloorfain Chiropractic Offices / Kumon
Land Value: \$413,900.00
Improvements Value: \$387,000.00
Land Area: 0.35 acres / **Zone:** LBE
GFA: 3,840 sf. / **No. of Stories:** 1 ½
Parking: 13 ps.
Comments: Building lacks architectural merit,

tion. Lacks landscape amenity.

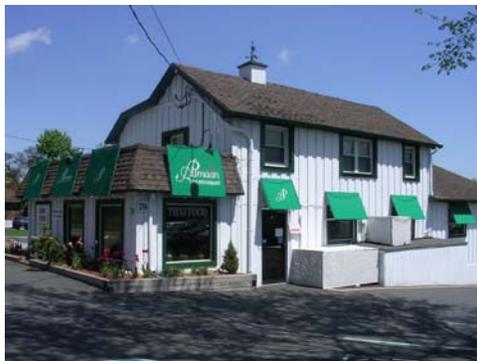
although appears in good condition.

Block: 610 **Lot:** 6
Use Description: Eating and Drinking Establishments
Establishment: Pimaan Thai Restaurant
Land Value: \$368,000.00
Improvements Value: \$353,900.00
Land Area: 0.37 acres / **Zone:** LBE
GFA: 1,380 sf. / **No. of Stories:** 1 / **No. of Seats:** 70 / **Parking:** 34 ps.
Comments: Building appears in good condi-

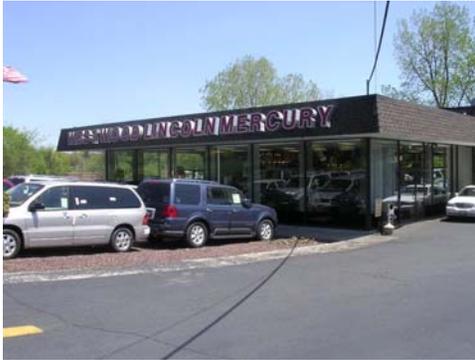
Block: 610 Lot: 7
Use Description: Automotive
Establishment: Westwood Lincoln Mercury
Land Value: \$1,548,500.00
Improvements Value: \$1,926,100.00
Land Area: 2.45 acres / **Zone:** LBE
GFA: 19,270 sf. / **No. of Stories:** 1
Parking: Auto Dealership
Comments: Pre-existing nonconforming use. Excessive land coverage.

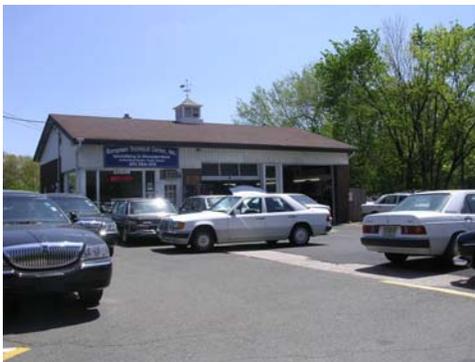
Block: 610 Lots: 8
Use Description: Automotive (Currently Vacant)
Establishment: European Technical Center
Land Value: \$333,200.00
Improvements Value: \$61,600.00
Land Area: 0.29 acres / **Zone:** LBE
GFA: 1,630 sf. / **No. of Stories:** 1
Parking: 21 ps.**
Comments: Pre-existing nonconforming use.

Parking layout undefined. Site on 2008 list of Known Contaminated Sites of New Jersey.

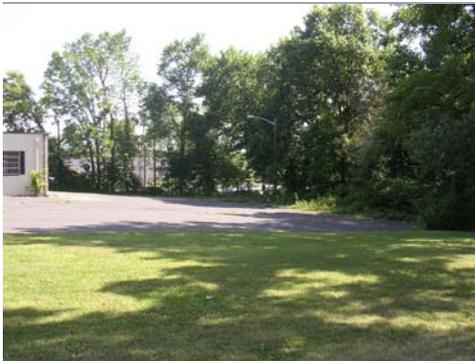
Block: 610 Lot: 9.01
Use Description: Vacant
Establishment: Not Applicable
Land Value: \$210,200.00
Improvements Value: \$0.00
Land Area: 0.47 acres / **Zone:** LBE
Comments: To the rear of the Oritani Bank on Lots 9.02 & 10. Property vacant for at least 10 years.

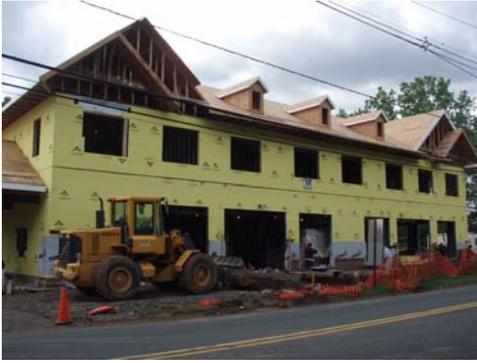
Block: 610 Lot: 9.02, 10

Comments: Site under construction, consistent with goals of CBD district.

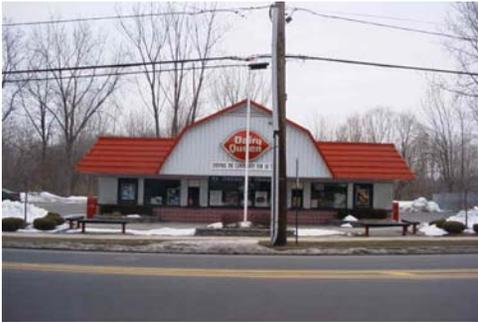
Block: 613 Lot: 1 area.

Comments: Maintained building and parking

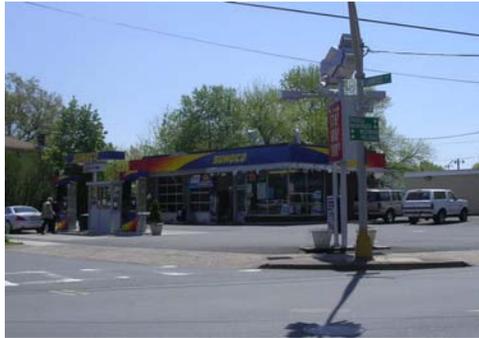
Block: 616 Lot: 1

Comments: Curb cuts too close to busy and irregularly configured intersection, causing con-

flicting turning movements. No landscape amenity as required by code. Site on 2008 list of Known Contaminated Sites of New Jersey.

The following is noted with respect to the land uses in this portion of the Study Area and their consistency with the statutory criteria. The gas station on Block 616 Lot 1 is designed with curb cuts that are placed at locations that impede the safe and efficient flow of vehicles in this area. The adjoining dwelling is characterized by overgrown vegetation, peeling paint, a rusted metal staircase along the side of the building, and related features. Lot 17 has fewer parking spaces than standard planning design criteria would dictate for the building, and the building design includes loading spaces that have poor vision clearance and /or require vehicles to maneuver in the public right of way to back into the loading area. Lot 23 is characterized by a use that parks vehicles all over the lot in a haphazard arrangement, and its curb cut extends the width of the property. A number of the lots in the area are characterized by excessive land coverage. Block 617.01 is typified by excessive coverage factors, poor circulation features, some of the lots lack direct road frontage, and the lots generally lack landscape amenity or suitable buffer plant material where they abut residences. The two blocks proximity to the train station also reflects on the relationship of these blocks to the smart growth principles noted above.

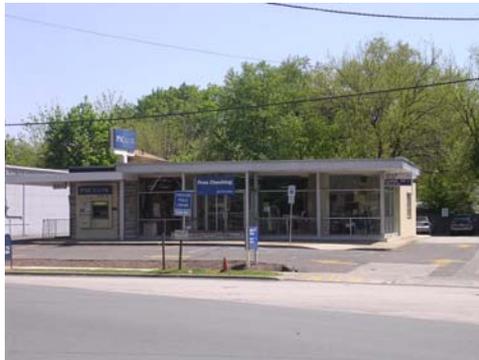
Block: 616 Lots: 16

Comments: Flat roof design. Very low floor area ratio.

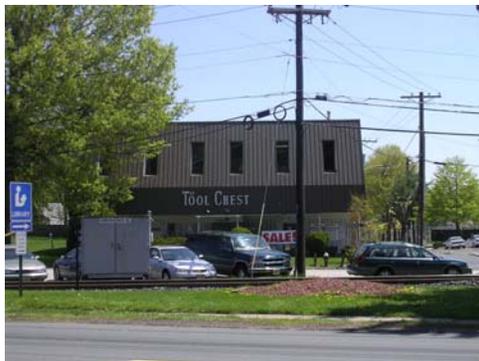
Block: 616 Lot: 17

blocking street to back into space, or has inadequate vision clearance for vehicles that are 'head in' parked.

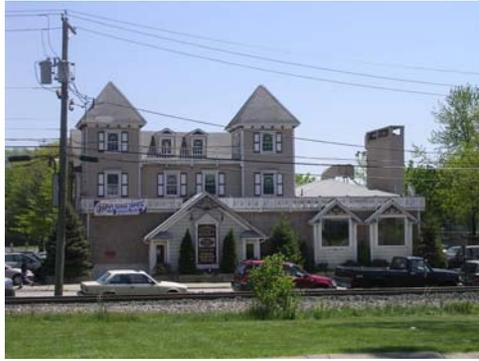
Block: 616 Lot: 19
Use Description: Commercial
Establishment: Emerson Hotel
Land Value: \$ 539,300.00
Improvements Value: \$ 745,200.00
Land Area: 0.58 acres / **Zone:** RC
GFA: 12,090 sf. / **No. of Stories:** 3
Parking: 59 ps.
Comments: Building represents unique architectural element for area.

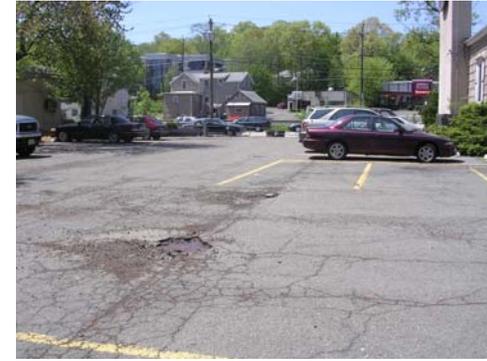
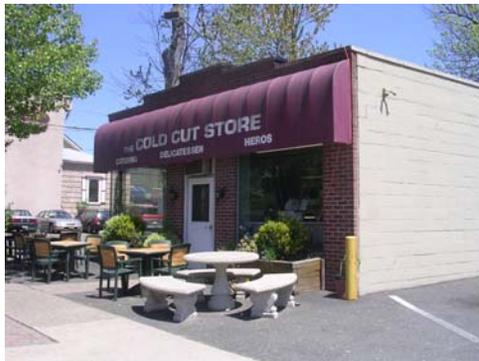
Block: 616 Lot: 20
Use Description: Eating and Drinking Establishments
Establishment: The Cold Cut Store
Land Value: \$ 306,800.00
Improvements Value: \$ 251,900.00
Land Area: 0.18 acres / **Zone:** RC
GFA: 1,580 sf. / **No. of Stories:** 1 / **No. of Seats:** 30
Parking: 7 ps.

Comments: Building appears maintained, but lacks architectural merit. Outdoor seating area is not integrated with site.

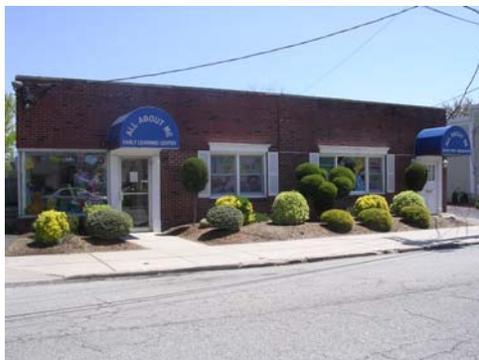
Block: 616 Lot: 21
Use Description: Commercial
Establishment: All about Me Early Learning Center
Land Value: \$ 348,200.00
Improvements Value: \$ 417,800.00
Land Area: 0.26 acres / **Zone:** RC
GFA: 5,640sf. / **No. of Stories:** 1
Parking: 1 ps.
Comments: Lacks sufficient parking. Landscaping adds to appearance.

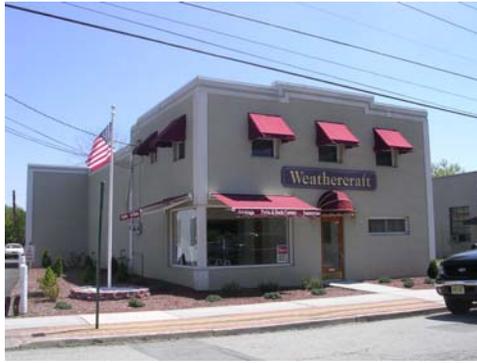
Block: 616 **Lot:** 22
Use Description: Commercial
Establishment: Weathercraft
Land Value: \$ 350,000.00
Improvements Value: \$ 331,600.00
Land Area: 0.26 acres / **Zone:** RC
GFA: 4,730 sf. / **No. of Stories:** 2
Parking: 7 ps.**
Comments: Parking layout not clearly defined.
 Building well maintained re visual appearance.

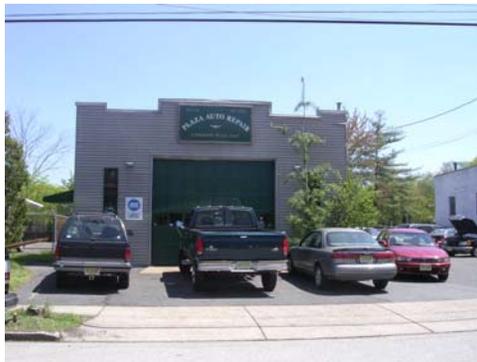
Block: 616 **Lots:** 23
Use Description: Auto Related Commercial
Establishment: Plaza Auto Repair
Land Value: \$ 359,800.00
Improvements Value: \$ 188,100.00
Land Area: 0.28 acres / **Zone:** RC
GFA: 2,530 sf. / **No. of Stories:** 1
Parking: 18 ps.**
Comments: Vehicles scattered all over lot in haphazard manner. Curb cut extends width of

site, precluding controlled access/egress. Site on 2008 list of Known Contaminated Sites of New Jersey.

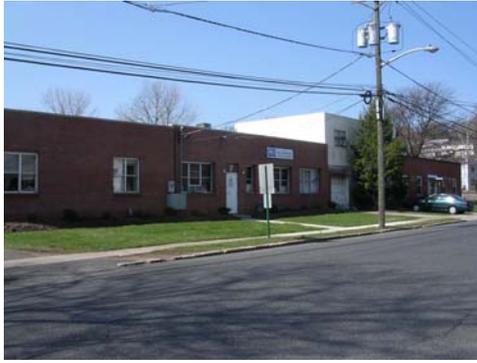
Block: 617.01 Lot: 1

Comments: Insufficient parking. Portion of structure exhibits deteriorating conditions. Varied façade materials.

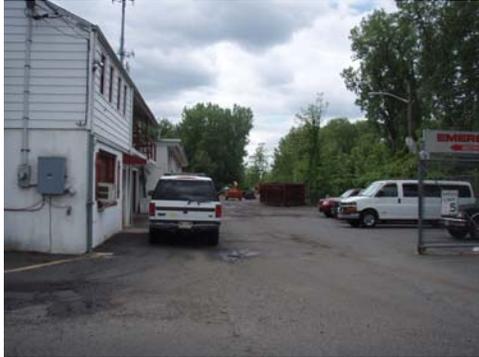
Block: 617.01 **Lot:** 8
Use Description: Municipal
Establishment: Borough Department of Public Works
Land Value: \$ 756,400.00
Improvements Value: \$ 1,017,100.00
Land Area: 1.751 acres / **Zone:** LBW
GFA: Approx 15,900 sf. / **No. of Stories:** 1 1/2
Parking: 8
Comments: No street frontage. Excessive building

and impervious coverage factors.

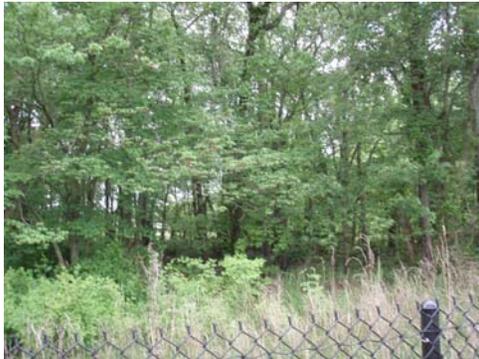
Block: 617.01 **Lot:** 9
Use Description: Vacant/Golf Club
Establishment: Emerson Golf Club
Land Value: \$ 178,300.00
Land Area: 1.981 acres / **Zone:** OSC-Open Space Conservation.
Comments: No street frontage. Part of Emerson Golf Club (in Oradell). Site is predominantly wetlands and partially located in State Planning Area 5—Environmentally Sensitive.

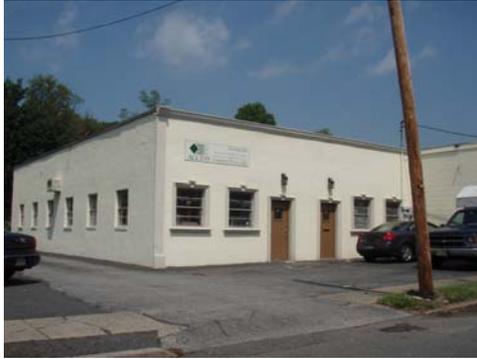
Block: 213 Lot: 1
Use Description: Industrial
Establishment: Access Computer Floors
Land Value: \$ 263,900
Improvements Value: \$ 186,200
Land Area: 0.16 acres / **Zone:** IM
GFA: Approx. 2,600 sf. / **No. of Stories:** 1
Parking: Sufficient.
Comments: Modest/sufficient structure.

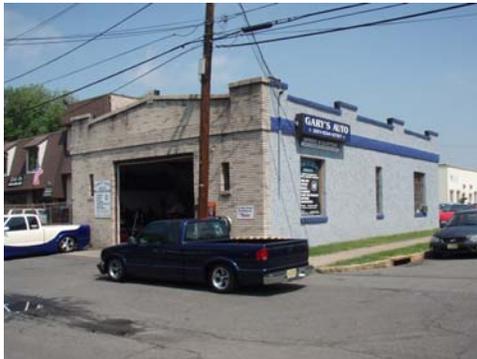
Block: 213 Lot: 2
Use Description: Auto Related Commercial
Establishment: Gary's Auto
Land Value: \$ 253,300
Improvements Value: \$ 122,600
Land Area: 0.11 acres / **Zone:** IM
GFA: Approx. 1,600 sf. / **No. of Stories:** 1
Parking: Parking areas are used for vehicle storage. Site appears to use the right-of-way for vehicle storage.

Comments: The land-improvement ratio is 48%. Small non-descript structure.

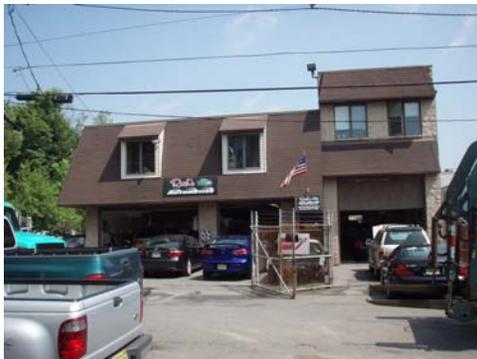
Block: 213 Lot: 3
Use Description: Auto Related Commercial
Establishment: Rich's Auto Body
Land Value: \$ 260,500
Improvements Value: \$ 121,500
Land Area: 0.15 acres / **Zone:** IM
GFA: Approx. 4,200 sf. / **No. of Stories:** 1—2
Parking: Parking areas are used for vehicle storage. Site appears to use the right-of-way for vehicle storage.

Comments: The land-improvement ratio is 47%. Small non-descript structure.

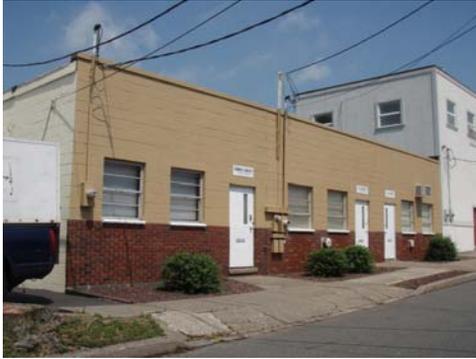
Block: 213 Lot: 4
Use Description: Industrial
Establishment: Anmoka Company, Tolin Design, N.B.C. Cosmetics
Land Value: \$ 279,300
Improvements Value: \$ 134,900
Land Area: 0.20 acres / **Zone:** IM
GFA: Approx. 4,300 sf. / **No. of Stories:** 1
Comments: Building appears in good condition.

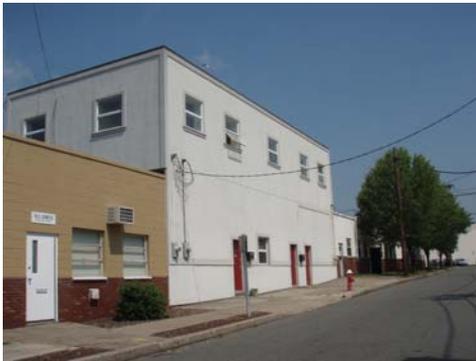
Block: 213 Lot: 5
Use Description: Industrial
Establishment: Engle and Frick Fuel Company
Land Value: \$ 289,300
Improvements Value: \$ 318,800
Land Area: 0.20 acres / **Zone:** IM
GFA: Approx. 9,000 sf. / **No. of Stories:** 2
Comments: Building appears in good condition.
Land-improvement ratio is 110%.

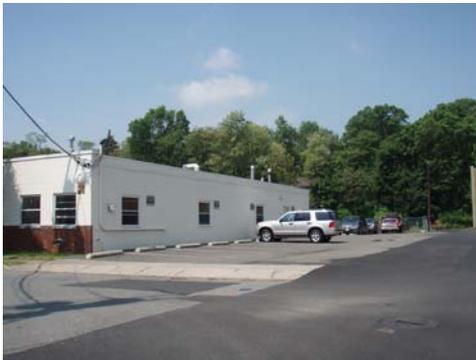
Block: 213 Lot: 6
Use Description: Industrial
Establishment: SDG, Inc, Creative Laminating, Inc.
Land Value: \$ 425,000
Improvements Value: \$ 587,600
Land Area: 0.64 acres / **Zone:** IM
GFA: Approx. 11,700 sf. / **No. of Stories:**
Parking: 31 ps.
Comments: Building appears in good condition.
Land-improvement ratio is 138%.

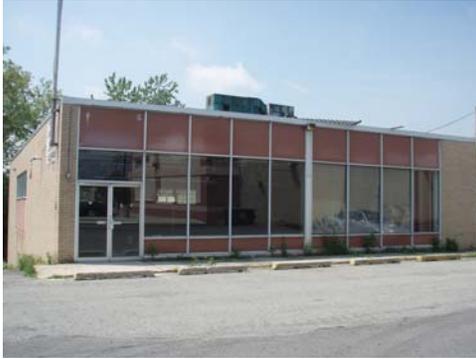
Block: 214 **Lot:** 1.02
Use Description: Commercial
Establishment: Vacant
Land Value: \$ 356,500
Improvements Value: \$ 387,700
Land Area: 0.33 acres / **Zone:** IM
GFA: Approx. 5,400 sf. / **No. of Stories:** 1-2
Parking: 6 delineated in front of structure.

Comments: Vehicles back directly into right-of-way.

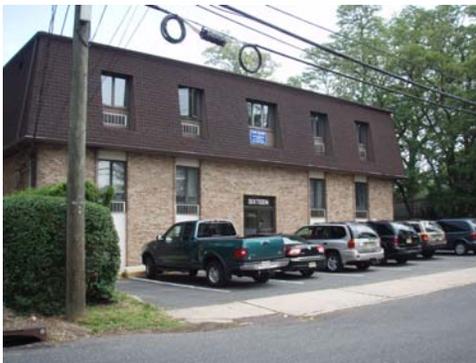
Block: 214 **Lot:** 5.02
Use Description: Office
Land Value: \$ 342,200
Improvements Value: \$ 673,000
Land Area: 0.26 acres / **Zone:** IM
GFA: Approx. 5,400 sf. / **No. of Stories:** 2-3
Parking: 16 ps.

Comments: Vehicles back directly into right-of-way. Three garage spaces in rear conflict with parking area.

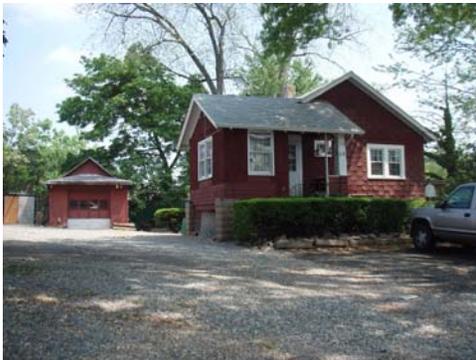
Block: 214 **Lot:** 6
Use Description: Residential
Land Value: \$ 340,900
Improvements Value: \$ 69,900
Land Area: 0.43 acres / **Zone:** IM
No. of Stories: 1-2
Comments: Incompatible, nonconforming use. Land-improvement ratio of 21%

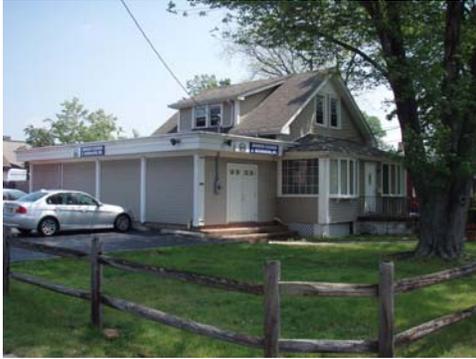
Block: 214 **Lot:** 7
Use Description: Commercial
Establishment: Advanced Cleaning and Restoration Inc./Bob Ruggieri Tree Service
Land Value: \$ 341,300
Improvements Value: \$ 155,400
Land Area: 0.27 acres / **Zone:** IM
GFA: Approx. 1,800 sf. / **No. of Stories:** 1-2
Parking: 10 ps.
Comments: Building appears in good condition.

Vehicles back out into street from parking area. Property has a land-improvement ratio of 46%.

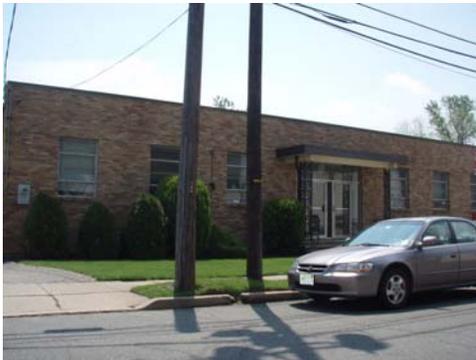
Block: 214 **Lot:** 8.02
Use Description: Commercial
Establishment: Viva-X/Uni-Com/SDG, Inc.
Land Value: \$ 385,000
Improvements Value: \$ 715,000
Land Area: 0.45 acres / **Zone:** IM
GFA: Approx. 8,300 sf. / **No. of Stories:** 1-2
Parking: 12 ps.
Comments: Building and site in good condition. The land-improvement ratio is 186%.

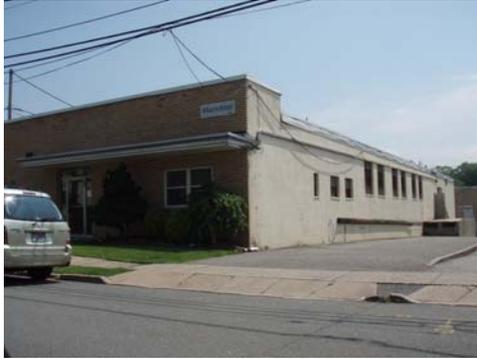
Block: 214 **Lot:** 9

Comments: Building and site in good condition. The land-improvement ratio is 198%.

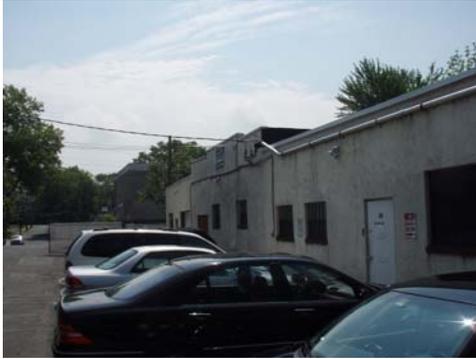
Block: 405 Lot: 1
Use Description: Commercial
Establishment: Turbo Wash
Land Value: \$ 356,900
Improvements Value: \$ 506,500
Land Area: 0.38 acres / **Zone:** IM
GFA: Approx. 7,500 sf. / **No. of Stories:** 1
Parking: 5 in front of building.
Comments: Parking backs out to street. No landscape amenity.

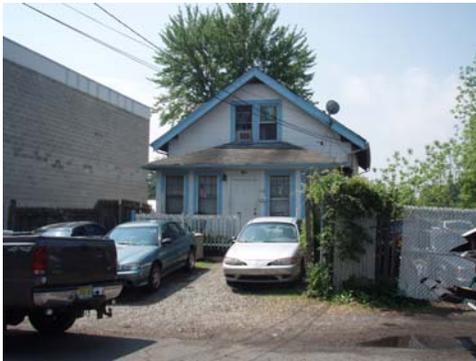
Block: 405 Lot: 2
Use Description: Residential
Establishment:
Land Value: \$ 282,600
Improvements Value: \$ 64,600
Land Area: 0.22 acres / **Zone:** IM
GFA: Approx. 1,000 sf. / **No. of Stories:** 1.5

Comments: Owned by Star Properties, Inc. (Same as 3.01 & 3.02). Nonconforming use. Land-improvement ratio of 23%. No residential character to site.

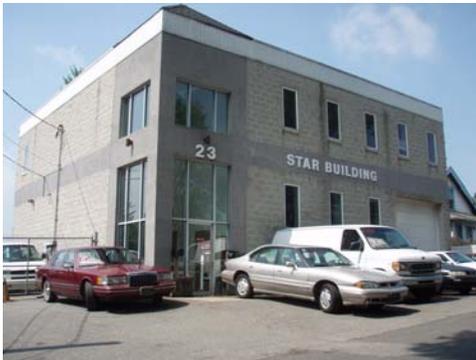
Block: 405 Lot: 3.01
Use Description: Commercial
Establishment: Star Building
Land Value: \$ 298,700
Improvements Value: \$ 333,900
Land Area: 0.23 acres / **Zone:** IM
GFA: Approx. 2,500 sf. / **No. of Stories:** 2
Parking: 5 parking spaces in front, plus additional parking to the side and rear.
Comments: Parking backs out to street.

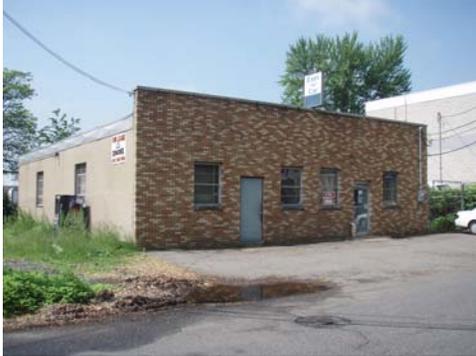
Block: 405 Lot: 3.02
Use Description: Commercial
Establishment: Exec-U-Car
Land Value: \$ 265,400
Improvements Value: \$ 235,800
Land Area: 0.17 acres / **Zone:** IM
GFA: Approx. 2,900 sf. / **No. of Stories:** 1
Parking: 6 ps.
Comments: Modest structure. Parked vehicles must back out into street.

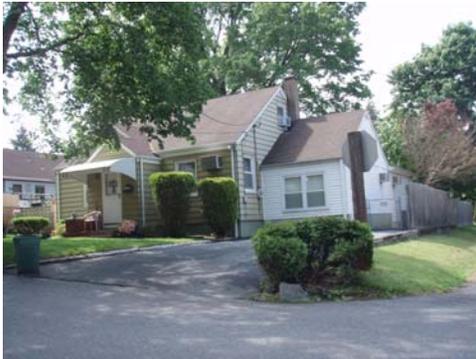
Block: 405 Lot: 4
Use Description: Residential
Land Value: \$ 261,100
Improvements Value: \$ 118,100
Land Area: 0.14 acres / **Zone:** IM
No. of Stories: 1.5
Parking: ps.
Comments: Nonconforming use. Building and site appear well maintained.

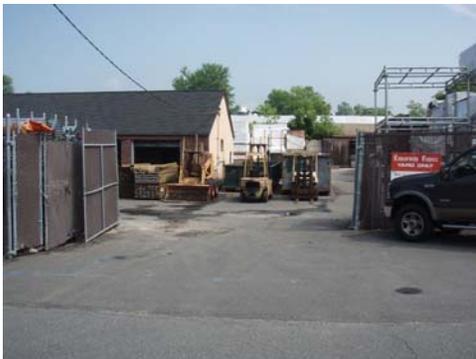
Block: 405 Lot: 12
Use Description: Commercial
Establishment: Emerson Fence
Land Value: \$ 494,100
Improvements Value: \$ 102,200
Land Area: 0.81 acres / **Zone:** IM
GFA: Approx. 4,400 sf.
Parking: ps.
Comments: Excessive outdoor storage. The land-improvement ratio is 21%

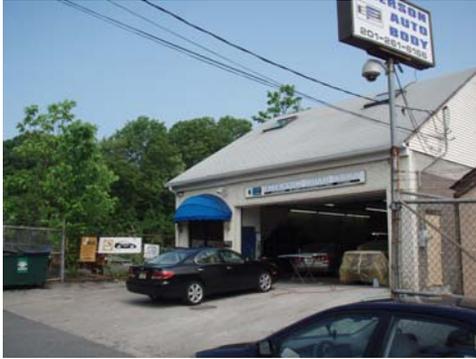
Block: 405 **Lot:** 13
Use Description: Auto Related Commercial
Establishment: Emerson Auto Body
Land Value: \$ 235,900
Improvements Value: \$ 285,100
Land Area: 0.08 acres / **Zone:** IM
GFA: Approx. 2,400 sf. / **No. of Stories:** 1.5
Parking: Parking areas are used for vehicle storage. Site appears to use the right-of-way for vehicle storage.

Comments: Small non-descript structure.
