BOROUGH OF EMERSON

Supplemental Planning Report to Determine if the Downtown Emerson Redevelopment Area Continues to Meet the Criteria for Designation as An Area in Need of Redevelopment

August 18, 2008

BA # 1951.03

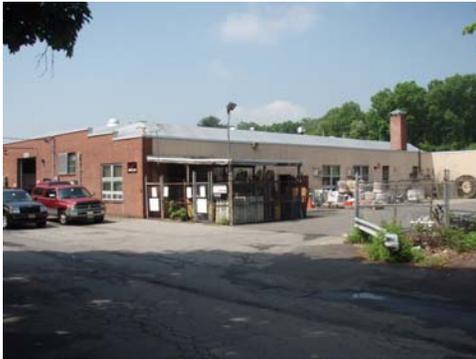
Block: 405 **Lot:** 14
Use Description: Commercial
Establishment: Verizon
Land Value: \$ 1,104,000
Improvements Value: \$ 1,406,700
Land Area: 2.70 acres / **Zone:** IM
GFA: Approx 25,000 sf. / **No. of Stories:** 1
Parking: Poorly delineated parking. Vehicles park all over site including lawn areas.

Comments: Excessive outdoor storage. No screening.
