BOROUGH OF EMERSON

Planning Report
To Determine If An Area Is In Need of Redevelopment

July 2004

PLANNING REPORT TO DETERMINE IF AN AREA IS IN NEED OF REDEVELOPMENT

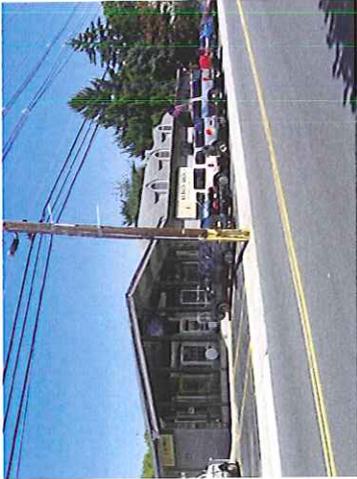
Block: 412 Lot: 1
Use Description: Commercial
Establishment: Kuiken Brothers
Land Value: \$427,500.00
Improvements Value: \$486,700.00
Land Area: 1.7 acres / **Zone:** IM & RC
GFA: 21,655 sf. / **No. of Stories:** 1
Parking: 23 ps.

Comments: Site design includes parking arrangement requiring vehicles to back directly out into Kinderkamack Road, which is inconsistent with planning design standards. Site's curb cut extends along width of lot, precluding ability to channelize and direct vehicular movements. Outdoor storage. No buffer between site and adjoining residential zone. Excessive land coverage.

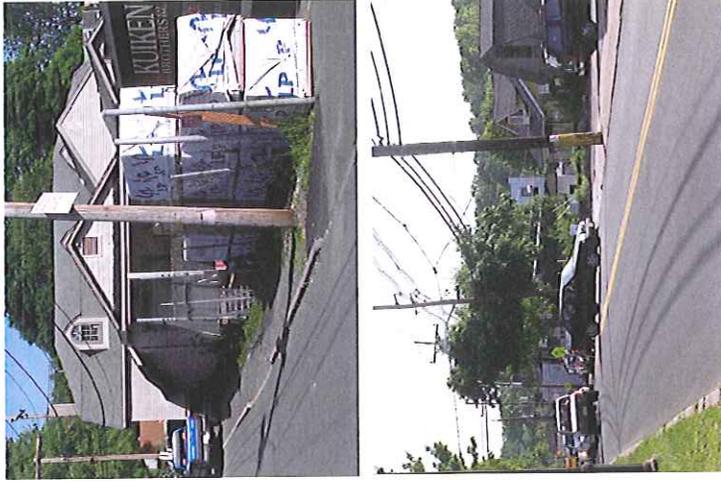
Block: 412 Lot: 2
Use Description: Commercial
Establishments: Cellular Signal II / Kuiken Brothers
Land Value: \$202,500.00
Improvements Value: \$138,400.00
Land Area: 0.22 acres / **Zone:** RC
GFA: 2,940 sf. / **No. of Stories:** 2
Parking: 8 ps.
Comments: Attractive well maintained build-

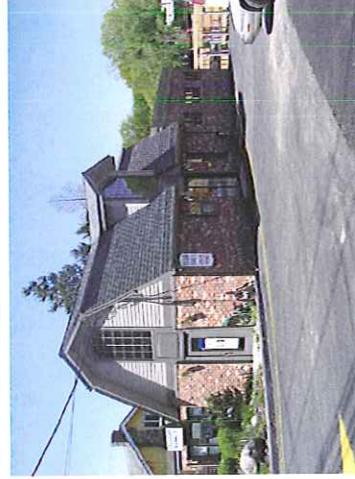
ing. Two way curb cut immediately next to curb cut of adjoining Lot 1; results in potential for conflicting turning movements. Excessive land coverage.

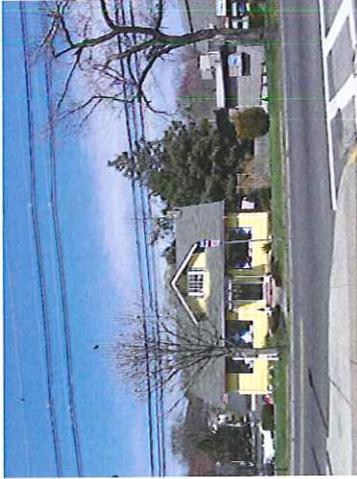
Block: 412 **Lot:** 3
Use Description: Commercial / Residential
Establishments: Sae Won Nails / 1 Family Residential
Land Value: \$315,900.00
Improvements Value: \$66,400.00
Land Area: 0.35 acres / **Zone:** RC
GFA: 3,630 sf. / **No. of Stories:** 2
Parking: 12 ps.
Comments: Existing residential use not permit-

ted in zone. Site improvements represents only 21% of land value. Building façade appears to have been recently repainted.

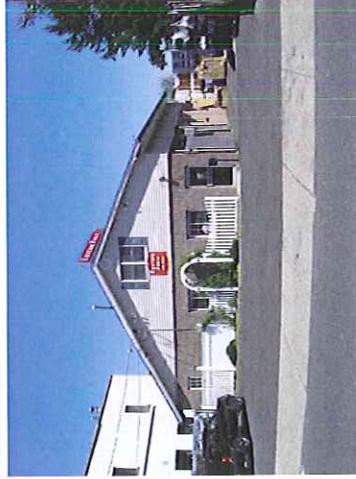
Block: 412 **Lot:** 4
Use Description: Commercial
Establishment: Emerson Fence
Land Value: \$188,600.00
Improvements Value: \$119,000.00
Land Area: 0.23 acres / **Zone:** IM
GFA: 3,908 sf. / **No. of Stories:** 1½
Parking: 7 ps.
Comments: Building façade good. Outdoor storage in side and rear. Excessive land cover-

age.

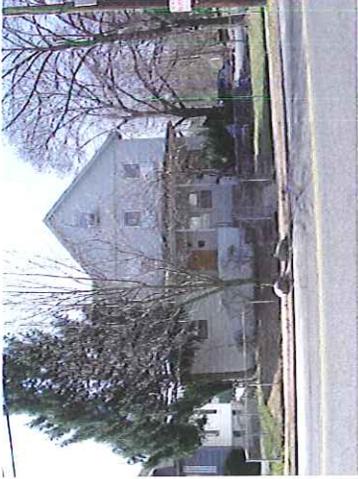
Block: 419 **Lot:** 1
Use Description: 2 Family Residential
Land Value: \$103,500.00
Improvements Value: \$45,400.00
Land Area: 0.09 acres / **Zone:** RC
GFA: 2,010 sf. / **No. of Stories:** 2
Parking: 0 ps.
Comments: Residence not permitted in zone. No parking. Percentage of improvement-to-land value is 44%. Lot very small.

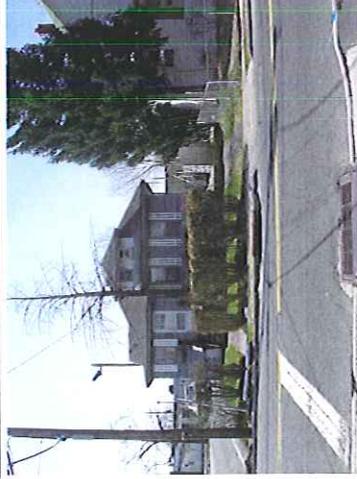
Block: 419 **Lot:** 2
Use Description: 1 Family Residential
Land Value: \$92,000.00
Improvements Value: \$14,300.00
Land Area: 0.09 acres / **Zone:** RC
GFA: 860 sf. / **No. of Stories:** 1
Parking: 0 ps.
Comments: Residence not permitted in zone. No parking. Roof and windows appear to be in need of repair. Percentage of improvement-to-land value is 16%.

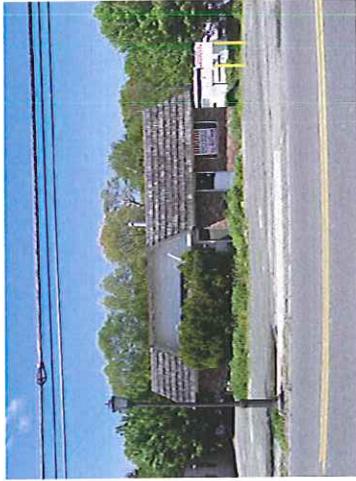
Block: 419 Lot: 5
Use Description: Vacant Building
Establishments: Vacant Commercial Building
Land Value: \$208,000.00
Improvements Value: \$12,000.00
Land Area: 0.23 acres / **Zone:** RC
GFA: 1,380 sf. / **No. of Stories:** 1
Parking: 15 ps.*
Comments: Existing structure appears in need of repair, with peeled wooden façade and peeling paint, and displaced cinder blocks. Overgrown weeds evident in rear. Building assessed value decreased from \$71,600 to \$12,000 over past 10 years. Site is identified on 2001 list of known contaminated sites of New Jersey.

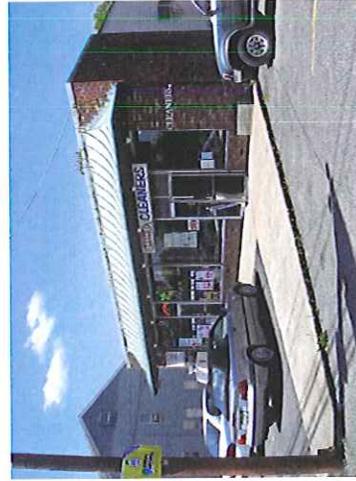
Block: 419 Lot: 6.01
Use Description: Commercial
Establishments: Ranch Cleaners / Cork & Keg
Land Value: \$278,800.00
Improvements Value: \$250,700.00
Land Area: 0.38 acres / **Zone:** RC
GFA: 4,630 sf. / **No. of Stories:** 1
Parking: 26 ps.
Comments: Curb cut extends width of site; precludes controlled access/egress & results in potential for conflicting turning movements. Observed vehicles backing directly out into Kinderkamack Road. Too many window signs. Potholes in paved parking lot provided in the rear yard of the property.

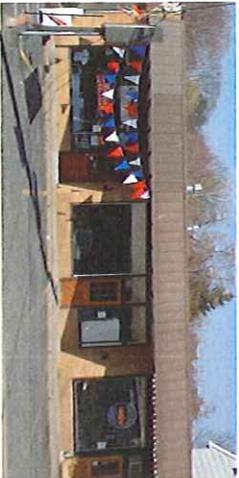
Block: 419 Lot: 8
Use Description: Commercial / Eating and Drinking Establishments
Establishment: Healthy Bodies Fitness / Laurel Chinese Restaurant / Shell's Deli (Inactive Business)
Land Value: \$150,000.00
Improvements Value: \$203,300.00
Land Area: 0.17 acres / **Zone:** RC
GFA: 3,920 sf. / **No. of Stories:** 1 / **Parking:** 15 ps.** / **No. of Seats:** Shell's Deli: 2 / Chinese Restaurant: 6
Comments: One vacant storefront. Curb cut extends width of lot, precluding controlled access/egress. Peeling paint on façade. Excessive land coverage.

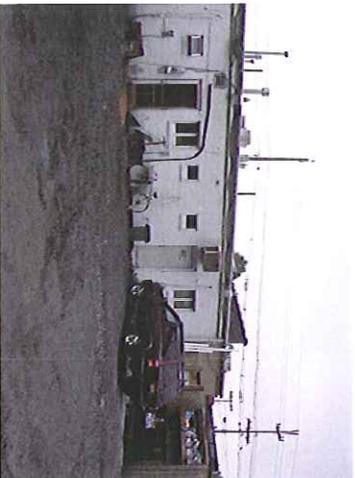
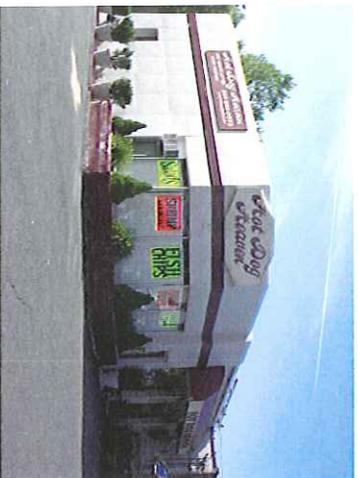
Block: 419 Lot: 9 14 ps.
Use Description: Commercial / Eating and Drinking Establishments
Establishments: Hot Dog Heaven / Major Home Remodeling
Land Value: \$252,400.00
Improvements Value: \$97,300.00
Land Area: 0.22 acres / **Zone:** RC
GFA: 1,915 sf. / **No. of Stories:** 1 / **No. of Seats (Hot Dog Heaven):** 21 / **Parking:** coverage.
Comments: Building appears in good condition. Stacked parking on one side inconsistent with planning design criteria. Curb cuts too close to major intersection, and they extend almost entire length of site, precluding controlled access at intersection. Insufficient landscape amenity. Parking lot appears to be recently repaved and striped. Excessive land coverage.

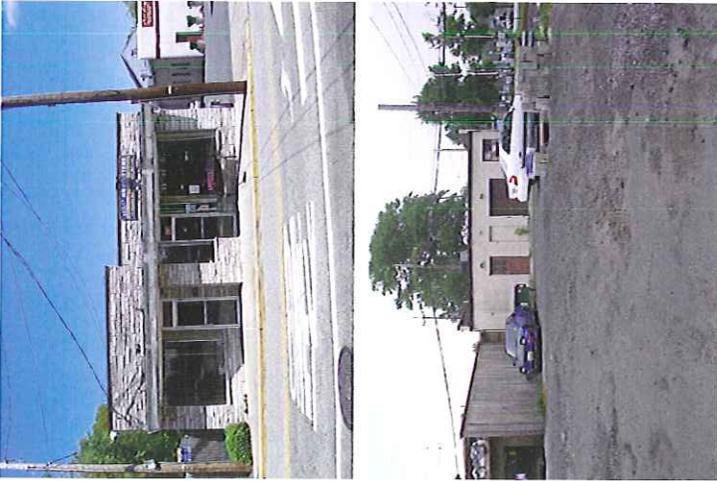
Block: 419 **Lot:** 10
Use Description: Commercial
Establishment: Hilo Haircutters/Unoccupied Retail Space
Land Value: \$77,000.00
Improvements Value: \$121,500.00
Land Area: 0.08 acres / **Zone:** RC
GFA: 1,780 sf. / **No. of Stories:** 1
Parking: 3 ps.**
Comments: Insufficient parking. Gravel parking area in rear does not delineate spaces. One retail storefront is vacant. Lot very small to stand on its own for conventional development.

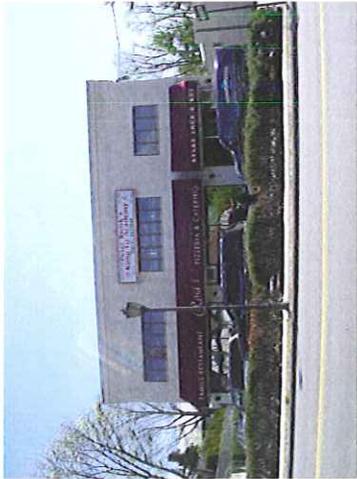
Block: 420 Lot: 2
Use Description: Commercial / Eating and Drinking Establishments
Establishment: Atlas Lock & Key / Rosa's Pizzeria / Peter Kwok's Kung Fu Academy
Land Value: \$308,800.00
Improvements Value: \$283,700.00
Land Area: 0.41 acres / **Zone:** RC
GFA: 6,860 sf. / **No. of Stories:** 2 / **No. of Seats (Rosa's Pizzeria):** 78 / **Parking :** 20 ps.
Comments: Insufficient parking based on planning design standards. Building appears to have been upgraded, canopies add to character. Landscape amenity in front serves to enhance site.

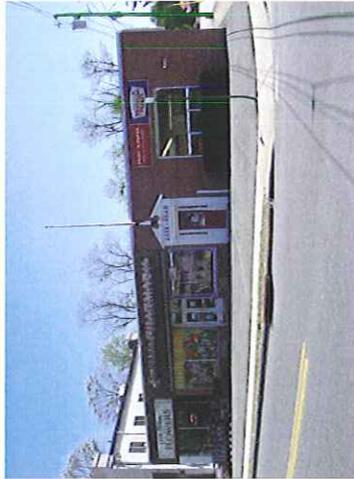
Block: 420 Lot: 16
Use Description: Commercial
Establishment: Little Shoppe Flowers / Emerson Pharmacy / Moore Paints
Land Value: \$237,300.00
Improvements Value: \$208,800.00
Land Area: 0.30 acres / **Zone:** RC
GFA: 4,050 sf. / **No. of Stories:** 1
Parking: 15 ps.
Comments: Insufficient parking per design standards. No landscape amenity, no integrated signage; presents discordant image. Building façade has some peeling/cracked paint and staining.

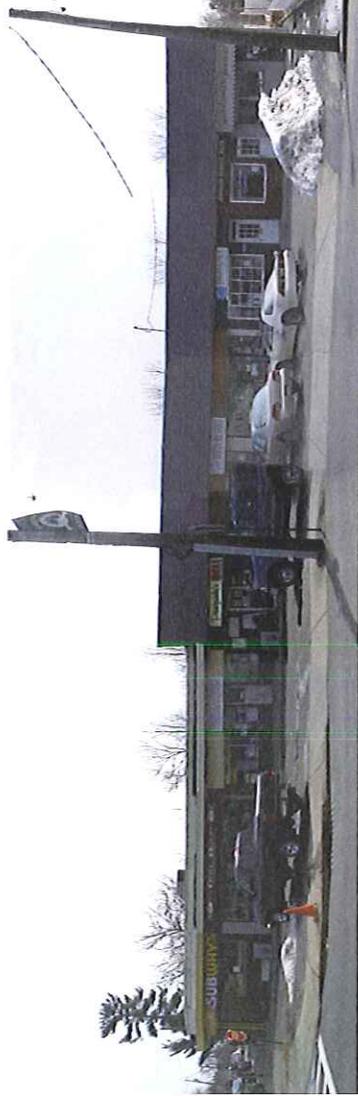
1.d. Block 422 Lot 1, 13-18

Comments: No landscape amenity, lack of integrated signage, and disconnected parapet presents discordant image. Signs on front façade inconsistent in design and material. Rear of building has all rooftop appurtenances visible. Potholes in rear parking area; characterized by poor design including some parking spaces with 'blind' movements around buildings. All of the individual tax lots are too small to stand on their own as developable parcels.

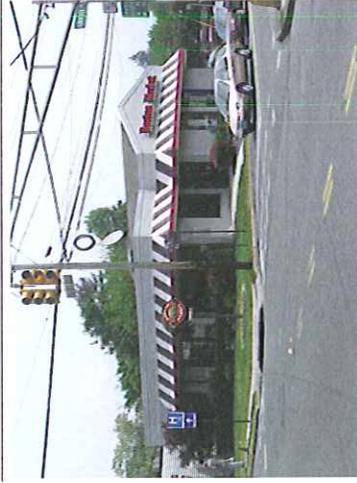
Block: 422 Lots: 10&11
Use Description: Eating and Drinking Establishments
Establishment: Boston Market
Land Value: \$274,200.00
Improvements Value: \$278,000.00
Land Area: 0.36 acres / **Zone:** RC
GFA: 2,355 sf. / **No. of Stories:** 1 / **No of Seats:** 31 / **Parking:** 31 ps.
Comments: Site well maintained with suitable parking lot design.

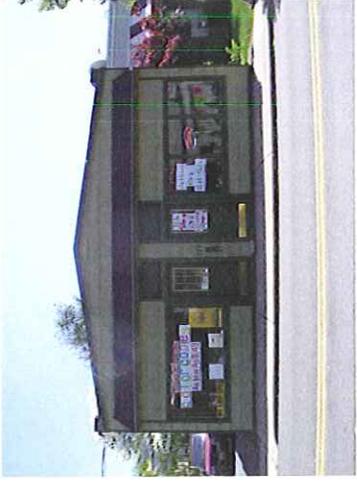
Block: 422 Lot: 12
Use Description: Commercial
Establishment: Fairmount Printing / Unique Collection
Land Value: \$106,600.00
Improvements Value: \$37,200.00
Land Area: 0.09 acres / **Zone:** RC
GFA: 960 sf. / **No. of Stories:** 1
Parking: 1 ps.
Comments: Small building without any architectural merit. Inconsistent façade materials and signage. Site too small to accommodate any meaningful level of development on its own.

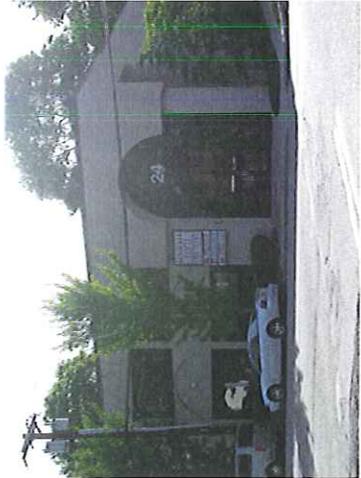
Insufficient parking based on design standards.

Block: 603 Lot: 2
Use Description: Office/Medical Office
Establishment: Emerson Power / Sigma Advertising / Family Dentistry
Land Value: \$124,800.00
Improvements Value: \$422,500.00
Land Area: 0.15 acres / **Zone:** RC
GFA: 4,950 sf. / **No. of Stories:** 2 / **Parking:** 12 ps.

Comments: Office use not permitted in zone. Building maintained in acceptable manner.

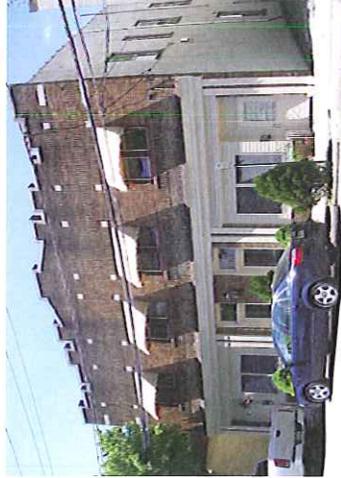
Block: 603 Lot: 3
Use Description: Multi Family Development
Establishment: 18 unit Apartment
Land Value: \$129,600.00
Improvements Value: \$321,300.00
Land Area: 0.16 acres / **Zone:** RC
GFA: 5,180 sf. / **No. of Stories:** 2
Parking: 9 ps.**
Comments: Residential use not permitted in zone. The gravel/grass parking area does not delineate parking spaces. Parking less than required by standard design criteria. Site's driveway has no vision clearance from parking lot onto sidewalk; conflicting movement with pedestrians.

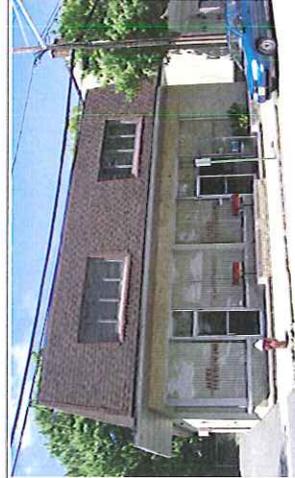
Block: 603 Lot: 4
Use Description: Office
Establishment: Alen Elevator
Land Value: \$132,000.00
Improvements Value: \$ 266,400.00
Land Area: 0.18 acres / **Zone:** RC
GFA: 2,155 sf. / **No. of Stories:** 2
Parking: 9 ps.

Comments: Office use not permitted in zone. Site's driveway has no vision clearance from parking lot onto sidewalk; conflicting movement with pedestrians.

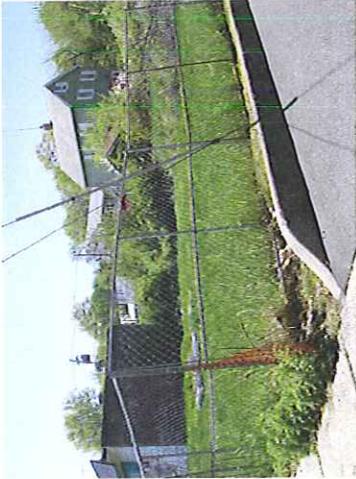
Block: 603 Lot: 5
\$285,600 to \$162,400 between 1999 and 2004.
Viewed as eyesore.

Use Description: Vacant
Establishment: Not Applicable
Land Value: \$162,400.00
Improvements Value: \$ 0.00
Land Area: 0.24 acres / **Zone:** RC
GFA: Not Applicable
Parking: Not Applicable
Comments: Site vacant for several years. Assessed value decreased 43 percent from

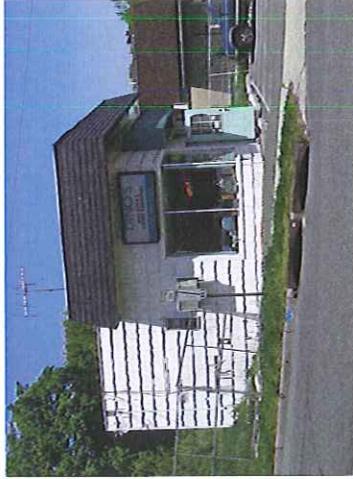
Block: 603 Lot: 6
Curb cut extends length of site at a busy intersection, resulting in potentially conflicting turning movements.

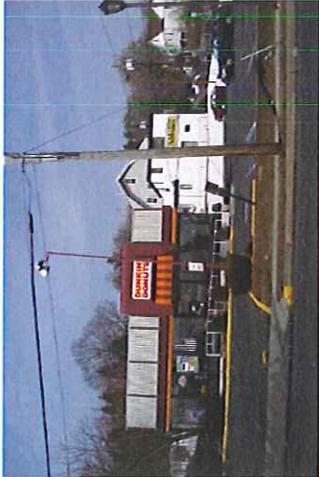
Block: 606 Lot: 3
Use Description: Eating and Drinking Establishments
Establishment: Dunkin Donuts
Land Value: \$249,000.00
Improvements Value: \$204,700.00
Land Area: 0.28 acres. / **Zone:** LBW
GFA: 1,710 sf. / **No. of Stories:** 1 / **No. of Seats:** 14 ps.
Parking: 13 ps.

Comments: Site well maintained with suitable parking lot design.

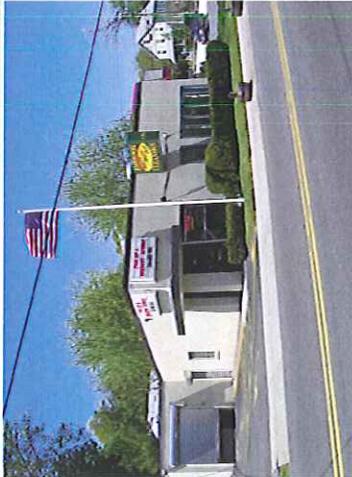
Block: 606 Lot: 4
Use Description: Commercial
Establishment: Emerson Cleaners
Land Value: \$288,800.00
Improvements Value: \$108,600.00
Land Area: 0.31 acres / **Zone:** LBW
GFA: 1,655 sf. / **No. of Stories:** 1
Parking: 14 ps.
Comments: Property maintenance acceptable.

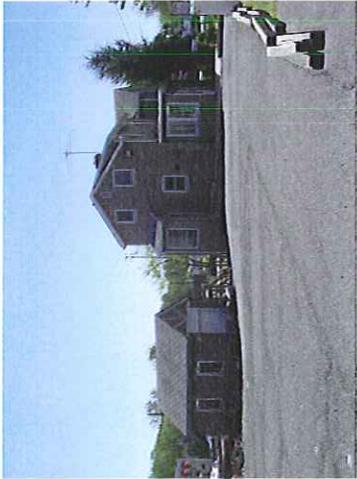
Block: 610 Lot: 1
Use Description: Residential
Establishment: 2 Family Residential
Land Value: \$174,800.00
Improvements Value: \$47,700.00
Land Area: 0.24 acres. / **Zone:** LBE
GFA: 1,280 sf. / **No. of Stories:** 2½
Parking: 4 ps.**
Comments: Residential use not permitted in zone.

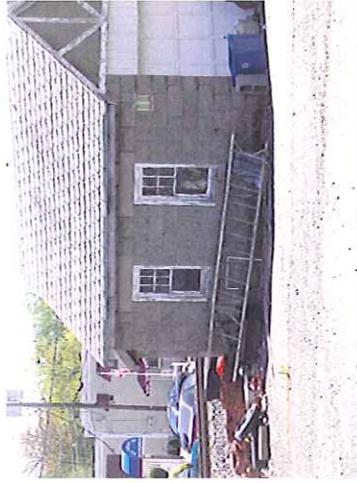
Block: 610 Lot: 2
Use Description: Commercial
Establishment: Floors Beautiful / Wicker Wonderland / All State
Land Value: \$278,100.00
Improvements Value: \$252,000.00
Land Area: 0.28 acres / **Zone:** LBE
GFA: 2,605 sf. / **No. of Stories:** 1
Parking: 11 ps.**
Comments: Building is nondescript and lacks

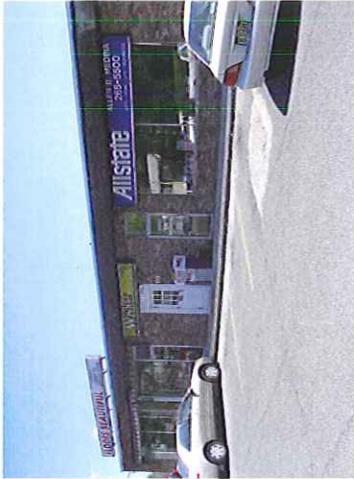
architectural merit. Existing signage inconsistent throughout. Lacks suitable landscape amenity. Curb cut extends along width of lot, thereby precluding controlled access/egress movement.

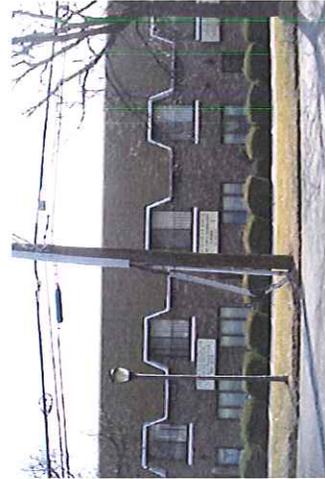
Block: 610 Lot: 4
Use Description: Multi Family Development / Medical Office
Establishment: 10 unit Apartment / Medical Office
Land Value: \$376,700.00
Improvements Value: \$476,900.00
Land Area: 0.44 acres / **Zone:** LBE
GFA: 4,150 sf. / **No. of Stories:** 2 / **Parking:** 29 ps.**

Comments: Multi-family residential use not permitted in zone. Building and site maintained.

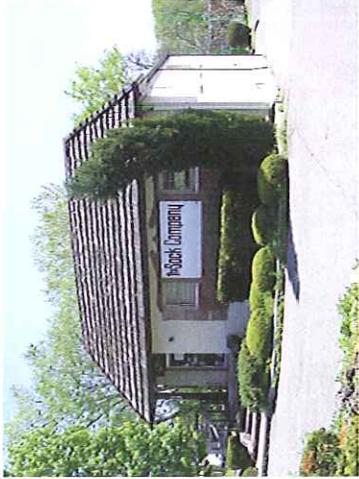
Block: 610 Lot: 5.01
Use Description: Commercial
Establishment: The Sock Company (last tenant)
Land Value: \$302,800.00
Improvements Value: \$405,900.00
Land Area: 0.38 acres / **Zone:** LBE
GFA: 1,935 sf. / **No. of Stories:** 1½
Parking: 14 ps.
Comments: Vacant building. Peeling paint and some boarded windows.

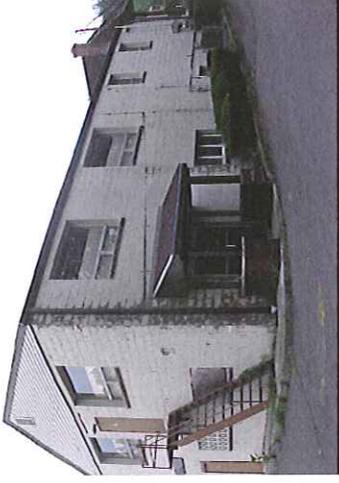
Block: 610 Lot: 5.02
Use Description: Office
Establishment: Law Office / Public Accountant / Kloorfain Chiropractic Offices / Kumon
Land Value: \$251,800.00
Improvements Value: \$110,700.00
Land Area: 0.35 acres / **Zone:** LBE
GFA: 3,840 sf. / **No. of Stories:** 1 ½
Parking: 13 ps.
Comments: Building lacks architectural merit,

although appears in good condition.

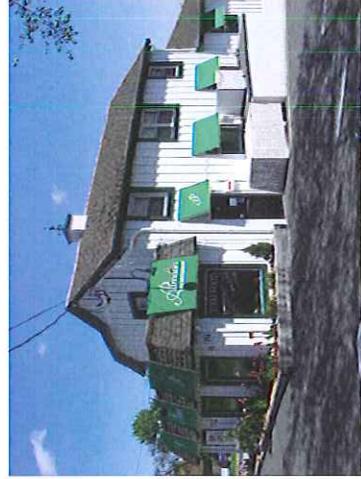
Block: 610 Lot: 6
Use Description: Eating and Drinking Establishments
Establishment: Pima Thai Restaurant
Land Value: \$225,000.00
Improvements Value: \$208,600.00
Land Area: 0.37 acres / **Zone:** LBE
GFA: 1,380 sf. / **No. of Stories:** 1 / **No. of Seats:** 70 / **Parking:** 34 ps.
Comments: Building appears in good condi-

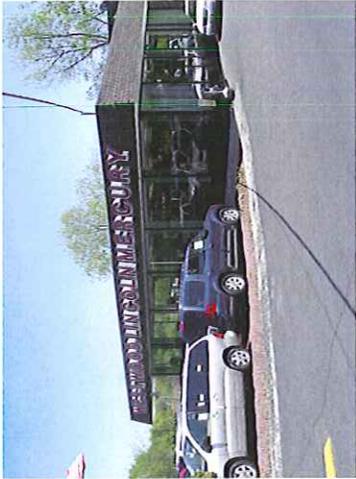
Block: 610 Lot: 7
Use Description: Automotive
Establishment: Westwood Lincoln Mercury
Land Value: \$1,020,400.00
Improvements Value: \$622,600.00
Land Area: 2.45 acres / **Zone:** LBE
GFA: 19,270 sf. / **No. of Stories:** 1
Parking: Auto Dealership
Comments: Pre-existing nonconforming use. Excessive land coverage.

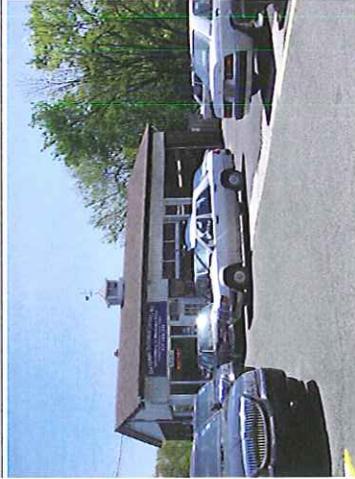
Block: 610 Lots: 8
Use Description: Automotive
Establishment: European Technical Center
Land Value: \$285,800.00
Improvements Value: \$118,500.00
Land Area: 0.29 acres / **Zone:** LBE
GFA: 1,630 sf. / **No. of Stories:** 1
Parking: 21 ps.**
Comments: Pre-existing nonconforming use. Parking layout undefined. Site on 2001 list of Known Contaminated Sites of New Jersey.

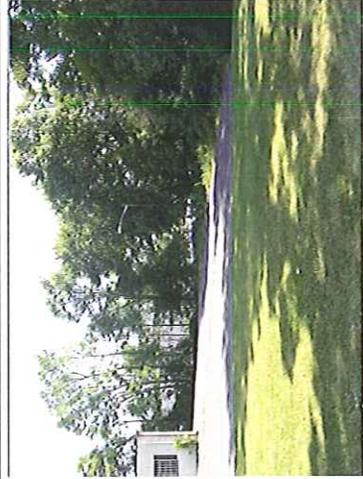
Block: 610 Lot: 9.01
Use Description: Vacant
Establishment: Not Applicable
Land Value: \$210,200.00
Improvements Value: \$0.00
Land Area: 0.47 acres / **Zone:** LBE
Comments: Property vacant for at least 10 years.

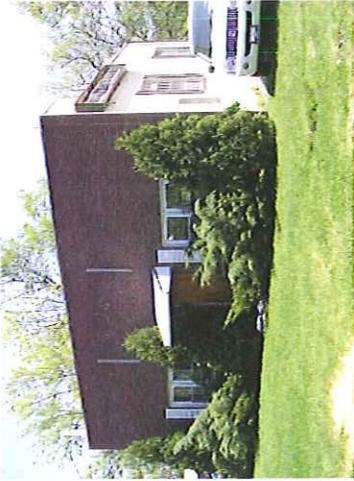
Block: 610 **Lot:** 9.02
Use Description: Vacant Building
Establishment: Vacant Commercial Building
Land Value: \$191,300.00
Improvements Value: \$47,700.00
Land Area: 0.21 acres / **Zone:** LBE
GFA: 1,475 sf. / **No. of Stories:** 1
Parking: 29 ps.**
Comments: Lots 9.02 and 10 in same ownership. Small lot based on zoning. Overgrown plant material and broken wall mounted sign.

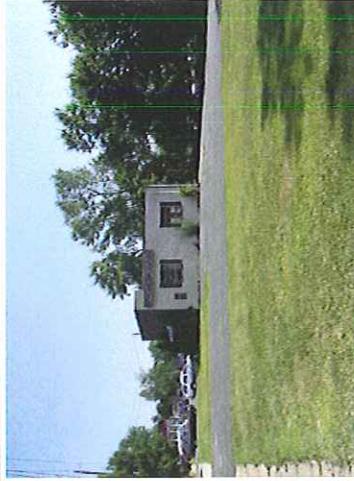
Block: 610 **Lot:** 10
Use Description: Vacant
Establishment: Not Applicable
Land Value: \$191,300.00
Improvements Value: \$9,400.00
Land Area: 0.22 acres / **Zone:** LBE
GFA: See Lot 9.02
Parking: See Lot 9.02
Comments: Vacant

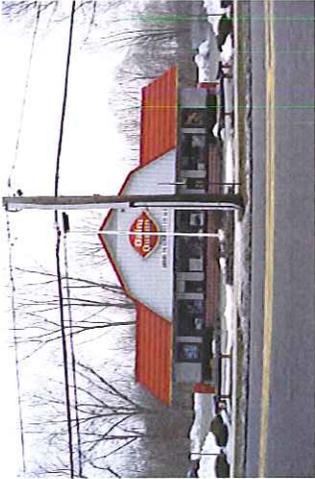
Block: 613 Lot: 1
Use Description: Commercial
Establishment: Dairy Queen
Land Value: \$397,000.00
Improvements Value: \$130,600.00
Land Area: 0.49 acres / **Zone:** LBE
GFA: 3,110 sf. / **No. of Stories:** 1 / **No. of Seats:** 25
Parking: 30 ps.
Comments: Maintained building and parking area.

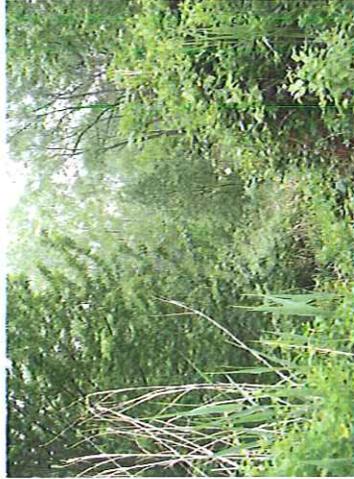
Block: 613 Lot: 2
Use Description: Vacant
Establishment: Not Applicable
Land Value: \$295,200.00
Improvements Value: \$0.00
Land Area: 1.2 acres / **Zone:** LBE
Comments: Vacant for at least 10 years. Wetlands on site.

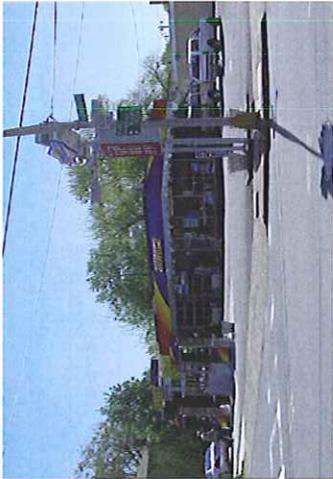
Block: 616 Lot: 1
Use Description: Auto Related Commercial
Establishment: Sunoco Gas Station
Land Value: \$ 274,500.00
Improvements Value: \$ 106,800.00
Land Area: 0.28 acres / **Zone:** RC
GFA: 1,130 sf. / **No. of Stories:** 1
Parking: 7 ps.
Comments: Curb cuts too close to busy and irregularly configured intersection, causing con-

flicting turning movements. No landscape amenity as required by code.

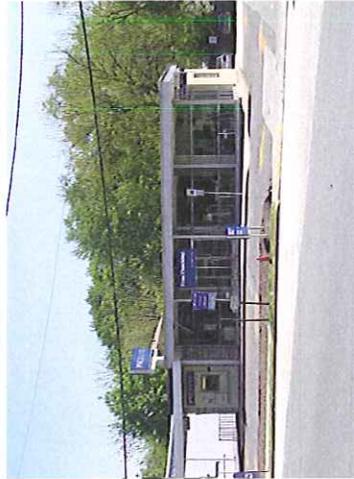
Block: 616 Lots: 16
Use Description: Commercial
Establishment: PNC Bank
Land Value: \$ 389,600.00
Improvements Value: \$ 142,900.00
Land Area: 0.59 acres / **Zone:** RC
GFA: 2,620 sf. / **No. of Stories:** 1
Parking: 14 ps.
Comments: Flat roof design. Very low floor area ratio.

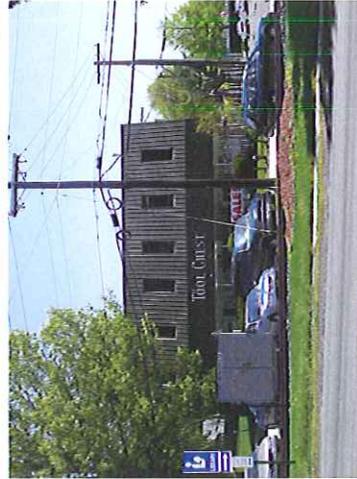
Block: 616 Lot: 17
Use Description: Commercial
Establishment: The Cool Chest
Land Value: \$ 182,200.00
Improvements Value: \$ 350,200.00
Land Area: 0.29 acres / **Zone:** RC
GFA: 12,580 sf. / **No. of Stories:** 2
Parking: 11 ps.
Comments: Insufficient number of parking spaces. Loading area design either requires

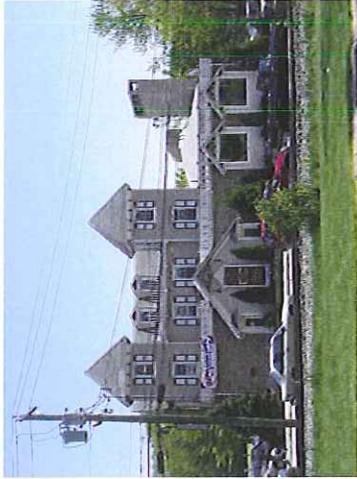
Block: 616 **Lot:** 19
Use Description: Commercial
Establishment: Emerson Hotel
Land Value: \$ 371,300.00
Improvements Value: \$ 414,700.00
Land Area: 0.58 acres / **Zone:** RC
GFA: 12,090 sf. / **No. of Stories:** 3
Parking: 59 ps.
Comments: Building represents unique architectural element for area.

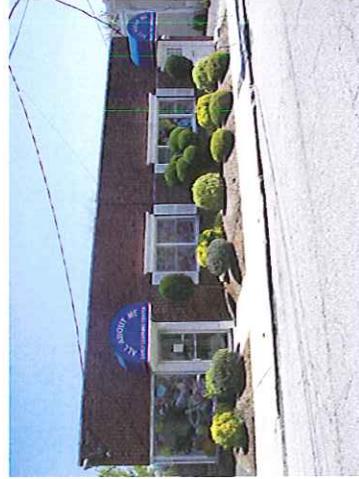
Block: 616 **Lot:** 21
Use Description: Commercial
Establishment: All about Me Early Learning Center
Land Value: \$ 159,800.00
Improvements Value: \$ 183,500.00
Land Area: 0.26 acres / **Zone:** RC
GFA: 5,640sf. / **No. of Stories:** 1
Parking: 1 ps.
Comments: Lacks sufficient parking. Landscaping adds to appearance.

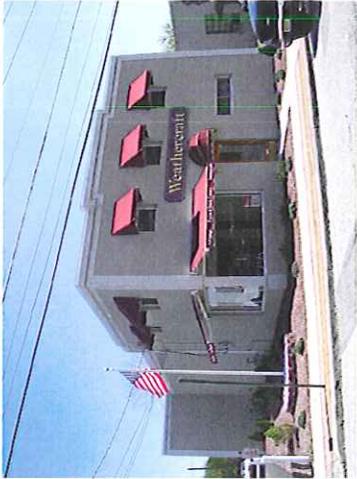
Block: 616 Lot: 22
Use Description: Commercial
Establishment: Wheathcraft
Land Value: \$ 162,000.00
Improvements Value: \$ 174,500.00
Land Area: 0.26 acres / **Zone:** RC
GFA: 4,730 sf. / **No. of Stories:** 2
Parking: 7 ps.**
Comments: Parking layout not clearly defined. Building well maintained re visual appearance.

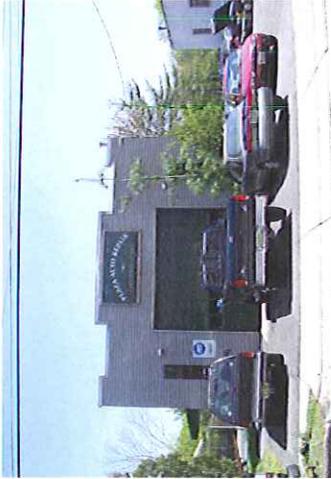
Block: 616 Lots: 23
Use Description: Auto Related Commercial
Establishment: Plaza Auto Repair
Land Value: \$ 172,800.00
Improvements Value: \$ 123,300.00
Land Area: 0.28 acres / **Zone:** RC
GFA: 2,530 sf. / **No. of Stories:** 1
Parking: 18 ps.**
Comments: Vehicles scattered all over lot in haphazard manner. Curb cut extends width of site, precluding controlled access/egress.

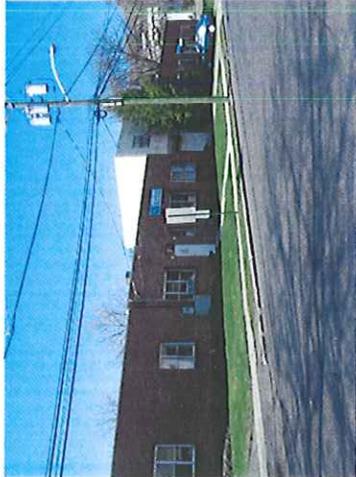
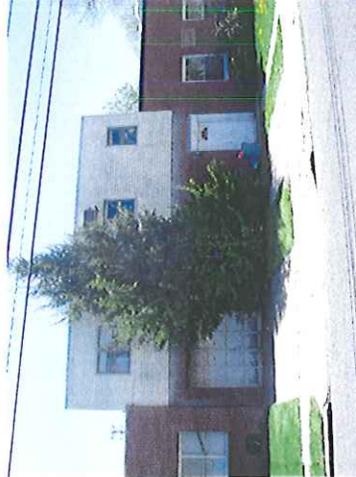
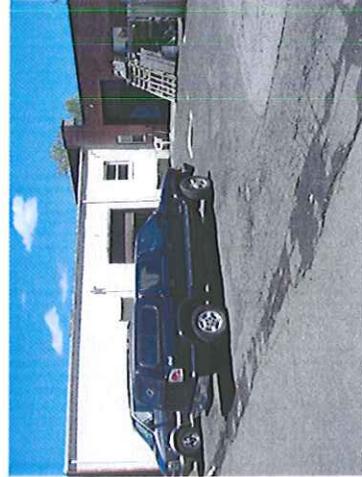
Block: 617.01 **Lot:** 1

Comments: Insufficient parking. Portion of structure exhibits deteriorating conditions. Varied façade materials.
