*THE*  
*Borough of Emerson*

Municipal Building Study January 2014 - Draft  
146 Linwood Avenue, Borough of Emerson, NJ 07630

Mechanical, Electrical, Plumbing, and Fire Alarm Technical Report

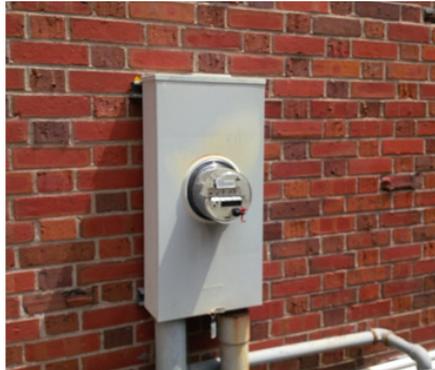
Existing electric service is 120/240VAC, 400A, 1-Phase, 3-Wire. Metering equipment is located on the exterior of the building (see Photo E-1). Main Electric Service Disconnect, Main Distribution Panel (MDP) and Automatic Transfer Switch (ATS) are located in the basement Locker Room Closet (see Photos E-2 & E-3). Telephone board and security system control panel are located in a back closet/room in the basement (see Photo E-4). Other electrical panelboards are located throughout the building.

*E-1 – Main Electric Service Meter*

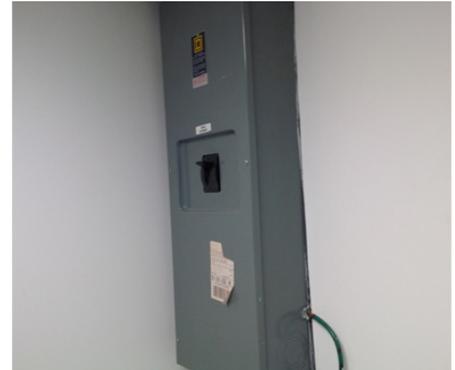
*E-2 – Main Electric Service Disconnect*

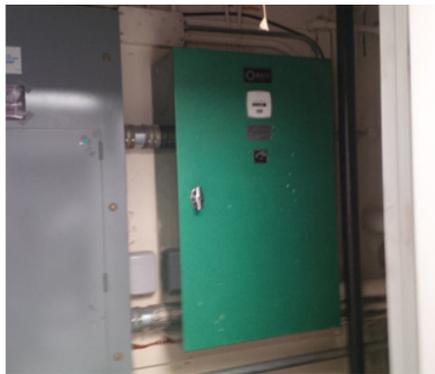
*E-3 – Main Distribution Panel & ATS*

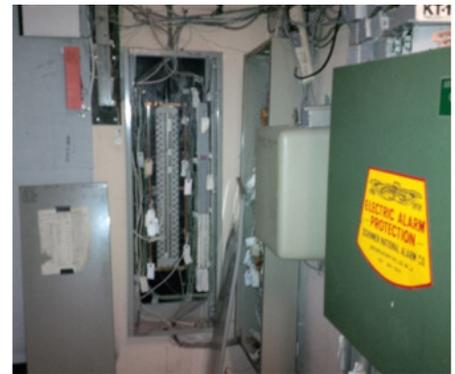
*E-4 – Telephone Board & Security System Panel*

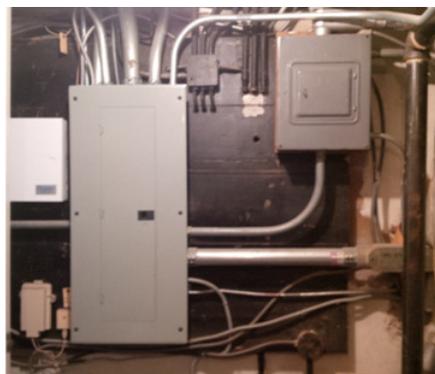
There are sub-panels and equipment disconnects located throughout the building, including the Boiler Room (see Photo E-5) and Administrative offices/spaces. There are HVAC and other electro-mechanical equipment with their own disconnects (see Photo E-6).

*E-5 – Boiler Room Sub-panels*

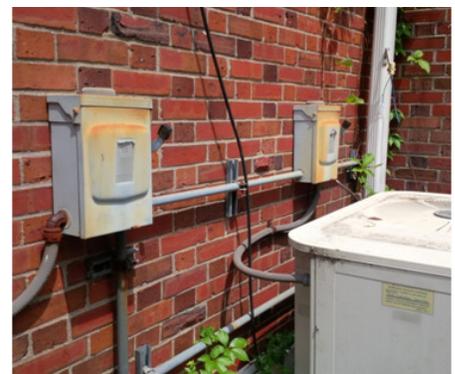
- All exterior electrical boxes and disconnects show signs of corrosion and they are not salvageable.
- There are areas in the building where lighting is insufficient, such as the attic and records room.

*E-6 – HVAC Disconnects*

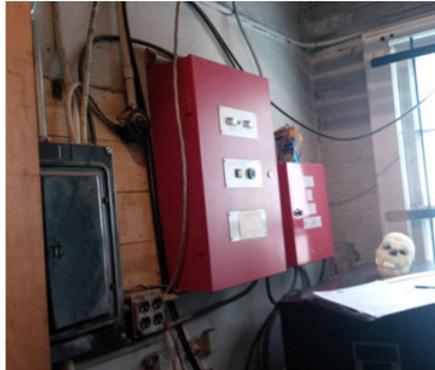
Existing Fire Alarm control panel is a conventional fire alarm system (see Photo E-7). It does not cover the entire building. For example, Police & Clerk/Administrative Departments don't have any fire alarm devices monitoring those spaces.

*E-7 – Fire Alarm Control Panel*

- There is an ADA lift that was not operational at the time of this inspection.
- Fire alarm system is antiquated and needs to be replaced. The proposed fire alarm system should be of “Addressable” type and should monitor the entire building, not just parts of it.

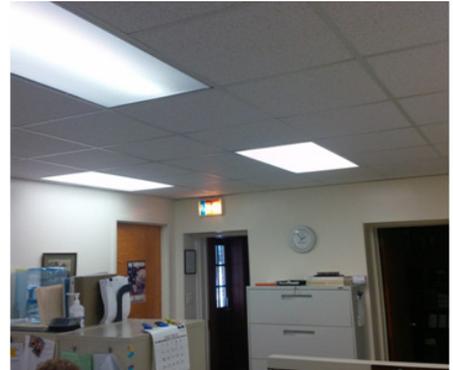
Interior lighting mostly consists of Fluorescent lighting fixtures (see Photo E-8) with high efficient fluorescent lamps. Battery backed up combination Emergency Lighting & Exit Signs are located throughout building's points of egress.

*E-8 – Fluorescent Lighting Fixtures*

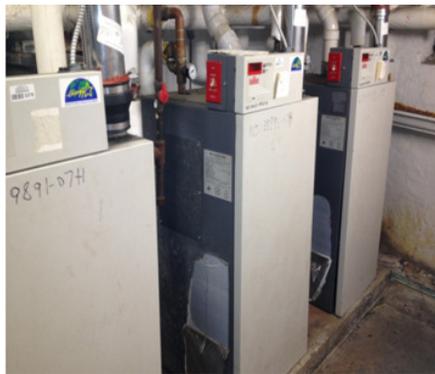
The building is heated via hot water system which consists of three hot water boilers with the capacity of 250,000 BTUH each and floor mounted fan coil units. Based on the information provided during the site visit the boilers were installed more than 12 years ago (see Photo M-1). The building is equipped with Trane hot water free standing fan coil units (see Photo M-2).

*M-1 - Hot Water Boilers*

The hot water boilers serving the entire building are old. Based on the information received from the maintenance personnel during the site visit, all three boilers are constantly working during the heating season and they need to be manually controlled. The automatic boiler controls are not functioning properly. Two hot water pumps, expansion tank and piping are old and rusty and at the end of their useful lives. Pipe insulation is damaged (see Photos M-12). Hot water heating system and equipment in the mechanical room need to be replaced; pipe insulation in the boiler room needs to be replaced. Boiler concrete pads need to be repaired.

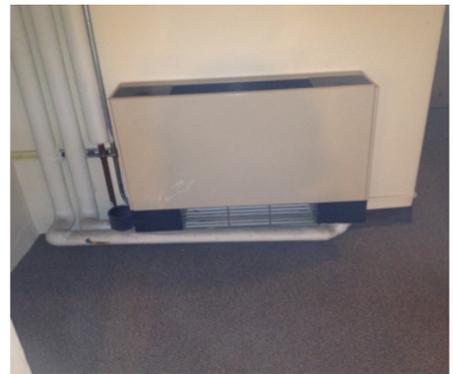
The free standing fan coil units appear to be in good working condition.

*M-2 - Fan Coil Units*

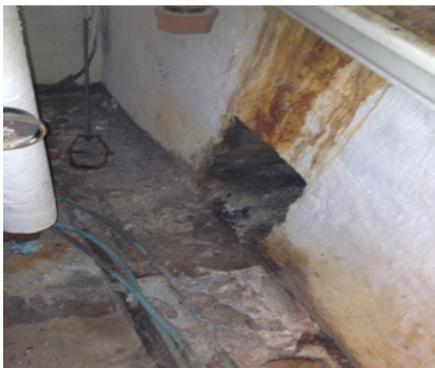
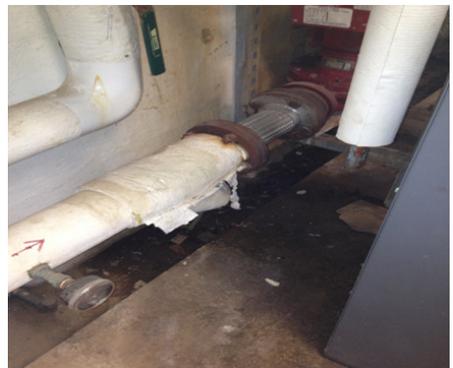
There are two hot water circulation pumps located in the boiler room. The mechanical room walls and equipment maintenance concrete pads are damaged by water leakage (see Photos M-3, M-3A).

*M-3 - Hot Water Circulation Pump & Evidence of Water Damage*

*M-3A - Hot Water Circulation Pump & Evidence of Concrete Pad Water Damage*

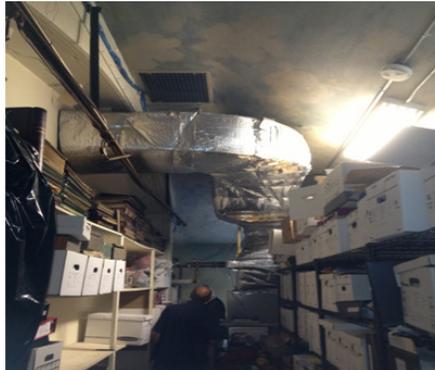
Building is cooled via local window air conditioning units. Only the Court Room (Counselor Chamber Room) is equipped with a Central Air Conditioning Split System. The Court room (Counselor Chamber Room) is served by a dedicated Air Conditioning Split System which consists of a 10-ton indoor Air Handling Unit (AHU) located in the storage room adjacent to the court room (see Photo M-4). This AHU is equipped with duct mounted hot water coil, a dedicated outdoor air-cooled condensing unit, and an evaporator

*M-4 - 10 Ton Air Handling Unit*

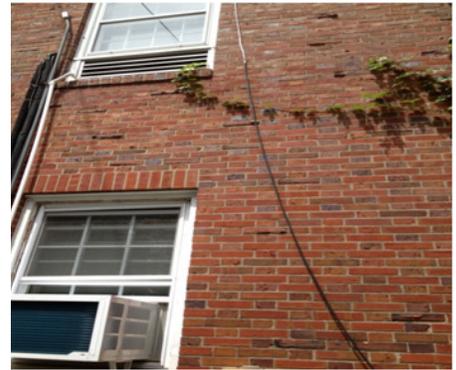
fan which provides conditioned air required for the Heating, Cooling and Ventilation. This A/C unit refrigeration system utilizes R22 refrigerant. A system ductwork from AHU unit distributes air to the space via sets of ductwork and ceiling diffusers/grilles. The system is controlled via wall mounted thermostat located in the court room. An outdoor air cooled condensing unit is connected to AHU unit via refrigerant lines which run along the exterior wall all the way up from the condensing unit to the AHU (see Photo M-5). The outside air intake ductwork is equipped with motorized damper and it is connected to an external louver located below the window in the closet adjacent to Court Room where AHU is located (see Photos M-6 & M-11). This outside air is required for ventilation.

*M-5 -Refrigerant Piping Serving Air Handling Unit*

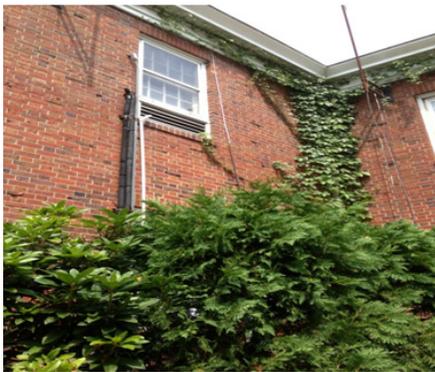
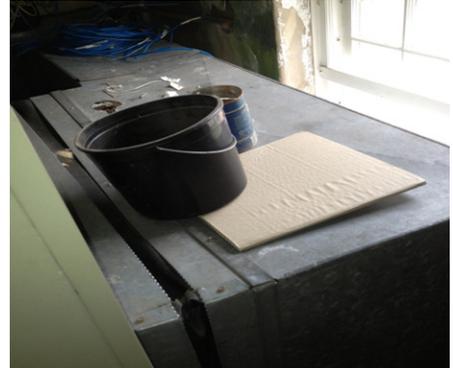
*M-6 - Outside Air Motorized Damper Under the Window*

*M-11 - Outside Air Motorized Damper*

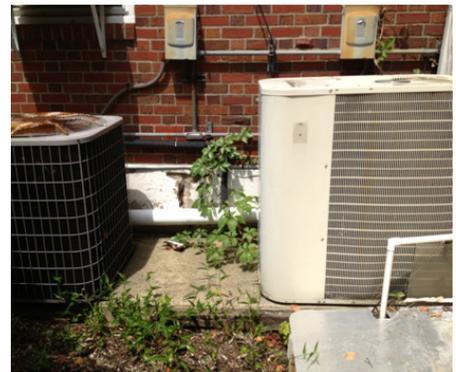
There is an abandoned air cooled condensing unit located outside next to condensing unit serving court room (see Photo M-7).

*M-7 - Abandoned Air Cooled Condensing Unit*

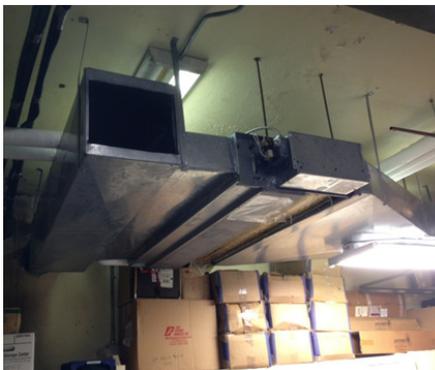
There is a dedicated Air Handling Unit serving part of clerk offices and administration offices. This unit is a heating unit only (no cooling). It is located in property equipment room (see Photo M-8). The heat from this unit is supplied into the space via ductwork distribution and ceiling mounted diffusers/grilles. Cooling in clerk and administration offices is provided via multiple A/C windows units (picture M-9). Communications office is equipped with ductless split system which consists of a wall-mounted ductless Air handling Unit and a dedicated outdoor condensing unit (see Photo M-10).

*M-8 - Heating Only Air Handling Unit*

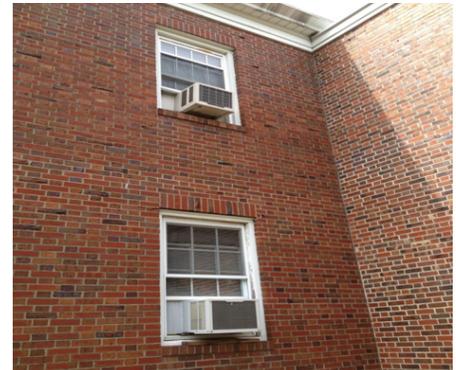
During the cooling season the ventilation is achieved via the window Air Conditioning units installed in some offices/rooms. The split HVAC system serving Court room appears to be in good working condition. The indoor air handling unit and outdoor condensing unit are working properly. The fresh air is supplied via the exterior louver located below the window.

*M-9 - A/C Window Units*

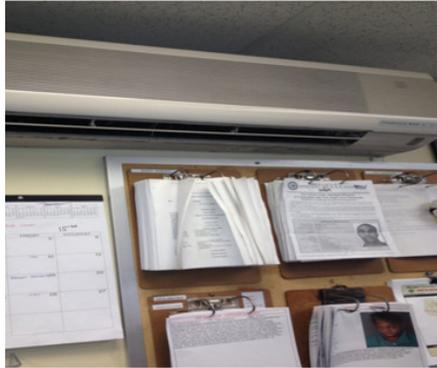
*M-10 - Ductless Split System*

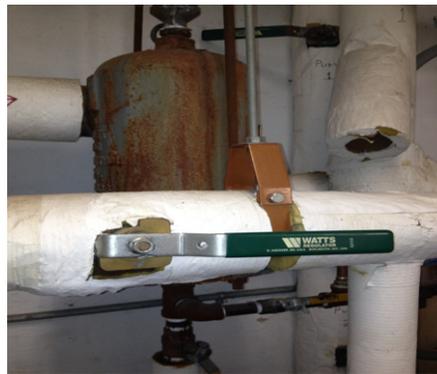
*M-12- Old/Damaged Hot water Pumps, Expansion Tank and Pipe Insulation*

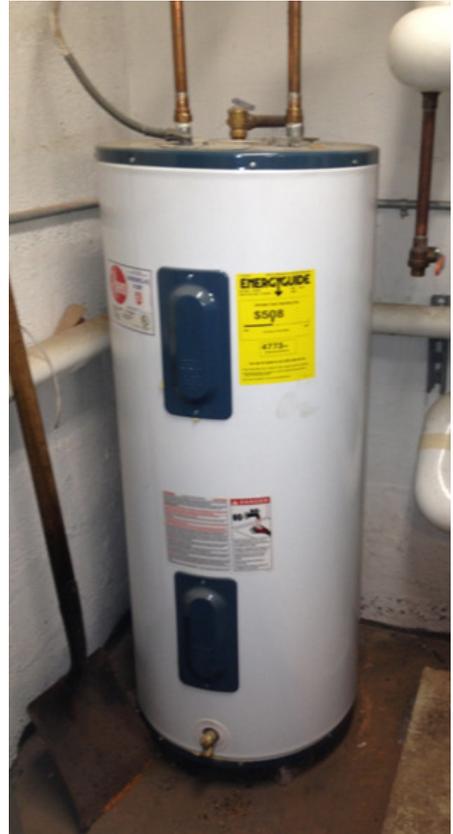
The 50 gallon domestic hot water heater located in the boiler room is in good working condition along with associated hot and cold water pipes (see Photo P-2).

*P-2 - Domestic Hot Water Heater*

It was noted that the hot water circulation pump is not installed in the building; therefore the occupants are complaining that it takes a very long time for the hot water to reach the sinks. It is recommended to install hot water circulation pump along with hot water return pipe to achieve proper domestic hot water circulation in the space.

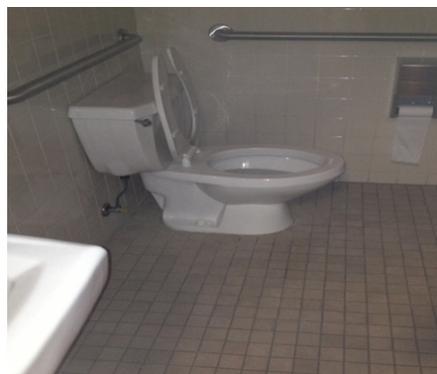
There are public bathrooms on the first and second floors. They are equipped with ADA plumbing fixtures. It was not possible to observe the plumbing pipes during the site visit, but the plumbing fixtures are in good condition (see Photos P-1).

*P-1 - Plumbing Fixture*
